# Appendix D

## Phase I Site Reconnaissance, Field Notes, Photographs, and Photo Logs Part 1

**HST PHASE I ENVIRONMENTAL SITE ASSESSMENT**

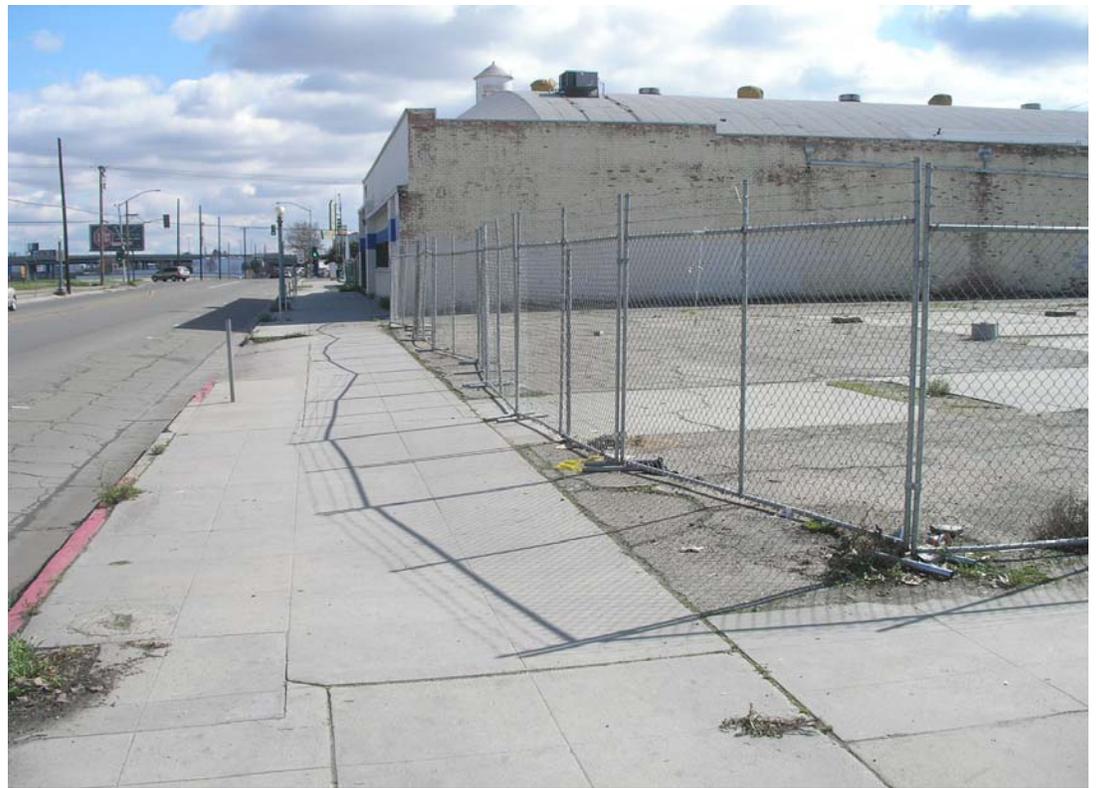
<p><b>Photo No.</b>  <b>2</b></p>	
<p><b>Direction Photo Taken:</b>                   Looking southwest</p>	
<p><b>Description:</b>                   Looking at the vacant site from the northwest corner. Note the former service station foundation and dispenser island location.</p>

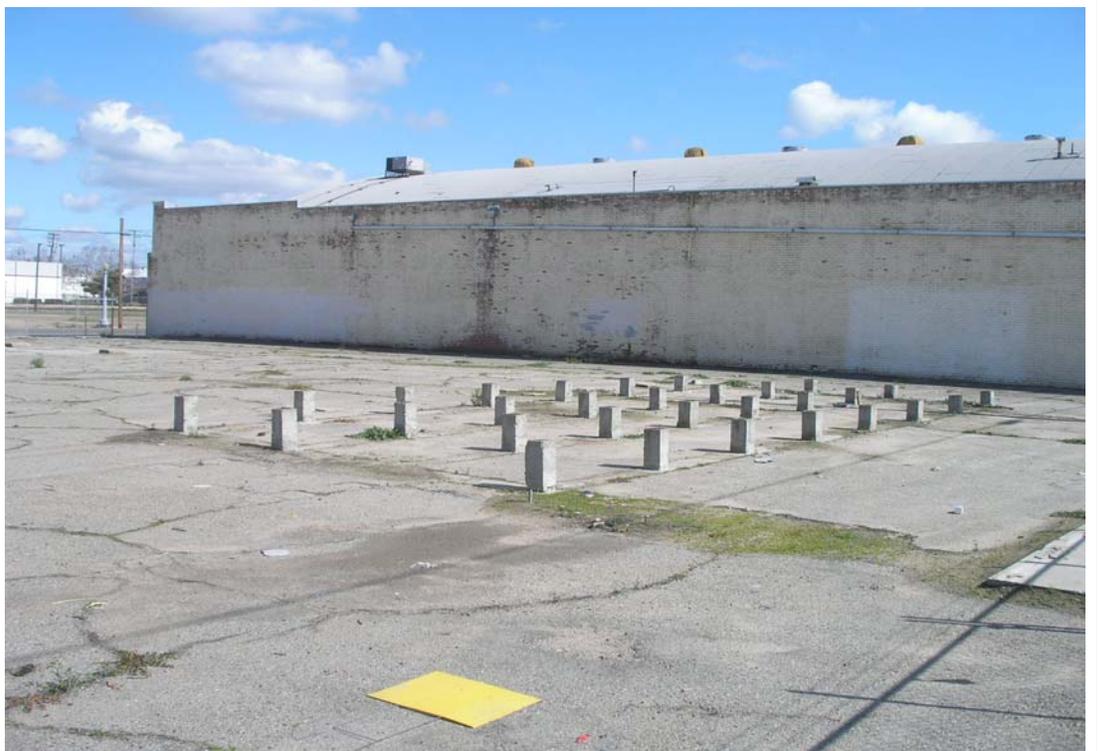
<p><b>Photo No.</b>  <b>4</b></p>	
<p><b>Direction Photo Taken:</b>                   Looking southeast</p>	
<p><b>Description:</b>                   Looking across the vacant site from the northwest corner. The use of the concrete pillars is unknown.</p>

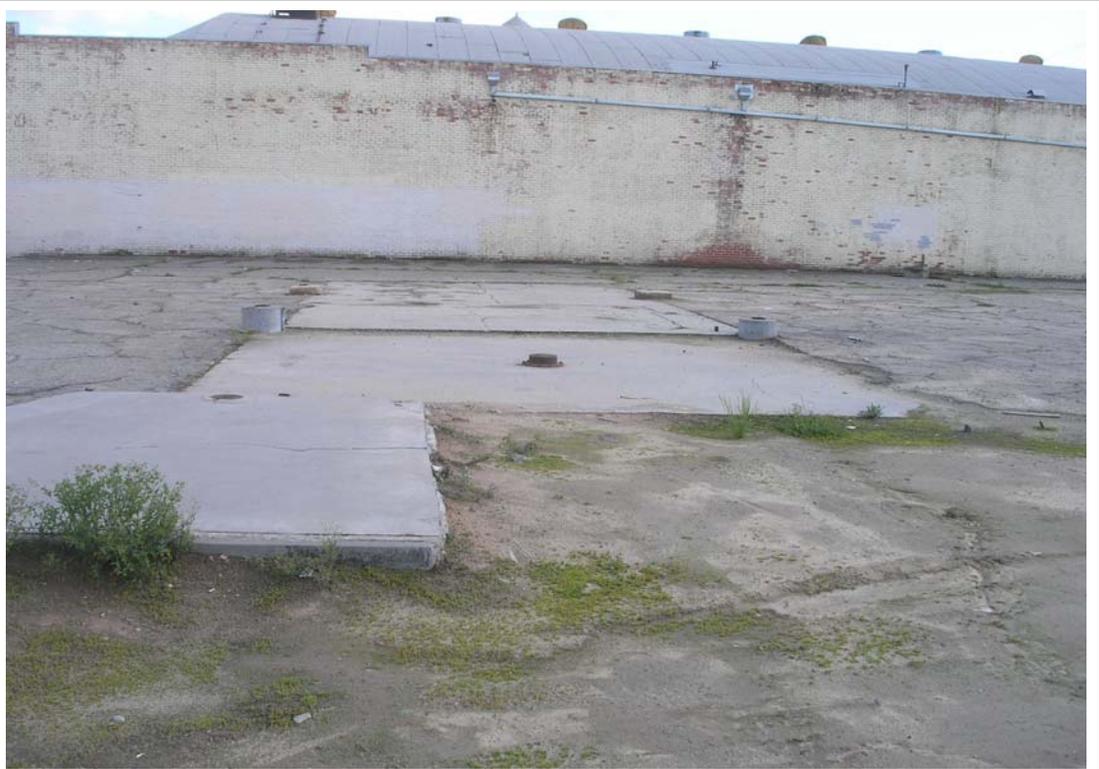
<p>Photo No.  <b>8</b></p>	
<p>Direction Photo Taken:                  Looking south</p>	
<p>Description:                  View of the vacant site and the former service station foundation. Note the in-ground hydraulic lift and the former UST location.</p>

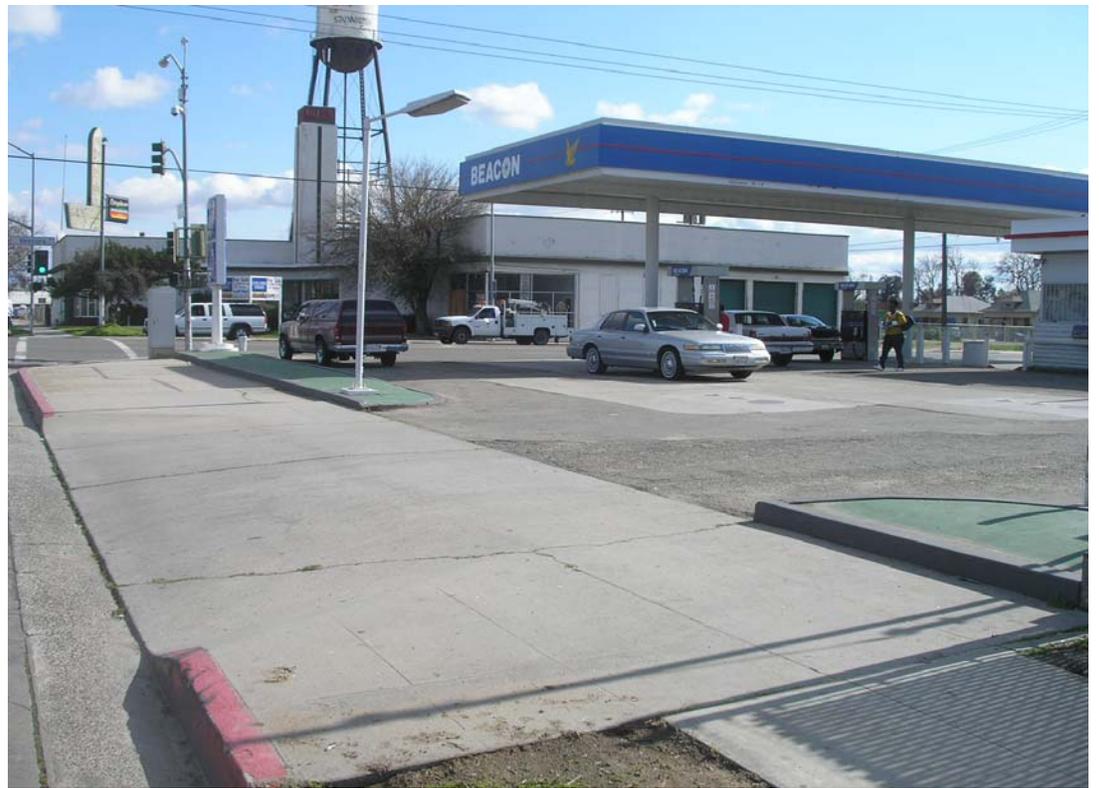
<p>Photo No.  <b>2</b></p>	
<p>Direction Photo Taken:                  Looking south</p>	
<p>Description:                  View of the UST location on the east side of the site. It appears that the tanks have been replaced at some point.</p>

10. What is the condition of the tanks as indicated by visual inspection etc.? GOOD (TANKS WERE REPLACED)

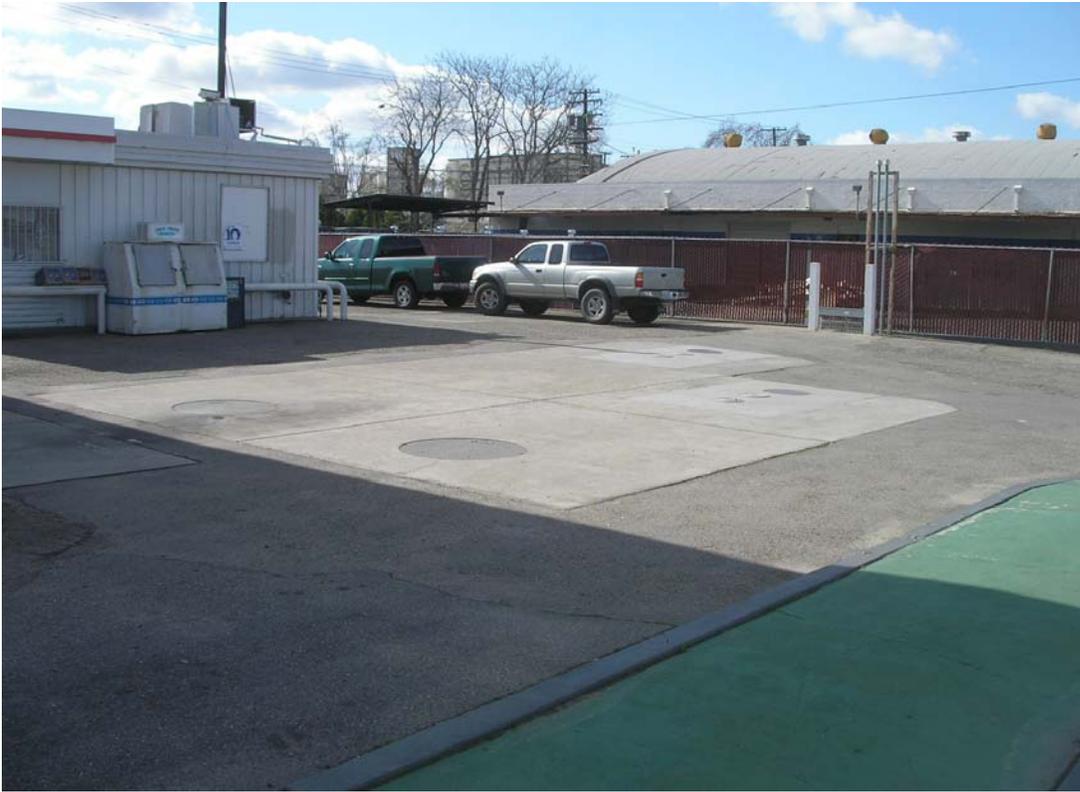
<p>Photo No.  <b>3</b></p>

<p>Direction Photo Taken:                  Looking northwest</p>	
<p>Description:                  Another view of the UST location.</p>

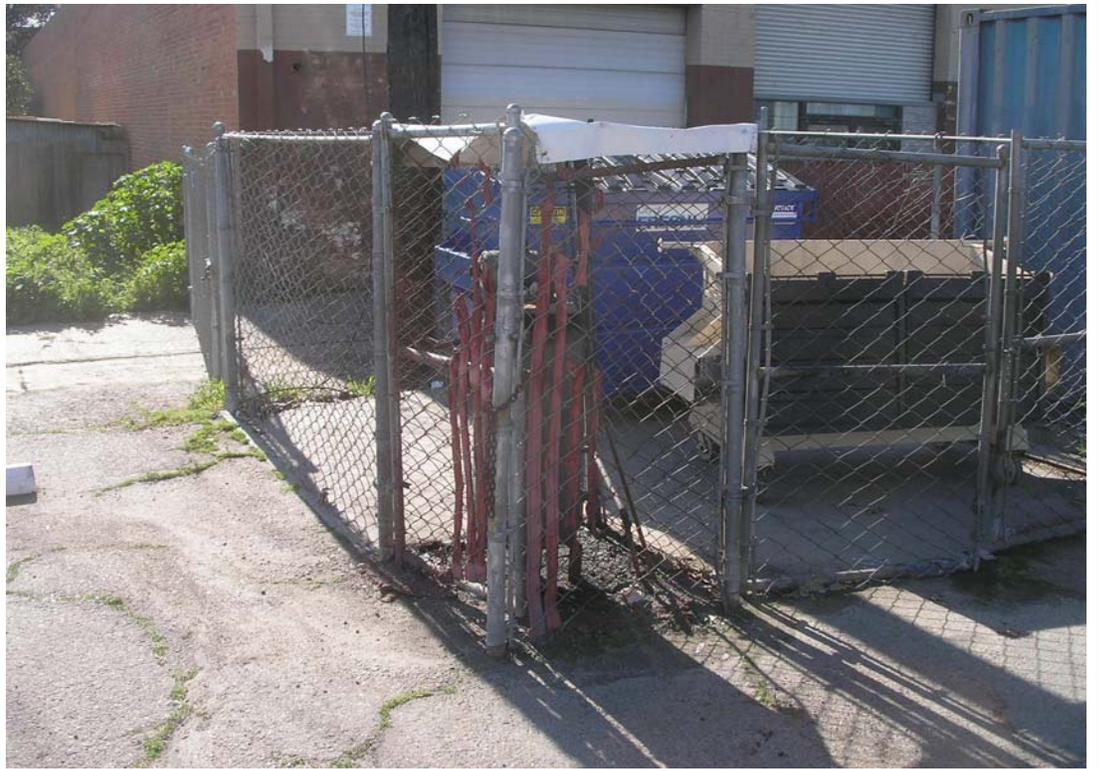
<p>Photo No.  <b>7</b></p>	
<p>Direction Photo Taken:                  Looking west</p>	
<p>Description:                  Dumpster, recycle bins, and burned out compressor in the northwest corner of the site.</p>

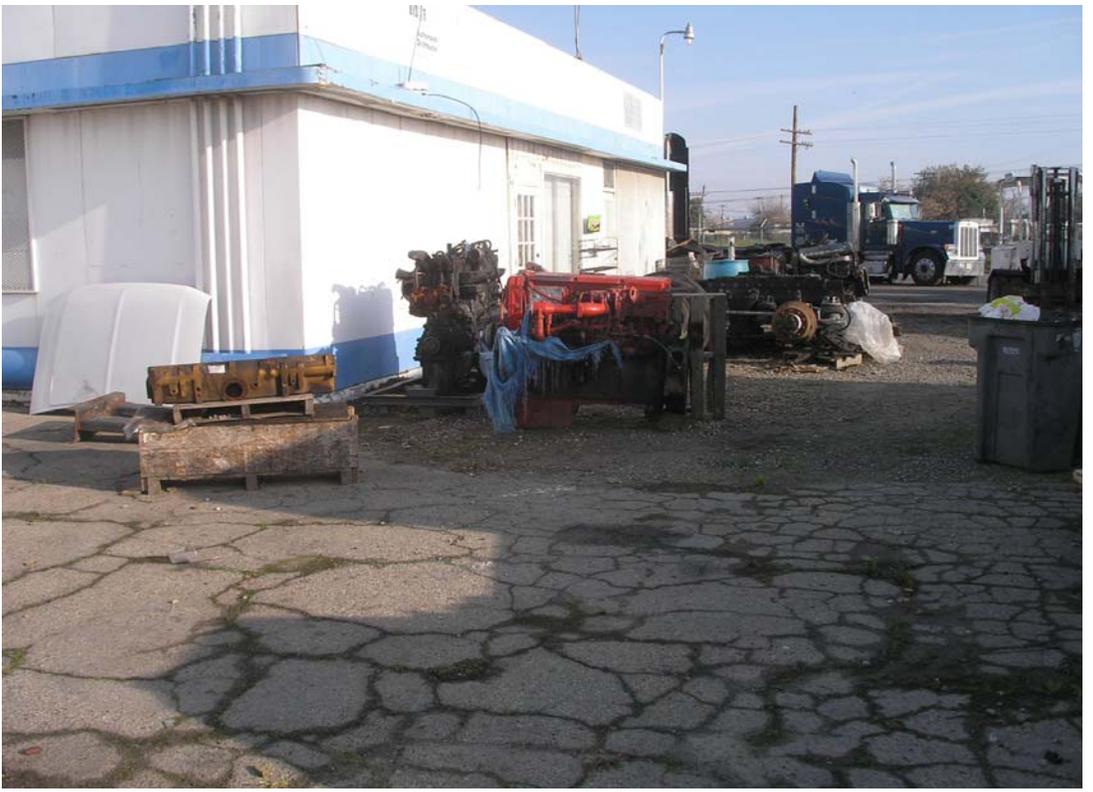
<p><b>Direction Photo Taken:</b>                   Looking northeast</p>	
<p><b>Description:</b>                   Diesel motors and used trucks stored on the southeast side of the shop.</p>

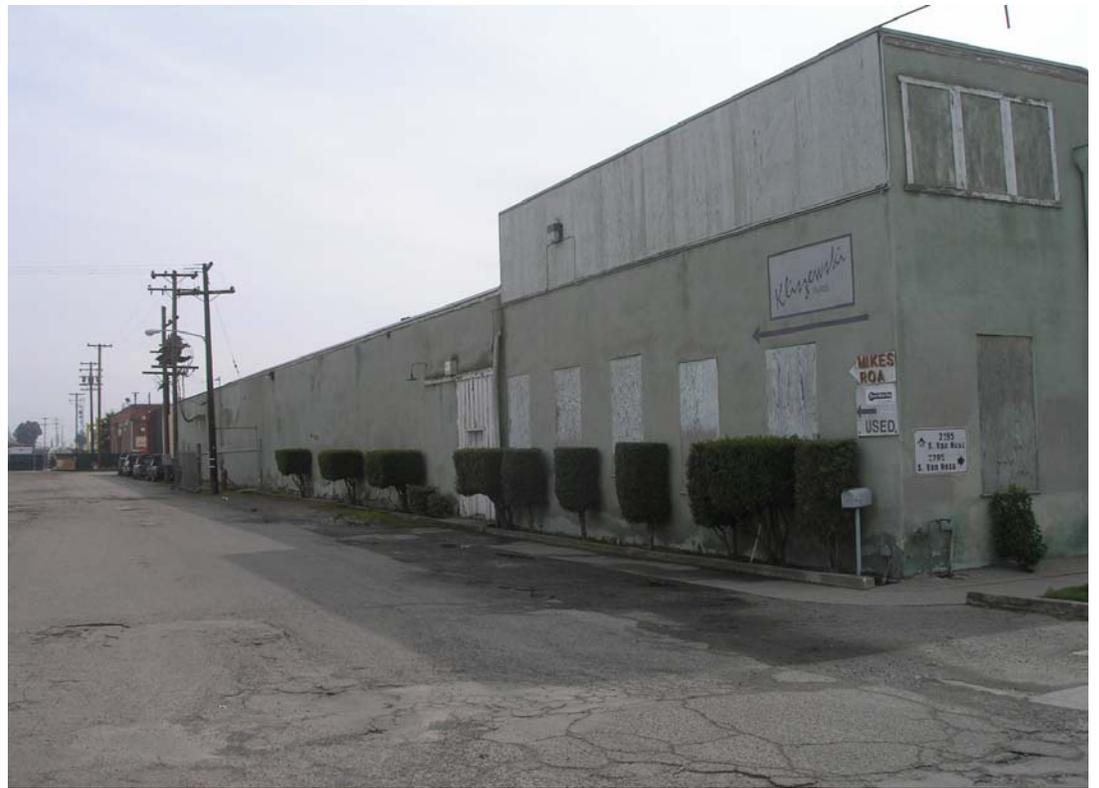
<p>Photo No.  <b>3</b></p>	
<p>Direction Photo Taken:                   Looking east</p>	
<p>Description:                   Looking at the north side of the Facility along Lorena Avenue. Note the vintage pole-mounted transformers in the left-center of the frame.</p>

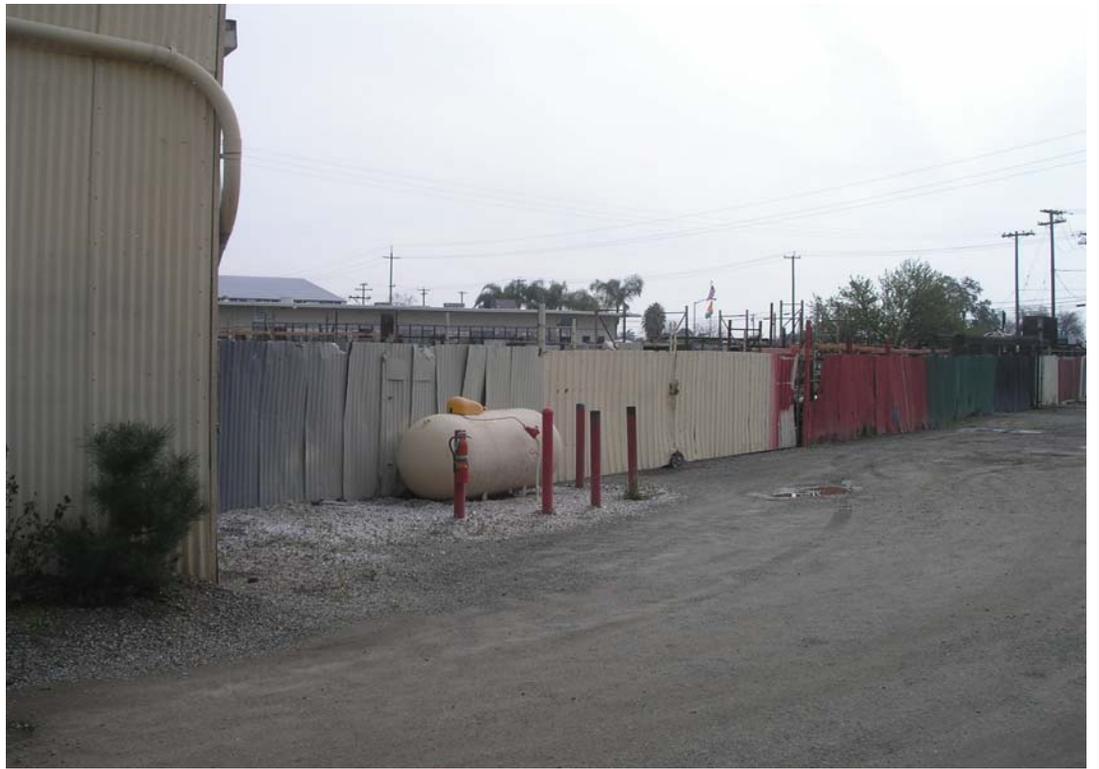
<p><b>Photo No.</b>  <b>7</b></p>	
<p><b>Direction Photo Taken:</b>                   Looking southeast</p>	
<p><b>Description:</b>                   View of the storage yard at the south end of the property. Note the propane tank.</p>

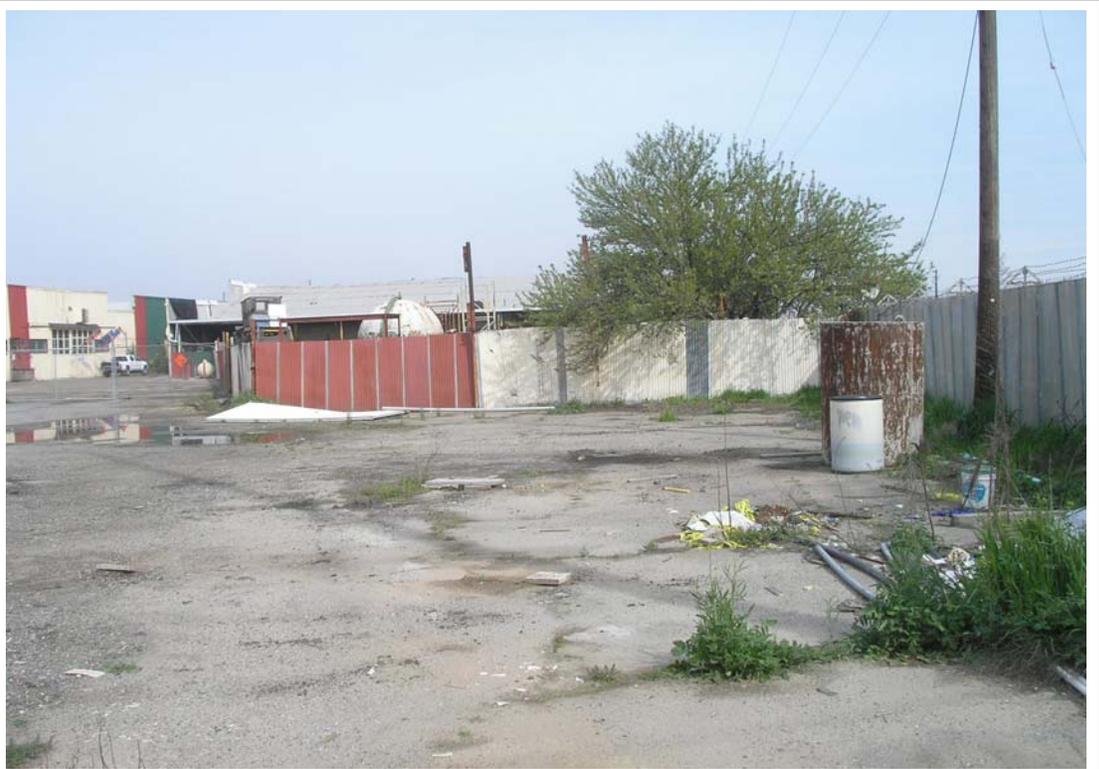
<p><b>Photo No.</b>  <b>8</b></p>	
<p><b>Direction Photo Taken:</b>                   Looking north</p>	
<p><b>Description:</b>                   Another view of the storage yard at the south end of the property. Note unused ASTs.</p>

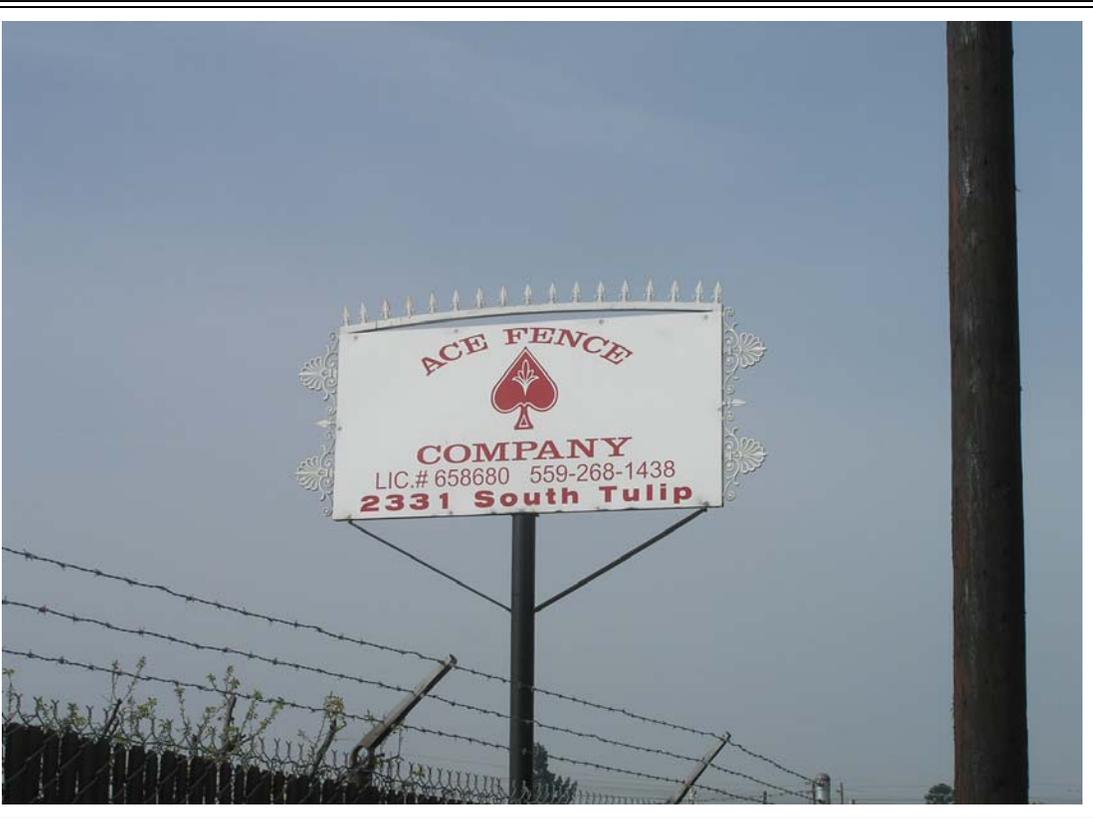
<p><b>Photo No.</b>  <b>1</b></p>

<p><b>Direction Photo Taken:</b>                   Looking west</p>	
<p><b>Description:</b>                   Ace Fence Company currently occupies the former Caltrans Service Yard Site.</p>

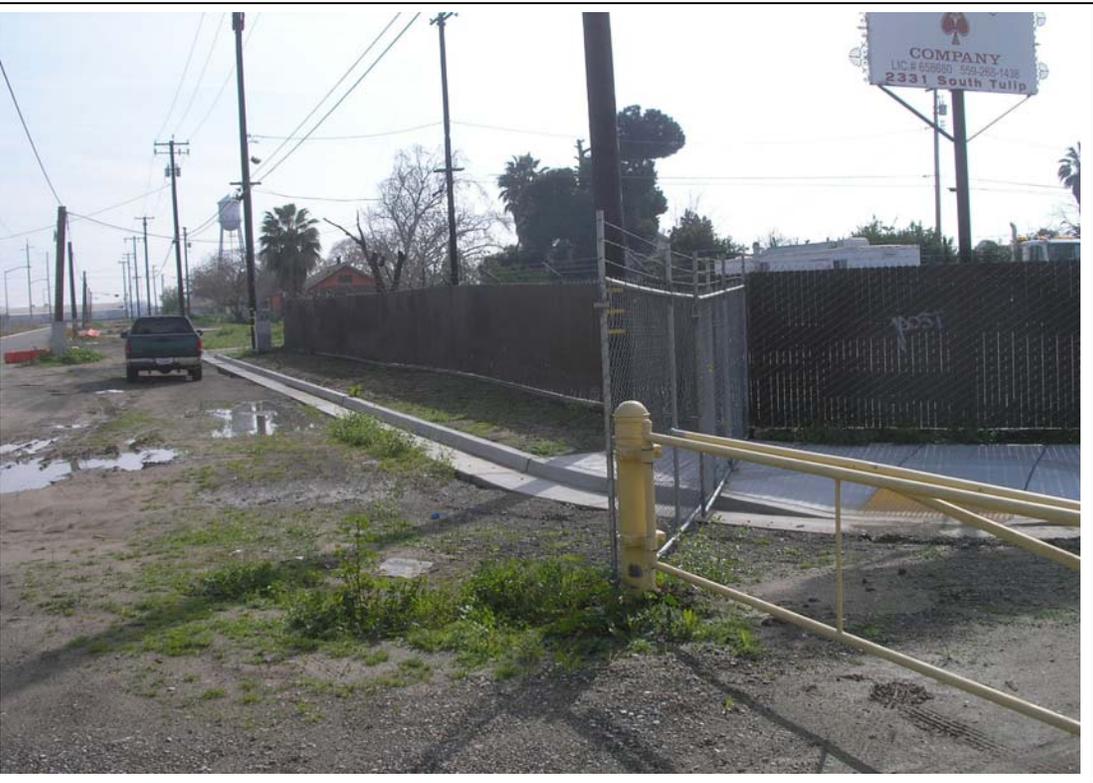
<p><b>Photo No.</b>  <b>2</b></p>

<p><b>Direction Photo Taken:</b>                   Looking east</p>	
<p><b>Description:</b>                   View of the north side of the site along Florence Avenue (under reconstruction).</p>

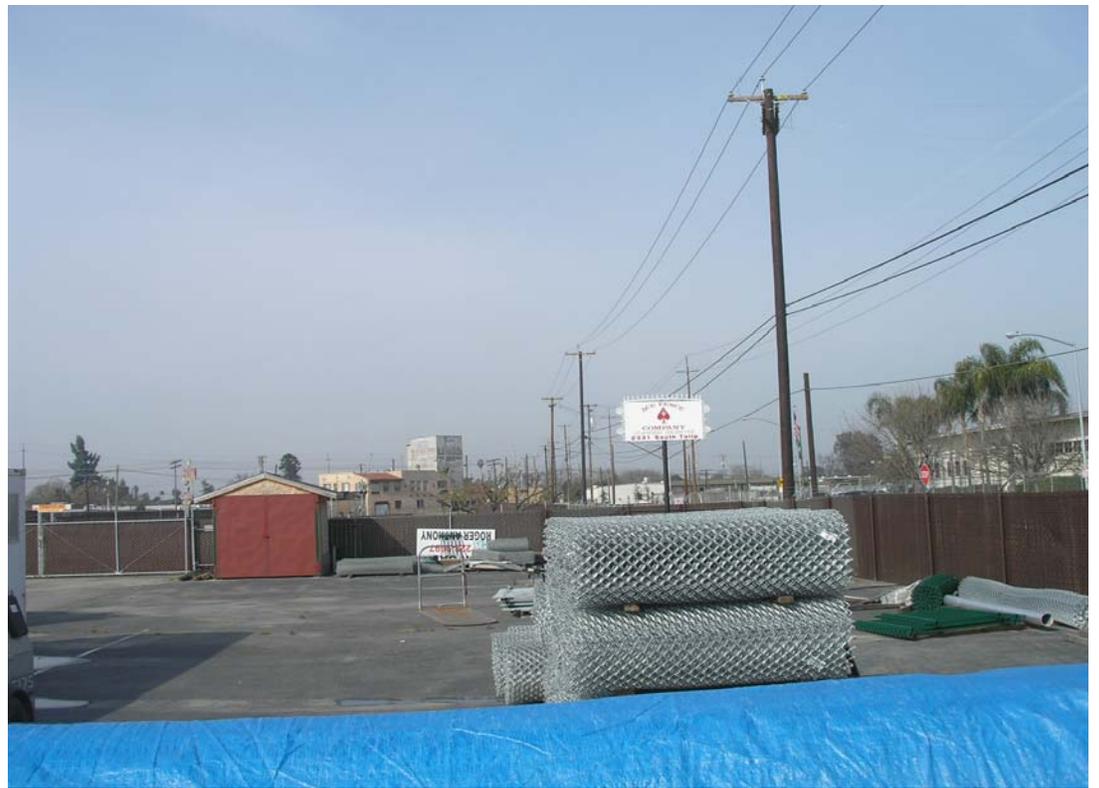
<p>Photo No.  <b>3</b></p>	
<p>Direction Photo Taken:                  Looking west</p>	
<p>Description:                  Material stored in the north end of the site.</p>

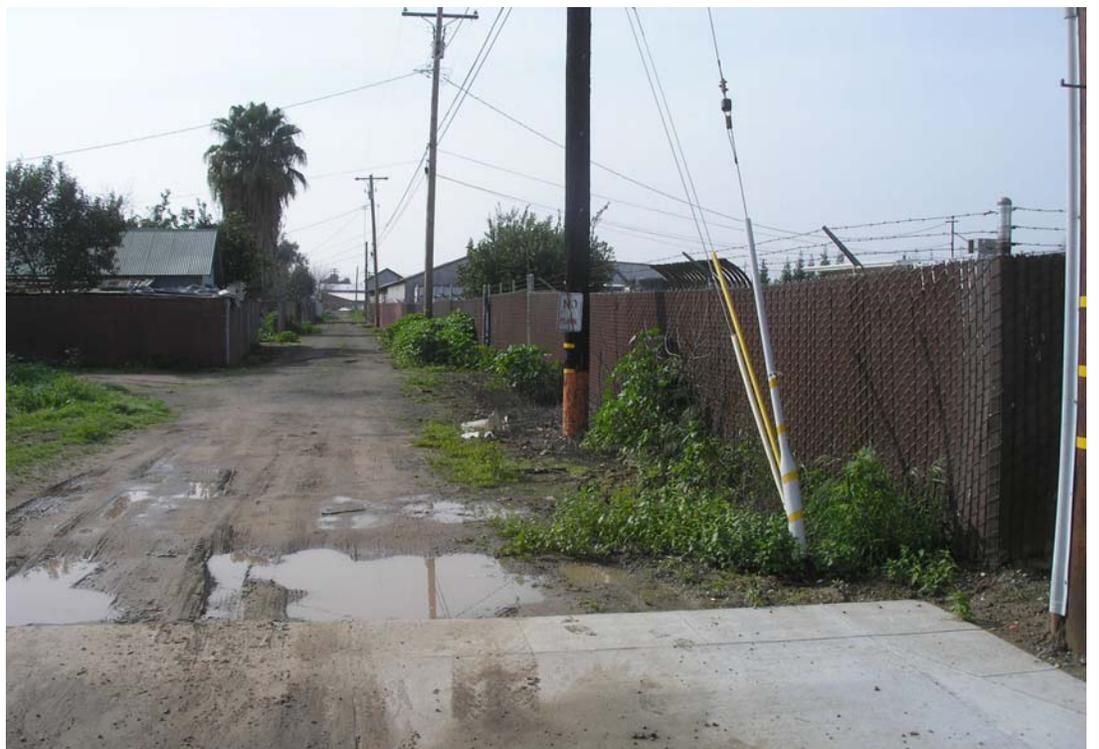
<p>Photo No.  <b>4</b></p>	
<p>Direction Photo Taken:                  Looking south</p>	
<p>Description:                  Looking down the alley on the east side of the site.</p>

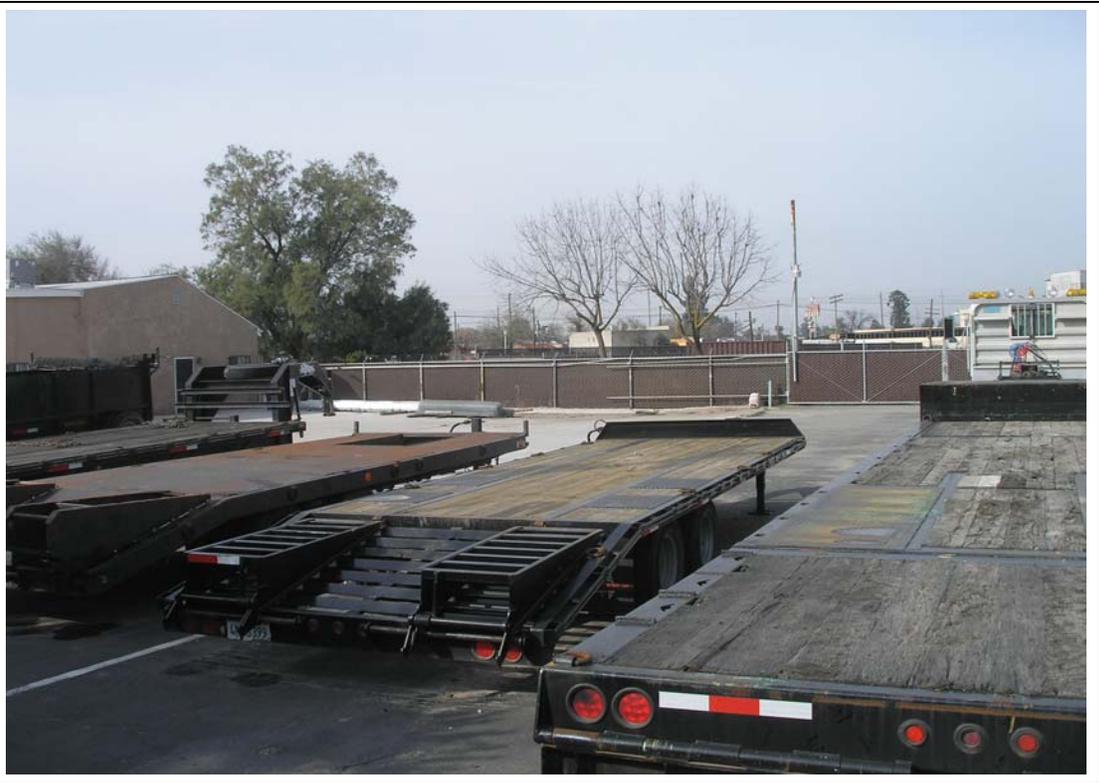
<p><b>Photo No.</b>  <b>5</b></p>
<p><b>Direction Photo Taken:</b>                   Looking west</p>
<p><b>Description:</b>                   Trailers stored in the north end of the site.</p>

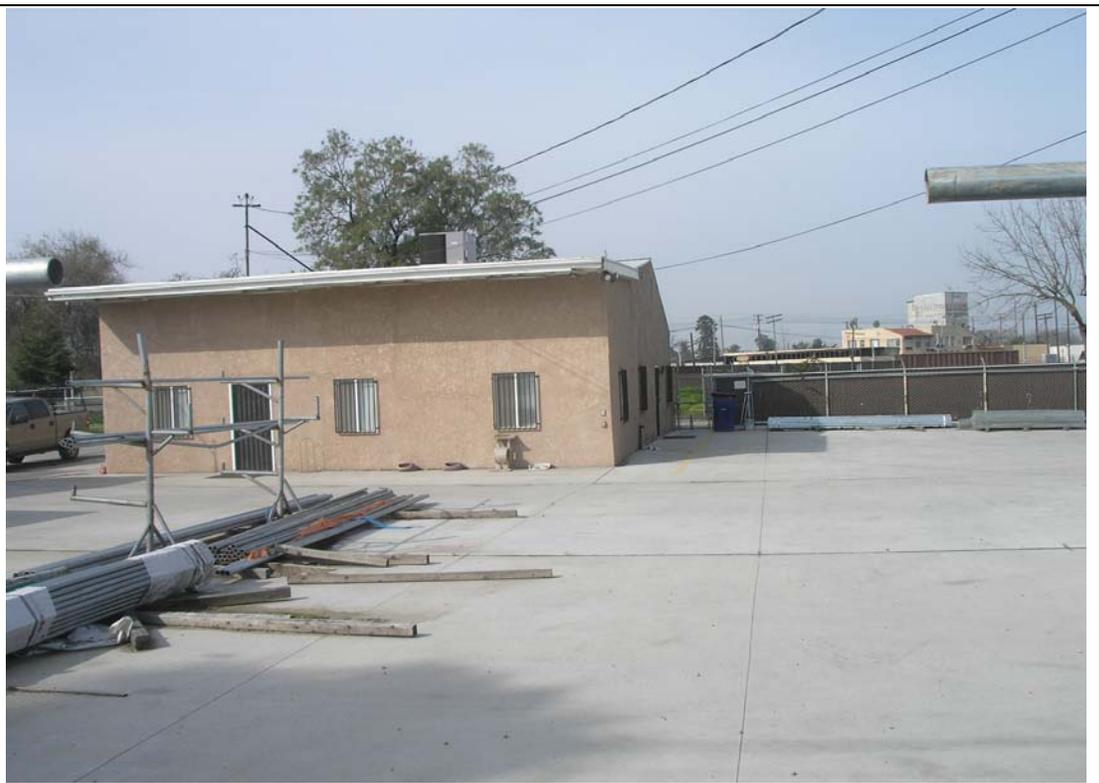
<p><b>Photo No.</b>  <b>6</b></p>
<p><b>Direction Photo Taken:</b>                   Looking west</p>
<p><b>Description:</b>                   Material stored in the north end of the site and the east side of the office building.</p>

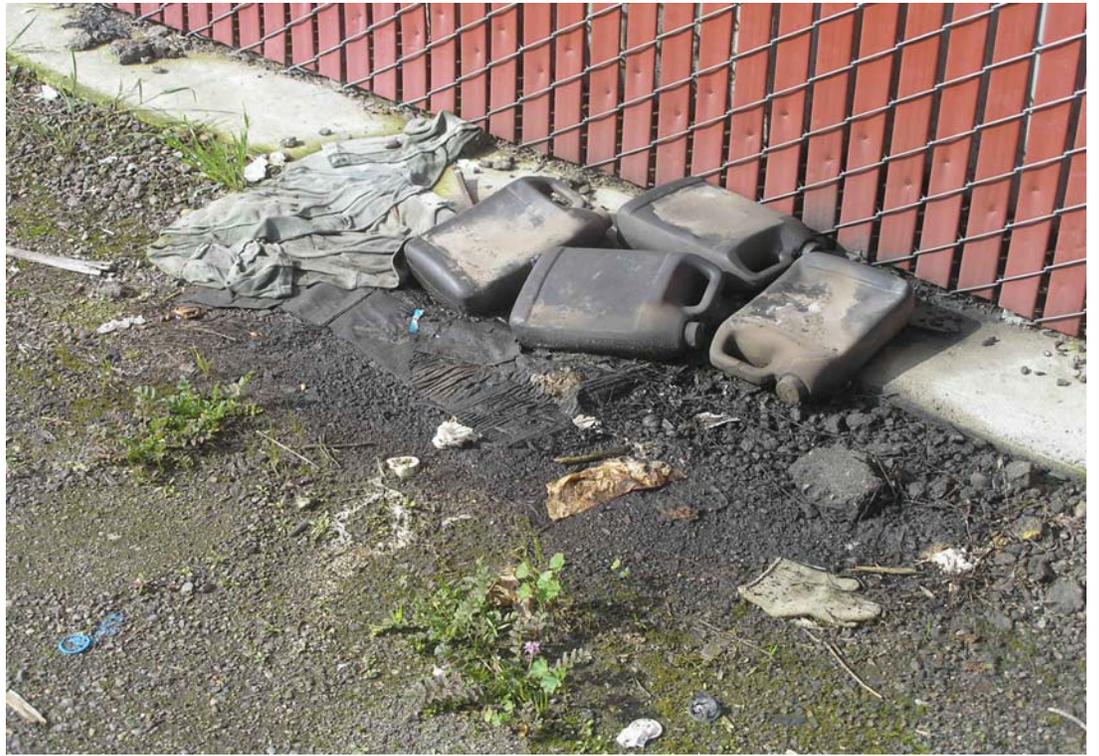
<p>Photo No. 7</p>	
<p>Direction Photo Taken:  Looking southwest</p>	
<p>Description:  Used motor oil dumped in the alley on the east side of the site.</p>

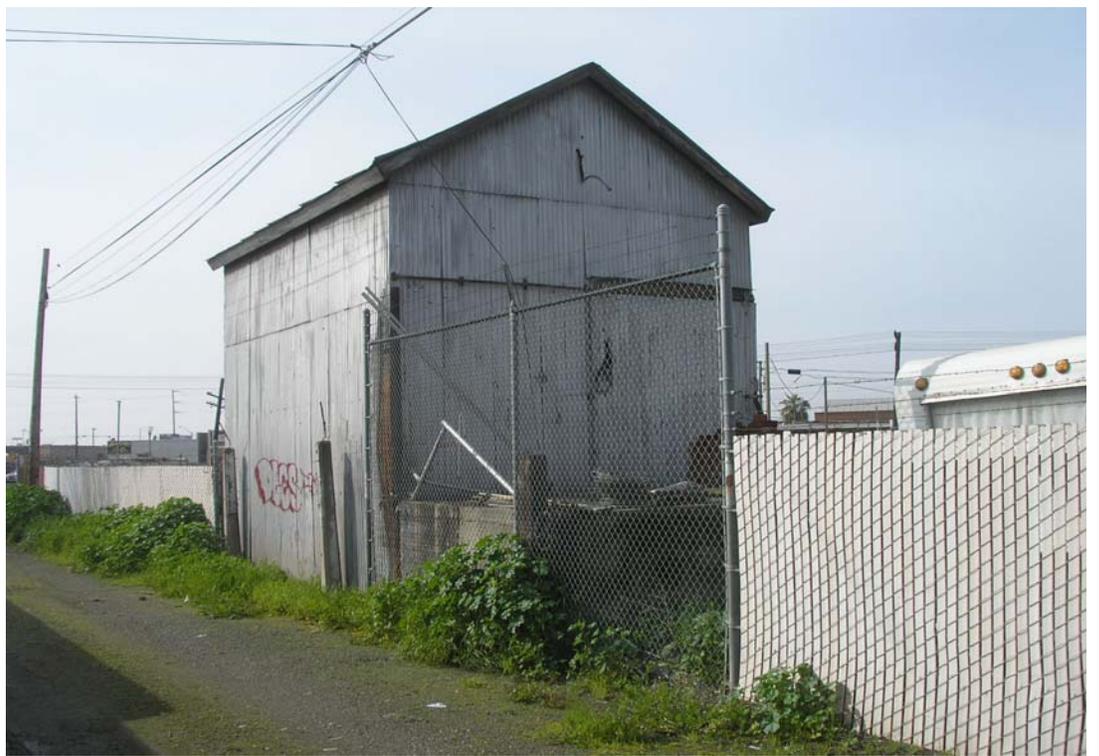
<p>Photo No. 8</p>	
<p>Direction Photo Taken:  Looking southwest</p>	
<p>Description:  Former Caltrans receiving shed. Note tar-covered loading dock.</p>

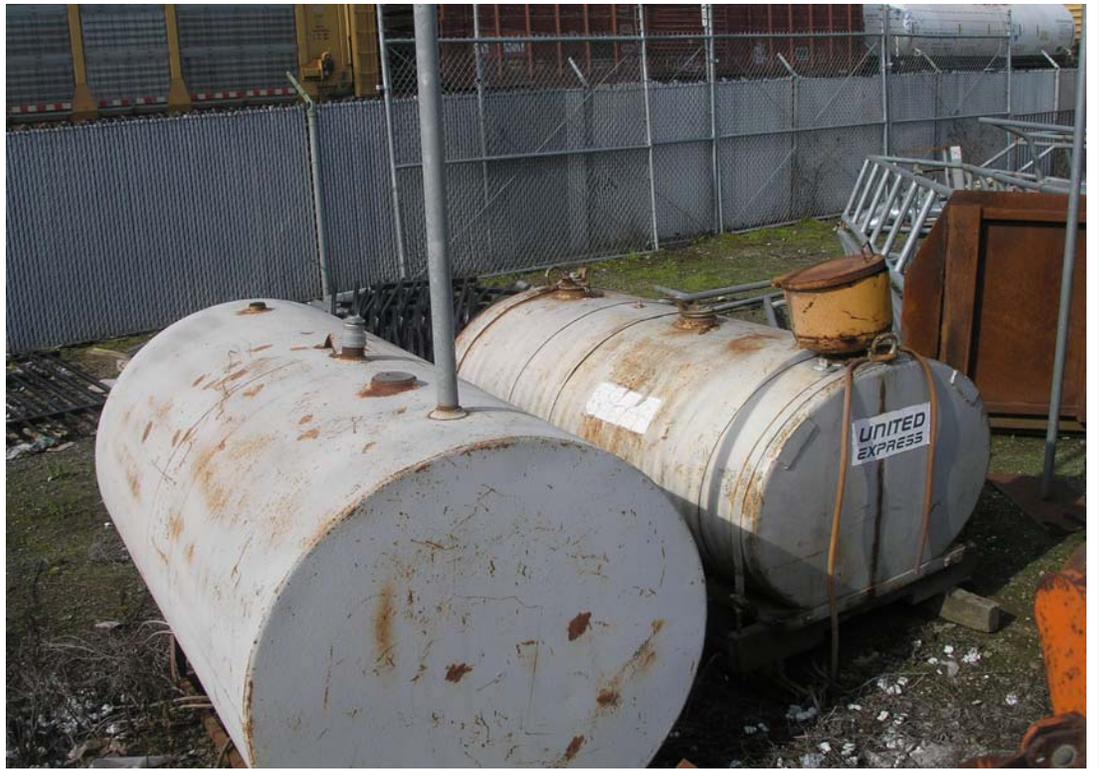
<p>Photo No.  <b>9</b></p>
<p>Direction Photo Taken:                  Looking west</p>
<p>Description:                  Unused ASTs stored at the south end of the site.</p>

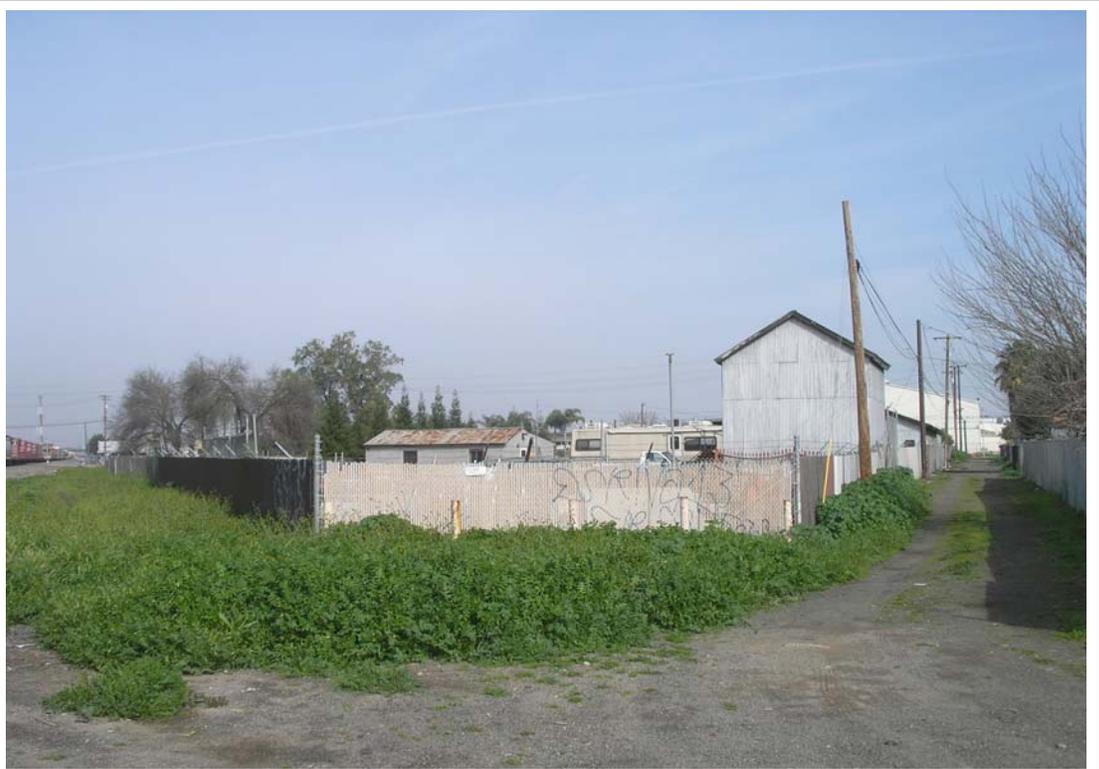
<p>Photo No.  <b>10</b></p>
<p>Direction Photo Taken:                  Looking north</p>
<p>Description:                  View of the south end of the site. Note the Union Pacific tracks in the left of the frame and the alley along the east side of the site on the right.</p>

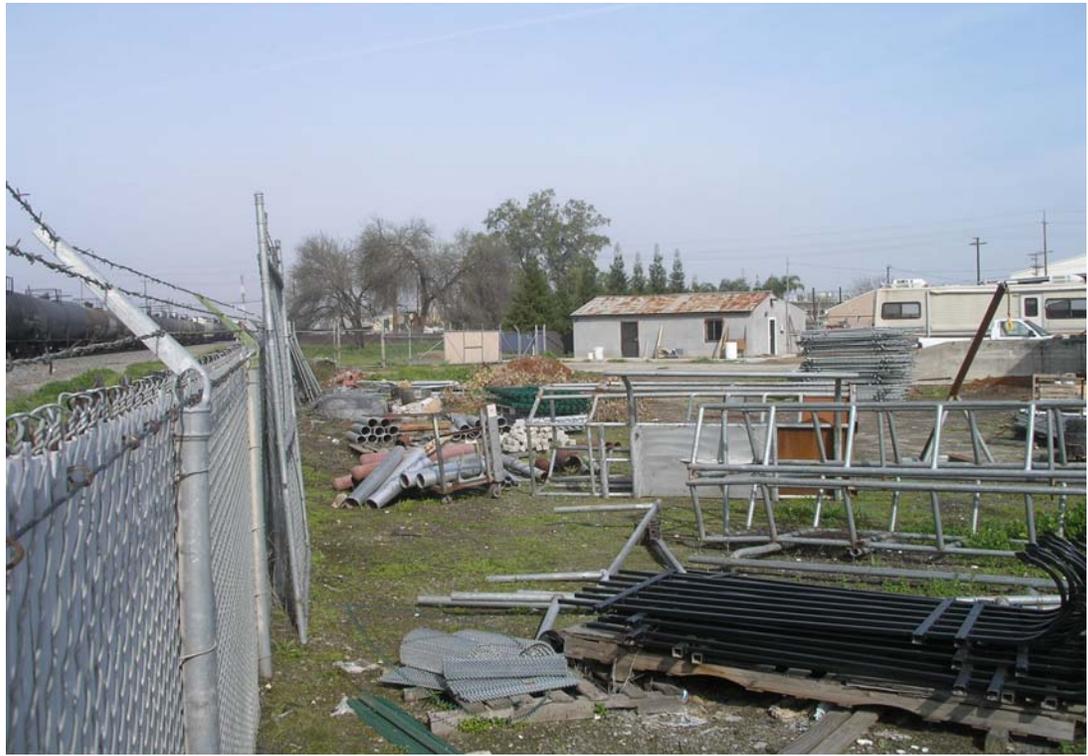
<p><b>Photo No.</b>  <b>11</b></p>

<p><b>Direction Photo Taken:</b>                   Looking northwest</p>	
<p><b>Description:</b>                   Material stored in the south end of the site.</p>

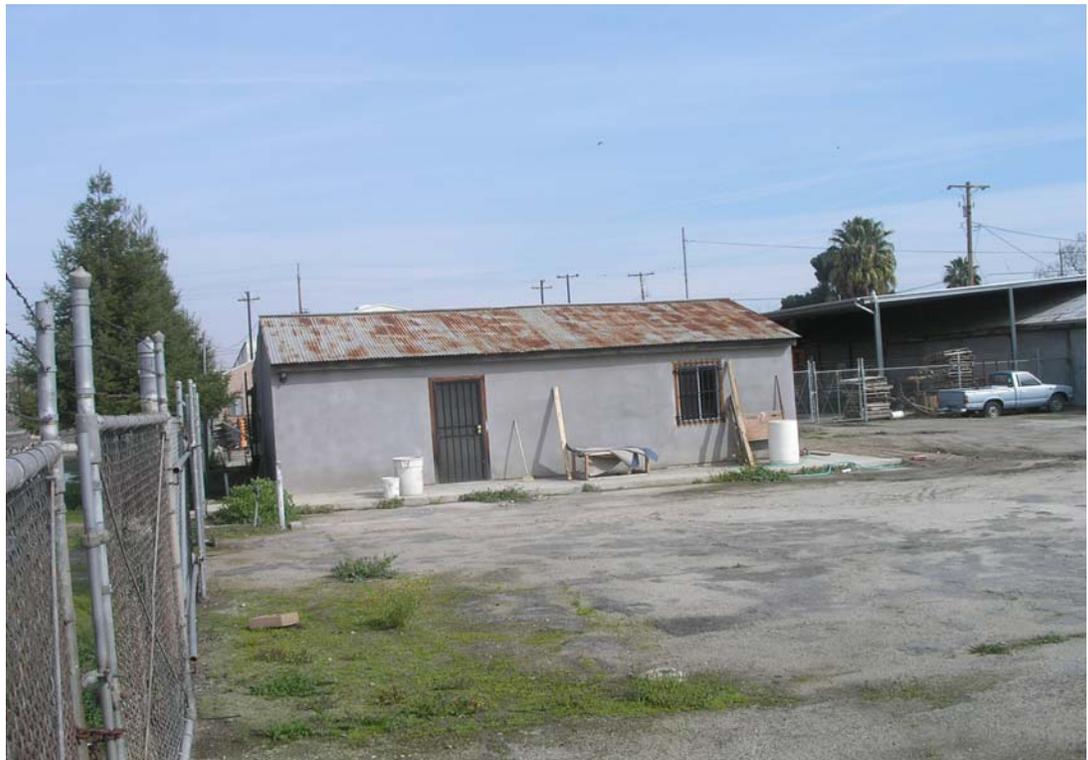
<p><b>Photo No.</b>  <b>12</b></p>

<p><b>Direction Photo Taken:</b>                   Looking north</p>	
<p><b>Description:</b>                   Former Caltrans business office located in the west-central part of the site.</p>

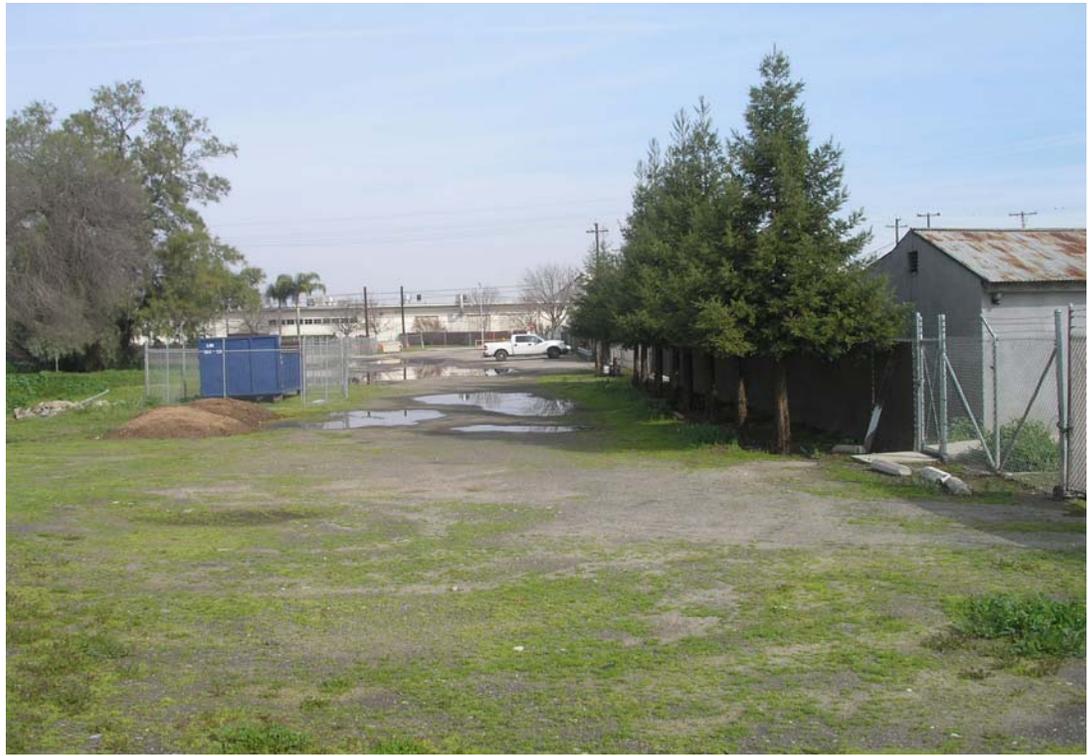
<p><b>Photo No.</b>  <b>13</b></p>

<p><b>Direction Photo Taken:</b>                   Looking north</p>	
<p><b>Description:</b>                   View along the west side of the site. Roll-off dumpster and debris piles belong to Ace Fence Company.</p>

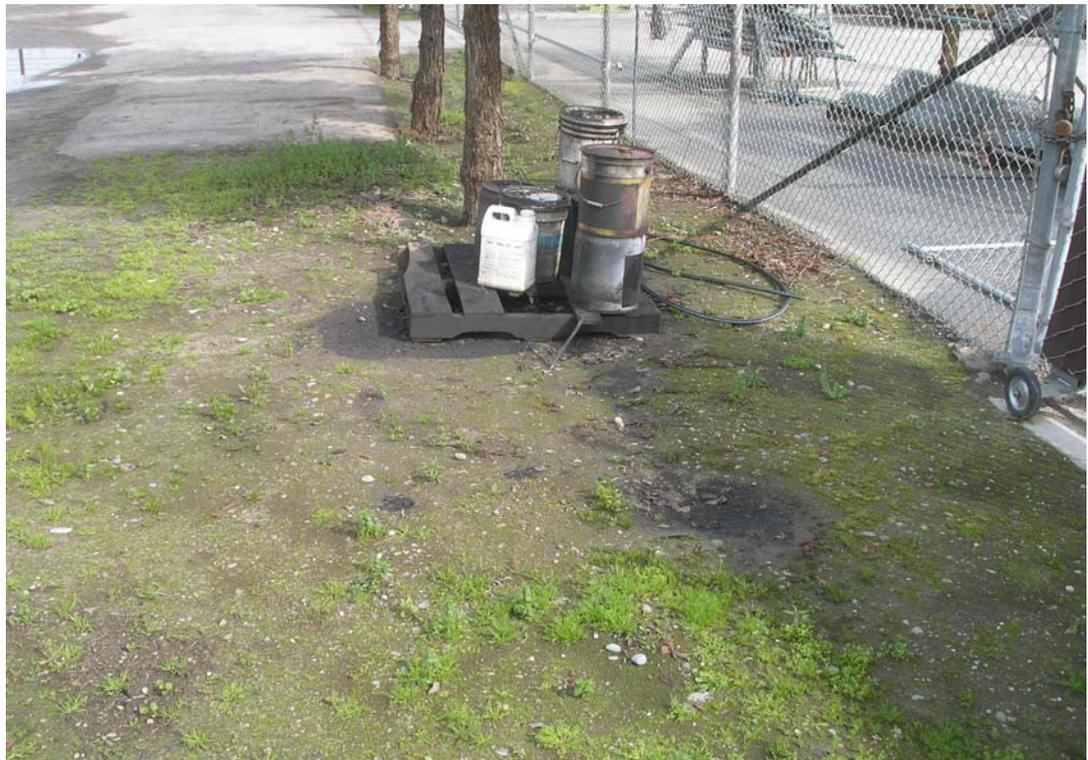
<p><b>Photo No.</b>  <b>14</b></p>

<p><b>Direction Photo Taken:</b>                   Looking north</p>	
<p><b>Description:</b>                   Used motor oil stored on a pallet outside of the west side of the site fence.</p>

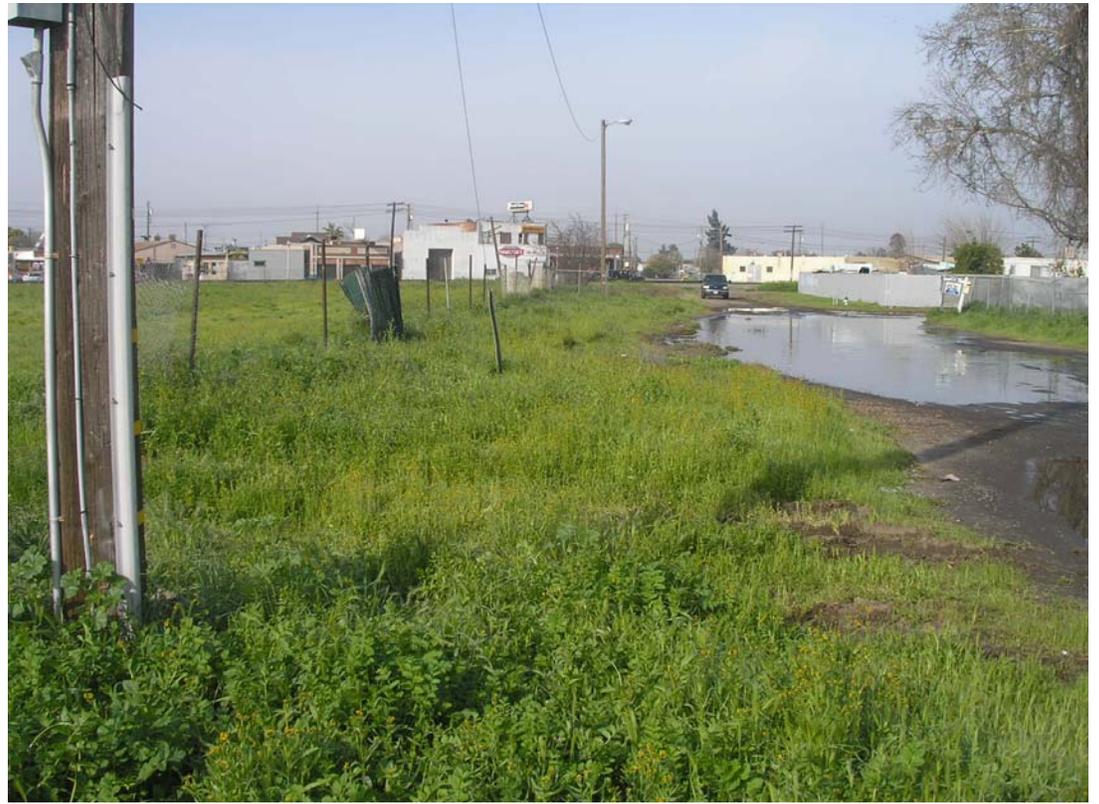
<p><b>Photo No.</b>  <b>1</b></p>	
<p><b>Direction Photo Taken:</b>                   Looking west</p>	
<p><b>Description:</b>                   View of the north end of the site along E Belgravia Avenue.</p>
