# Appendix D

## Phase I Site Reconnaissance, Field Notes, Photographs, and Photo Logs Part 1

**HST PHASE I ENVIRONMENTAL SITE ASSESSMENT**

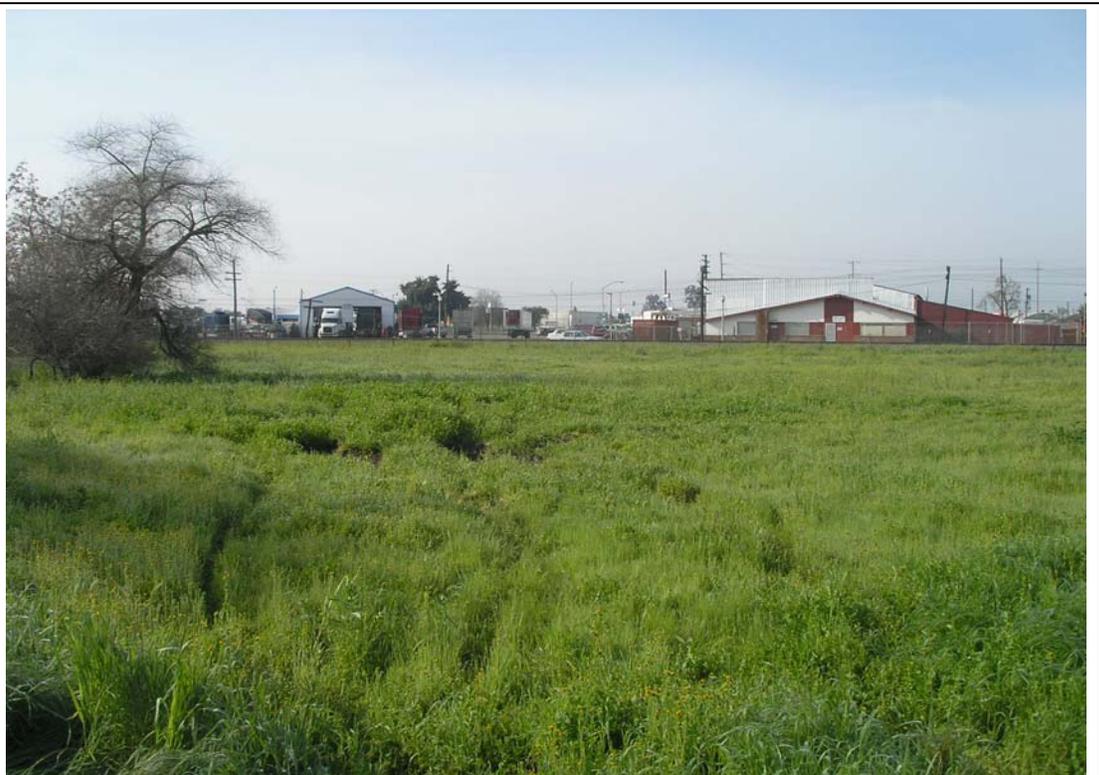
<p><b>Photo No.</b>  <b>2</b></p>	
<p><b>Direction Photo Taken:</b>                   Looking southwest</p>	
<p><b>Description:</b>                   View of the site from the northeast corner. Structures in the distance are not on the site.</p>

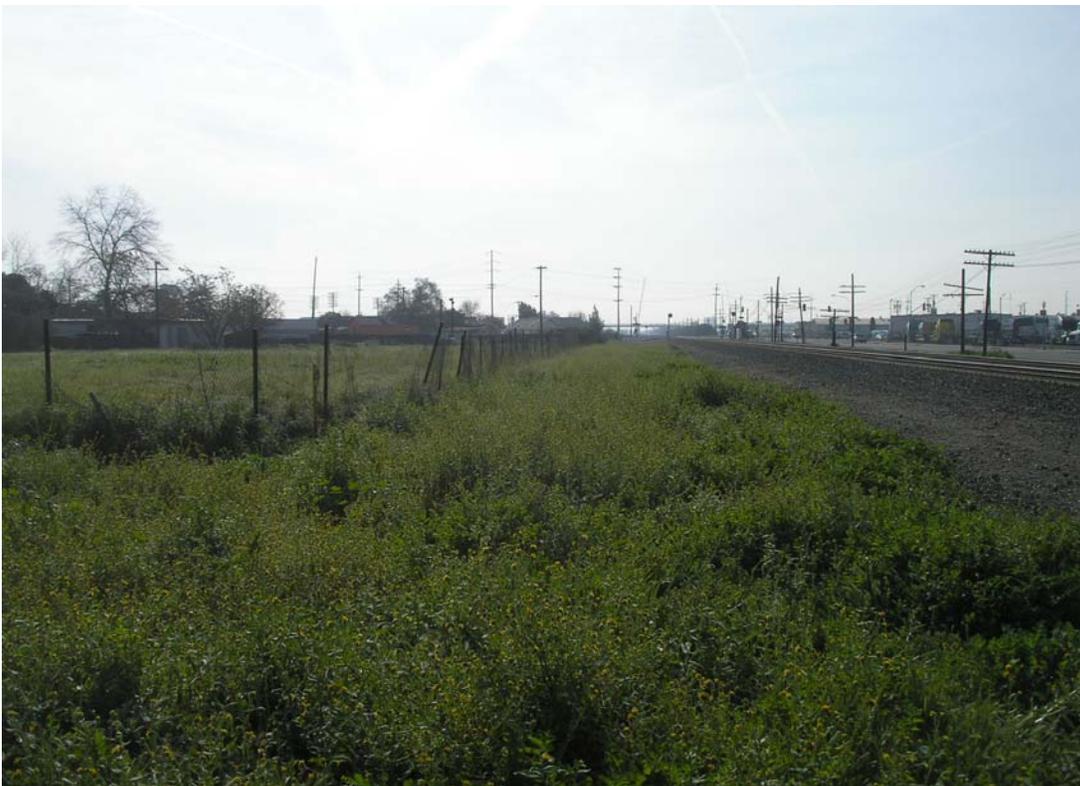
<p><b>Photo No.</b>  <b>3</b></p>

<p><b>Direction Photo Taken:</b>                   Looking south</p>	
<p><b>Description:</b>                   View of the west side of the site along the Union Pacific tracks.</p>

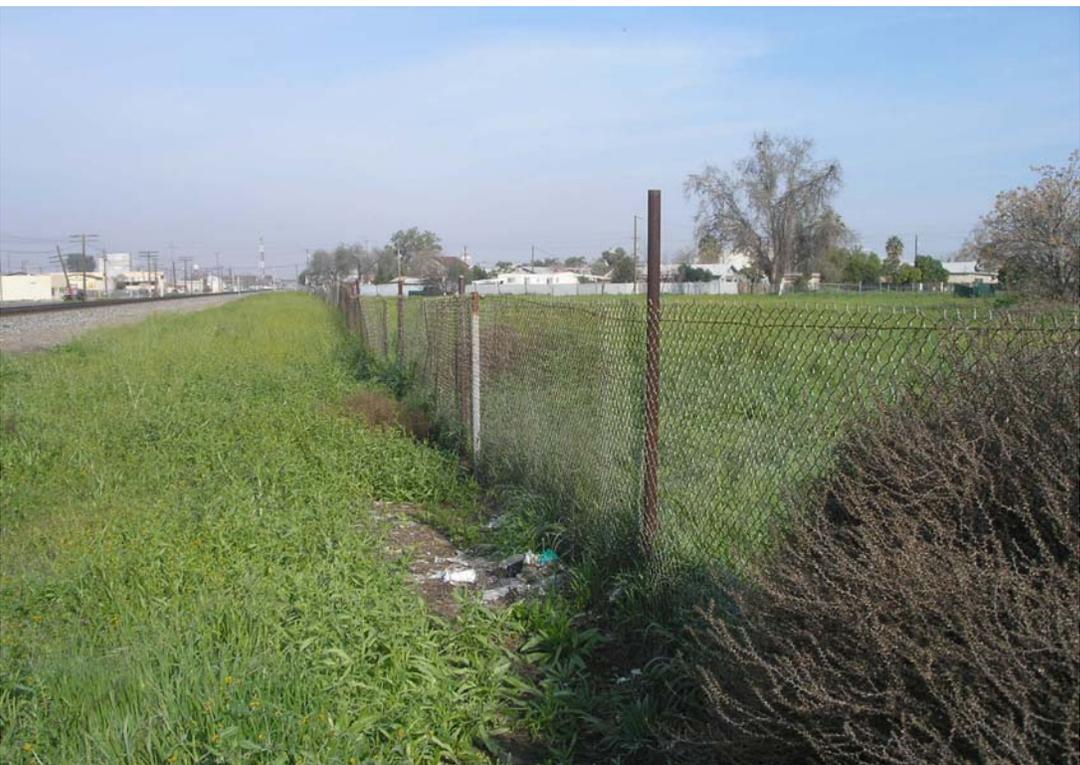
<p><b>Photo No.</b>  <b>4</b></p>

<p><b>Direction Photo Taken:</b>                   Looking north</p>	
<p><b>Description:</b>                   View of the site from the south end.</p>

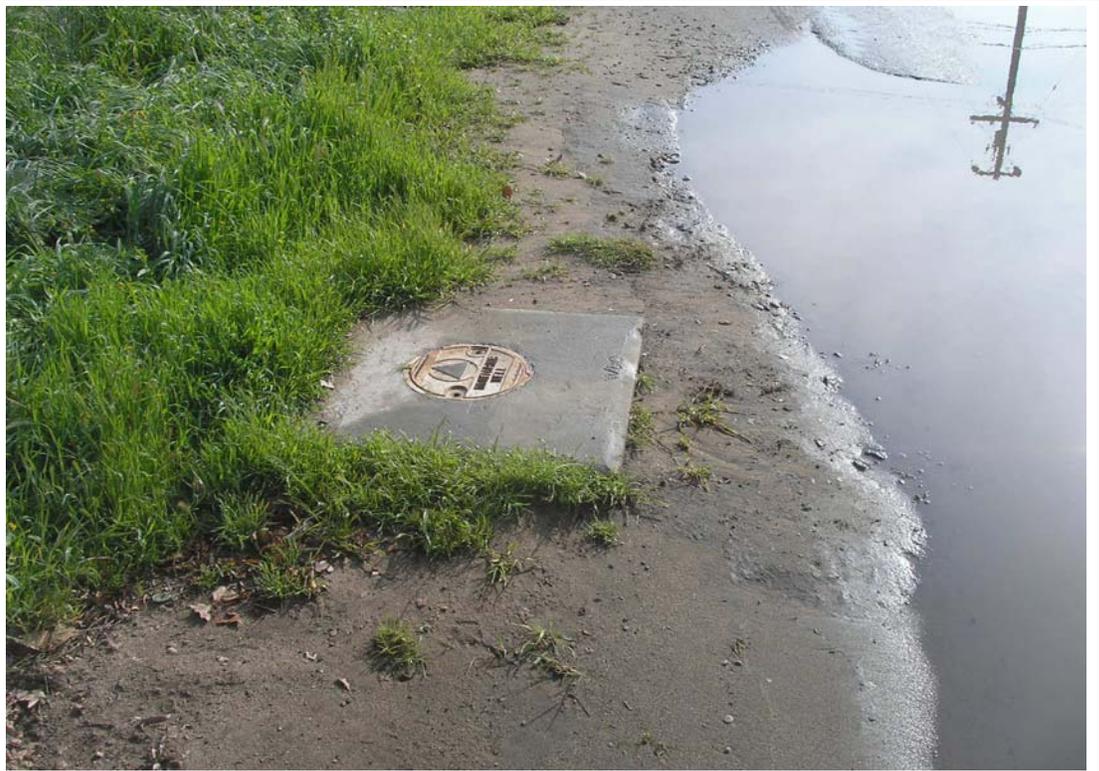
<b>Photo No.</b> <b>5</b>
<b>Direction Photo Taken:</b>  Looking east
<b>Description:</b>  Monitoring well located on the north side of E Belgravia Avenue across from the site.

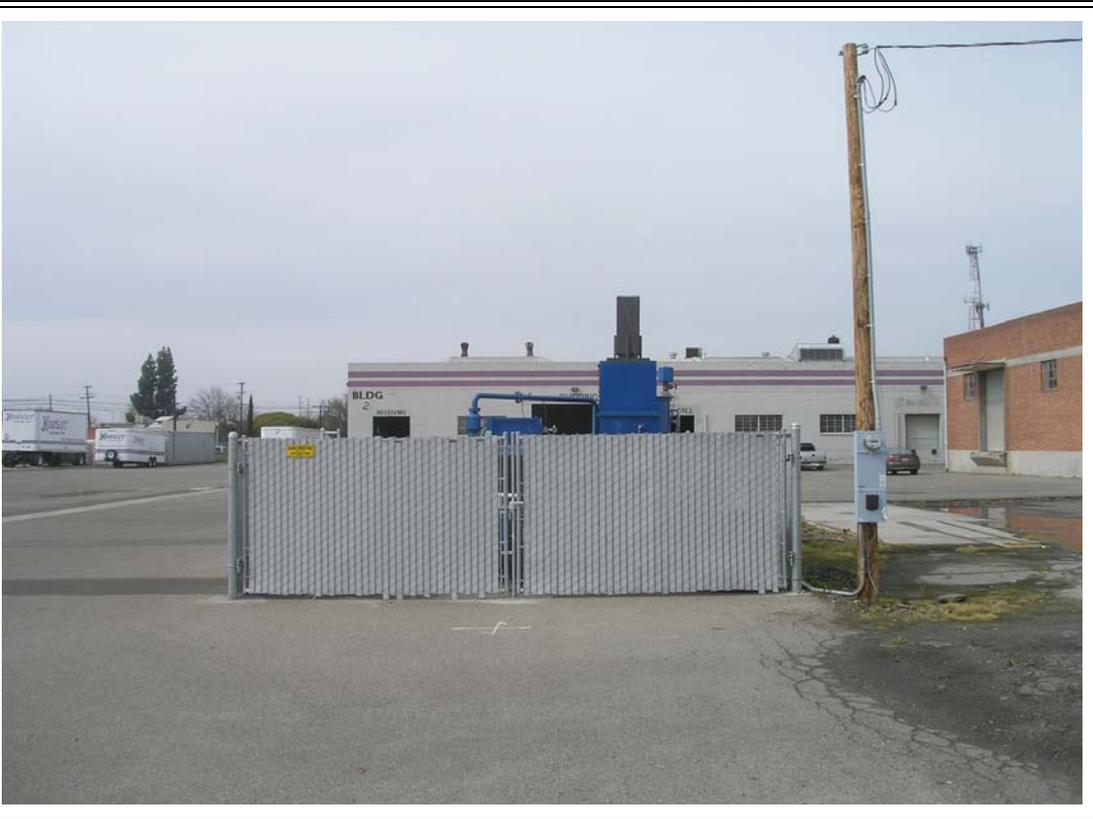
<p><b>Direction Photo Taken:</b>                   Looking west</p>	
<p><b>Description:</b>                   View of the soil vapor extraction (SVE) remediation system compound.</p>

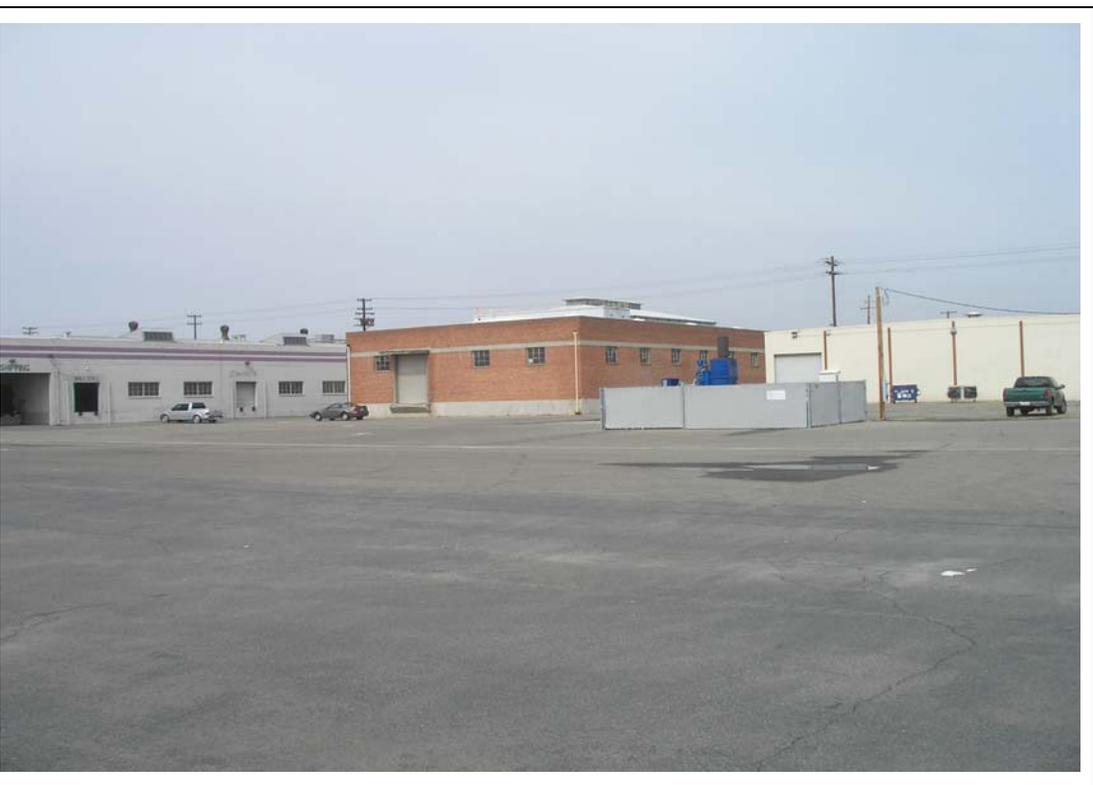
<p><b>Direction Photo Taken:</b>                   Looking northwest</p>	
<p><b>Description:</b>                   View of the SVE well field and remediation system compound.</p>

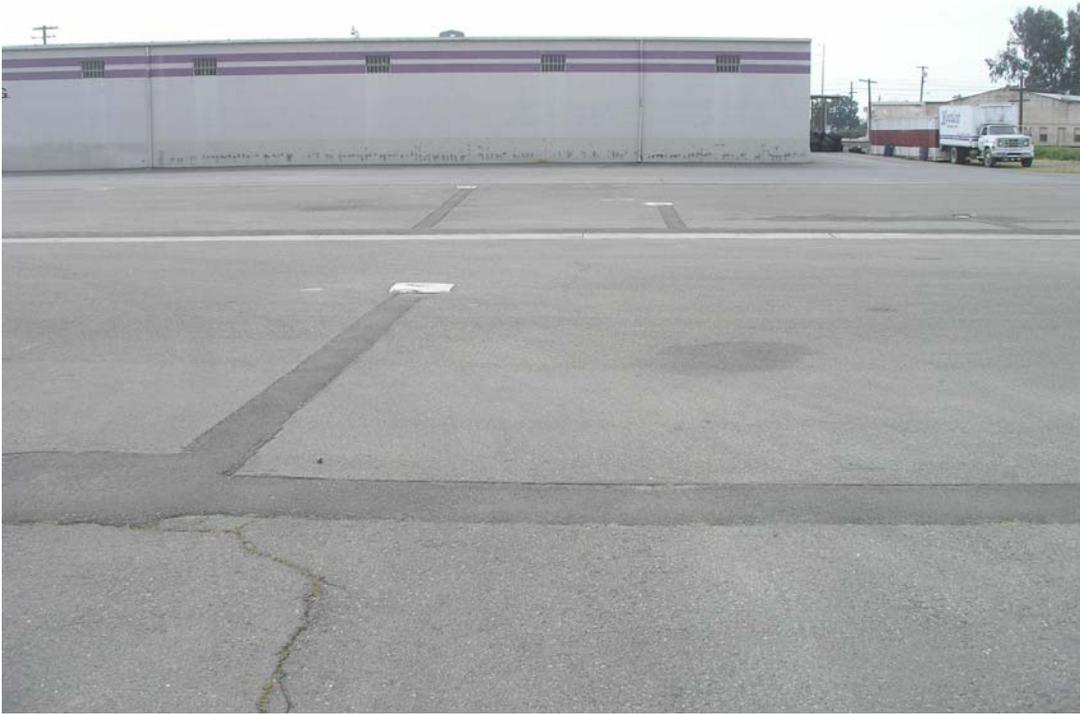
<p><b>Photo No.</b>  <b>3</b></p>

<p><b>Direction Photo Taken:</b>                  Looking south</p>	
<p><b>Description:</b>                  SVE system well field.</p>

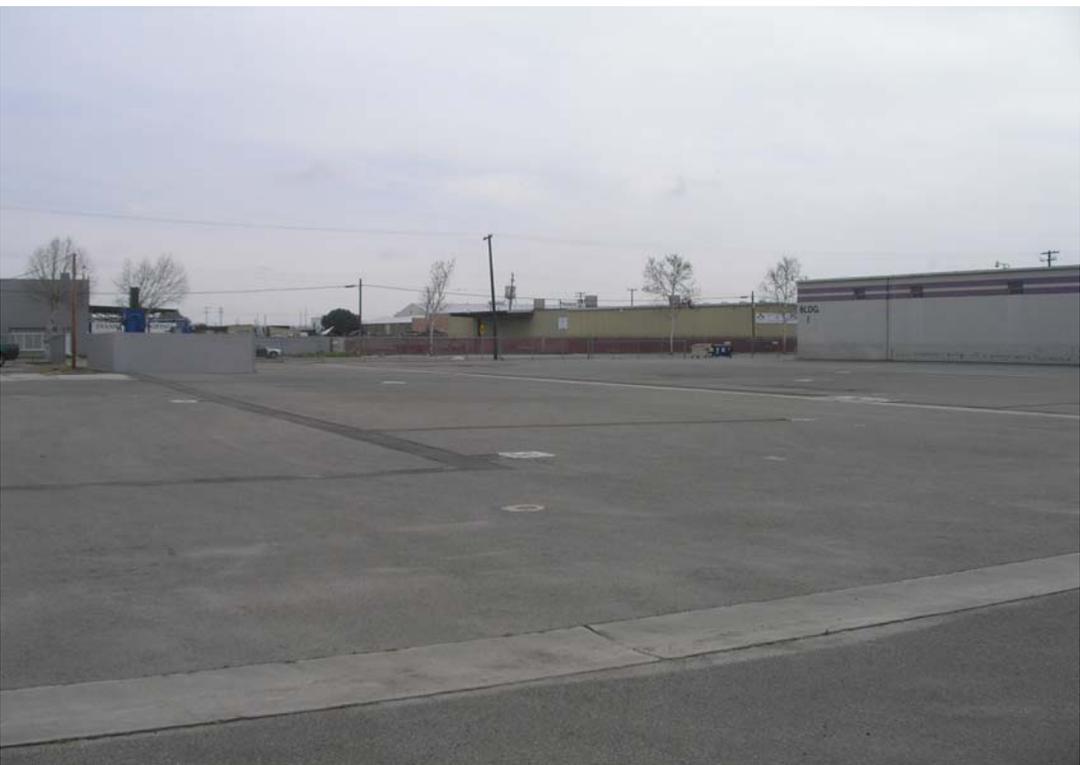
<p><b>Photo No.</b>  <b>4</b></p>

<p><b>Direction Photo Taken:</b>                  Looking southeast</p>	
<p><b>Description:</b>                  SVE system well field and compound (left-center of frame).</p>

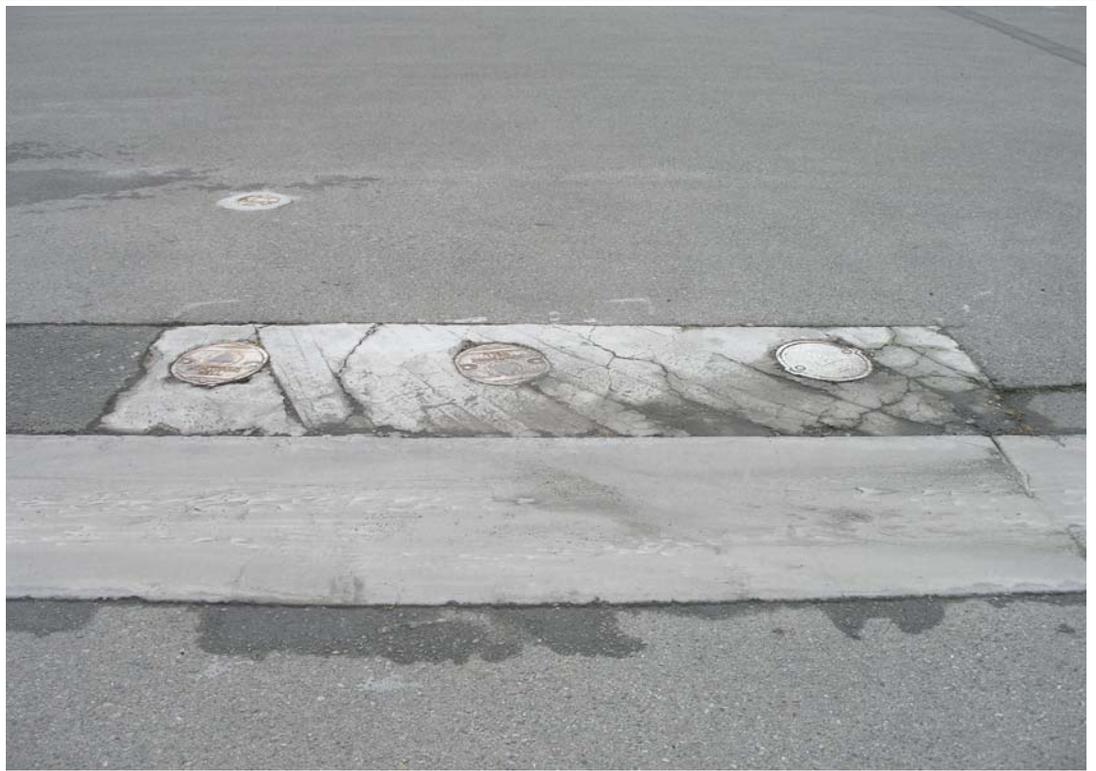
**Direction Photo Taken:**  
 Looking south

**Description:**  
 Monitoring well cluster near the center of the site.

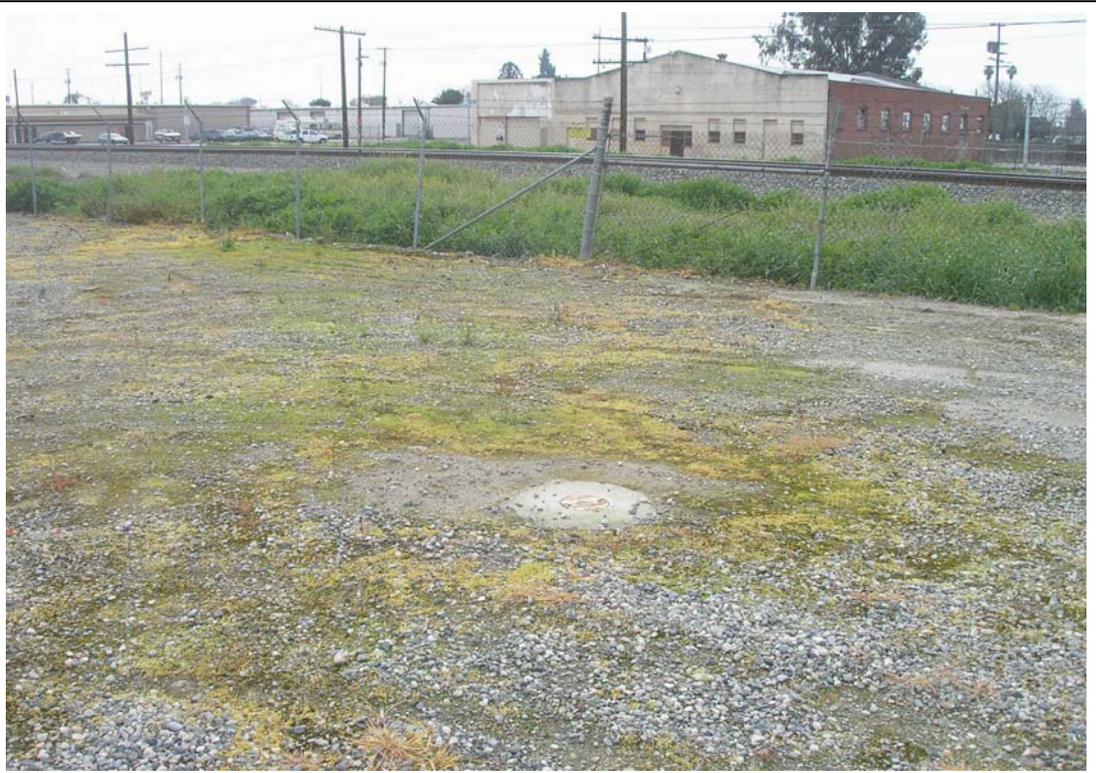
**Photo No.**  
**6**

**Direction Photo Taken:**  
 Looking southwest

**Description:**  
 Monitoring well near the west side of the site. Note the Union Pacific tracks in the background.

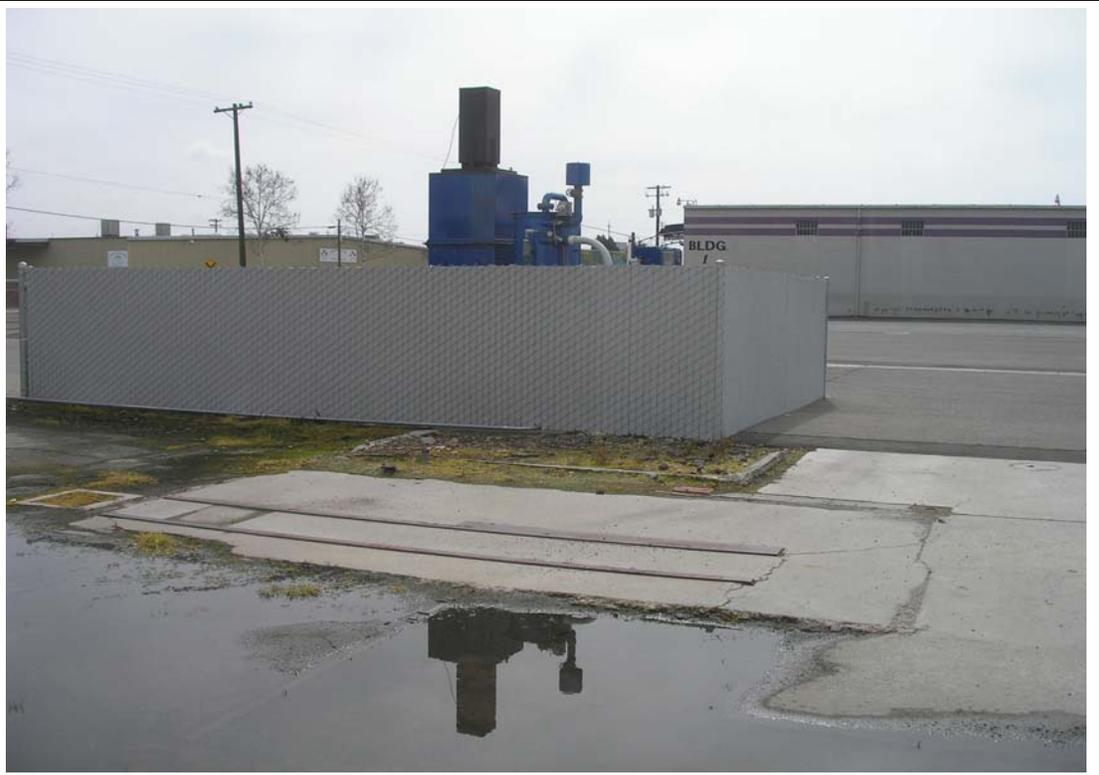
<p>Photo No.  <b>8</b></p>	
<p>Direction Photo Taken:                  Looking west</p>	
<p>Description:                  Thermo-oxidizer in the SVE remediation system compound.</p>

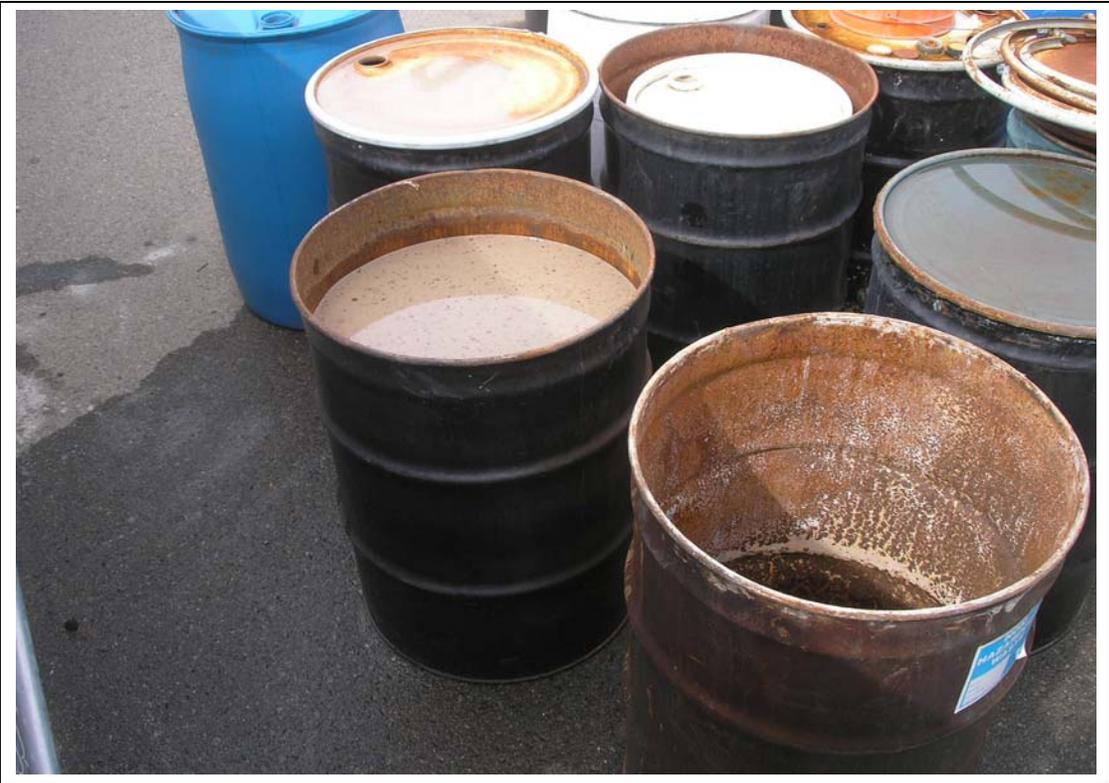
<p><b>Photo No.</b> <b>9</b></p>
<p><b>Direction Photo Taken:</b>  Looking west</p>
<p><b>Description:</b>  Waste drums in the SVE compound.</p>

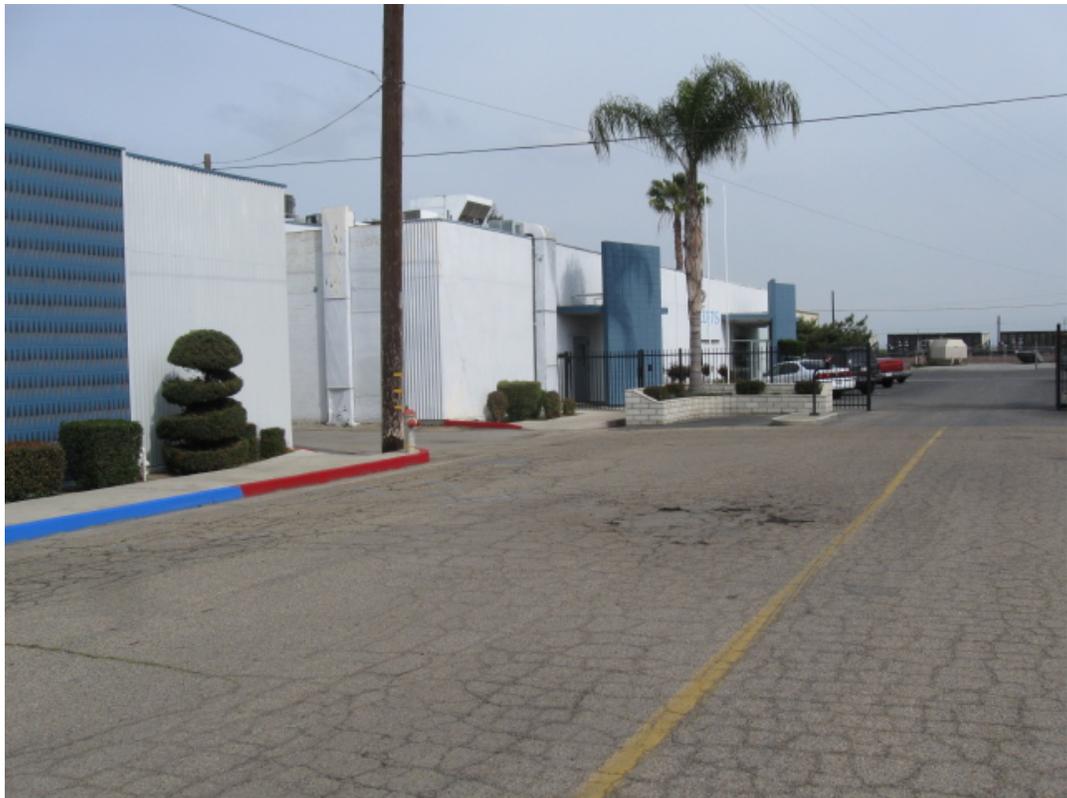
<p>Photo No.  <b>1</b></p>

<p>Direction Photo Taken:                   Looking east</p>	
<p>Description:                   View along 5<sup>th</sup> Street and the Main Gate.</p>

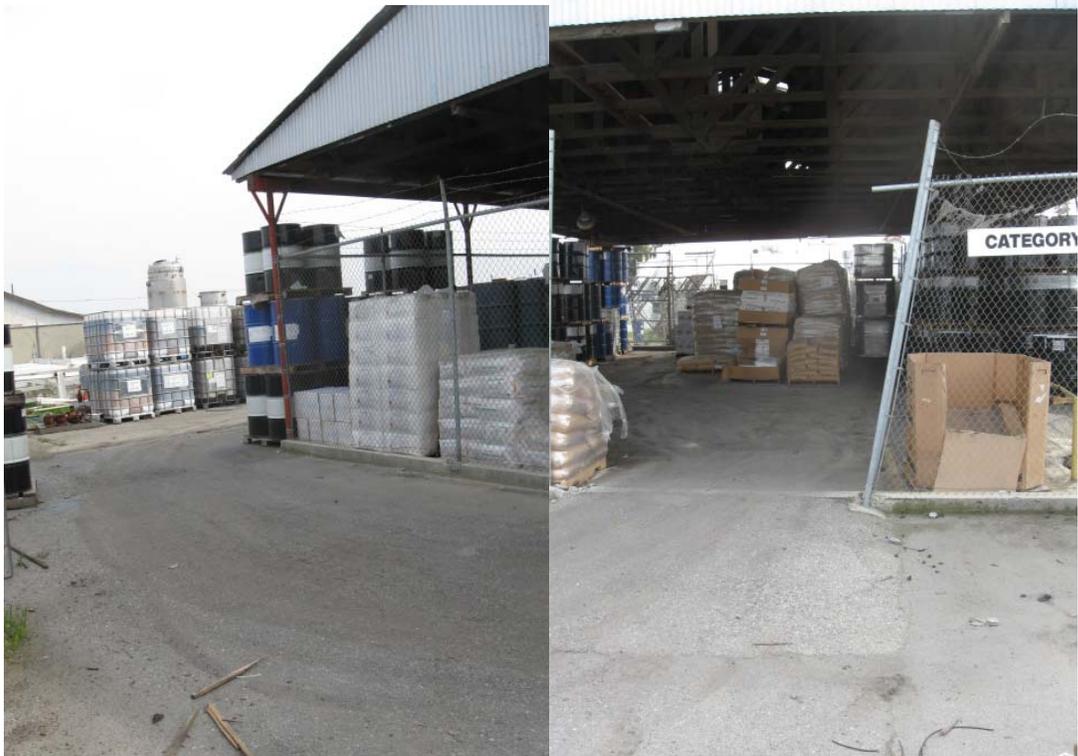
<p>Photo No.  <b>2</b></p>

<p>Direction Photo Taken:                   Interior views</p>	
<p>Description:                   Drums, totes, and other storage containers are stored at several locations onsite.</p>

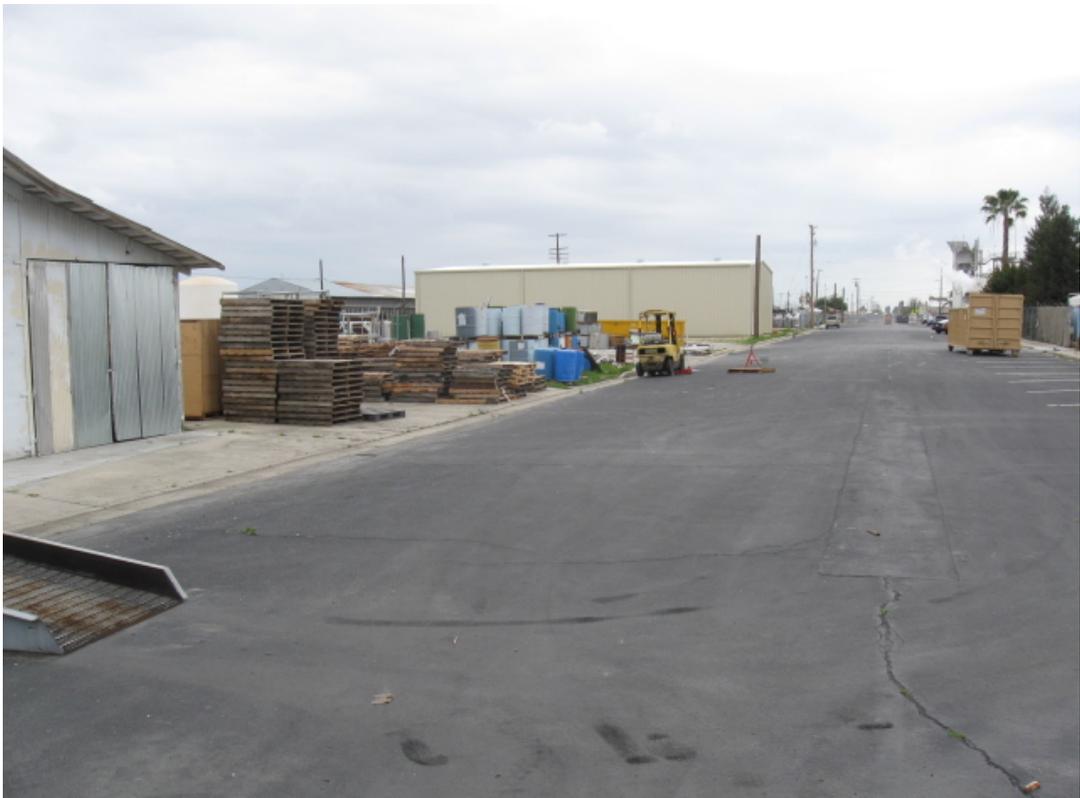
<p><b>Direction Photo Taken:</b>                   Looking south</p>	
<p><b>Description:</b>                   View along G Street inside the complex. Note chemical storage containers and buildings where containers are stored.</p>

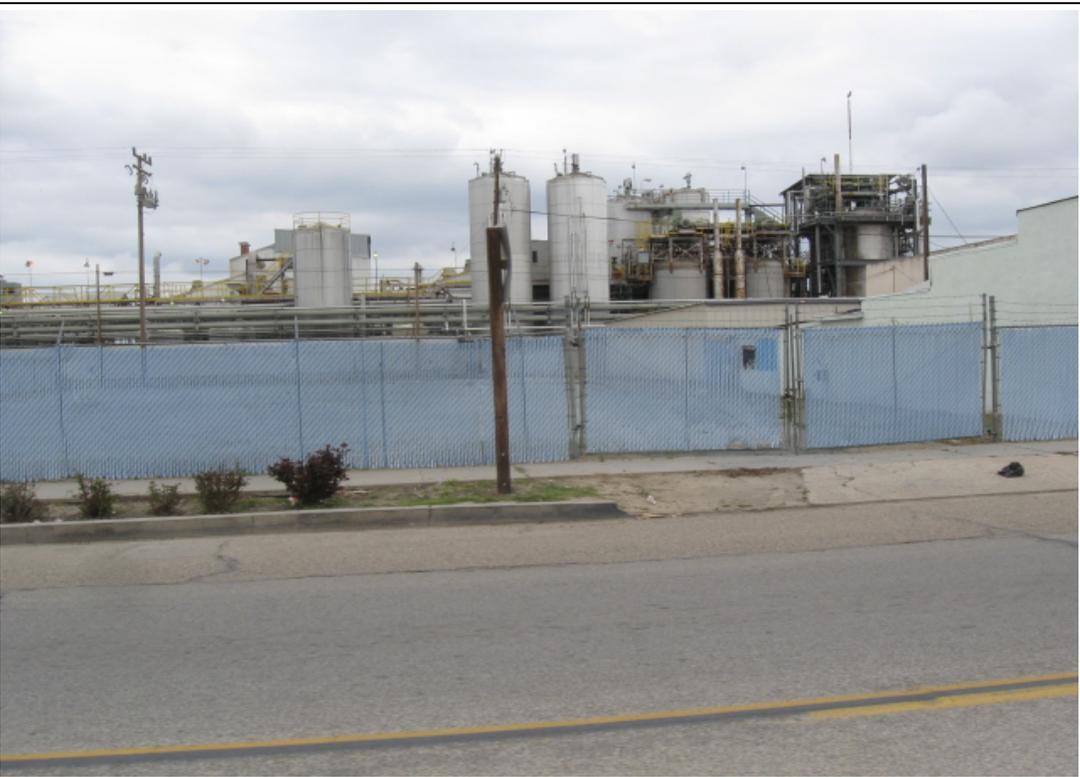
<p><b>Photo No.</b>  <b>4</b></p>

<p><b>Direction Photo Taken:</b>                   Looking east</p>	
<p><b>Description:</b>                   View across F Street at process storage tanks located at the south end of the site.</p>

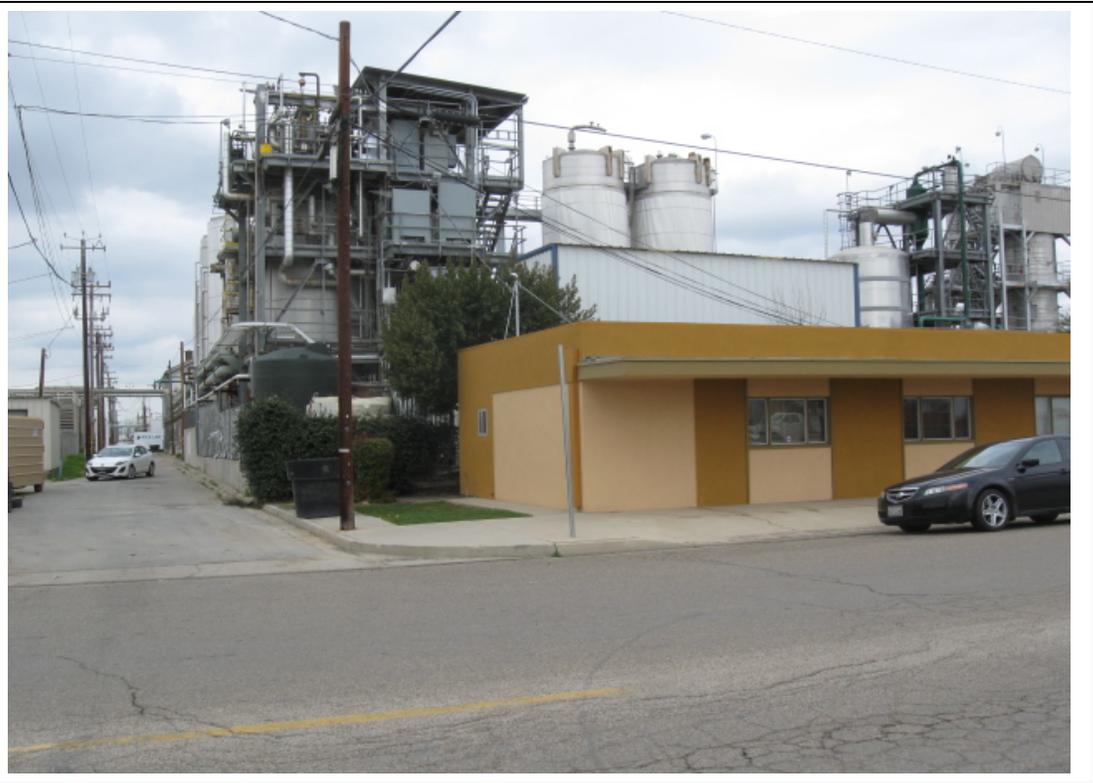
<p><b>Photo No.</b>  <b>5</b></p>
<p><b>Direction Photo Taken:</b>                   Looking north</p>
<p><b>Description:</b>                   View across 6<sup>th</sup> Street. Chemical processing plant tanks and equipment at the south end of the site.</p>

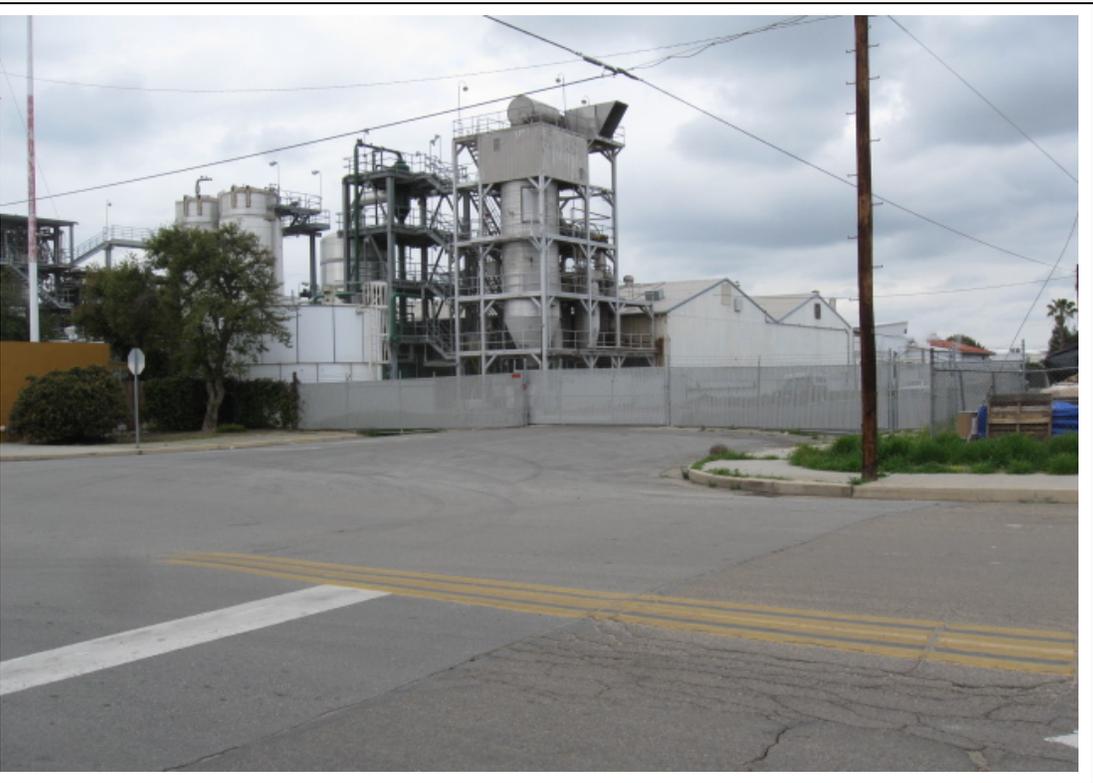
<p><b>Photo No.</b>  <b>6</b></p>
<p><b>Direction Photo Taken:</b>                   Looking northwest</p>
<p><b>Description:</b>                   View from the corner of 6<sup>th</sup> and G Streets. Chemical processing facility and warehouses in the southeast corner of the site.</p>

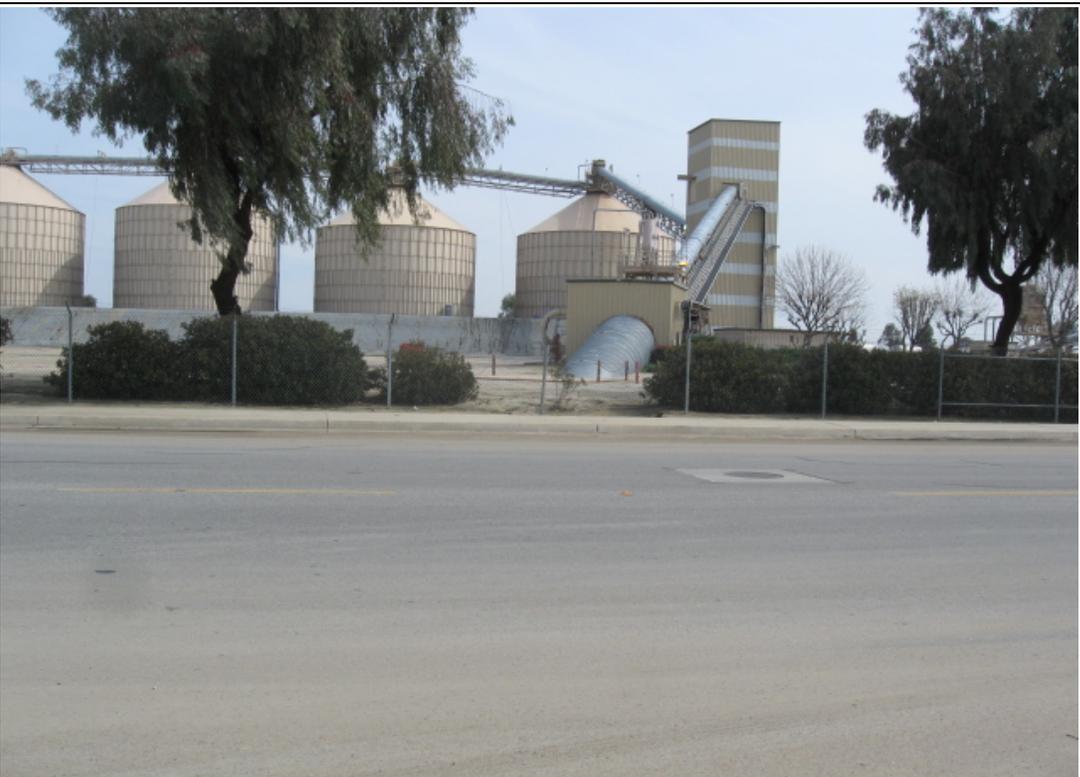
<p><b>Photo No.</b>  <b>2</b></p>

<p><b>Direction Photo Taken:</b>                   Looking east</p>	
<p><b>Description:</b>                   Coal is moved via conveyors beneath H Street to the storage yard.</p>

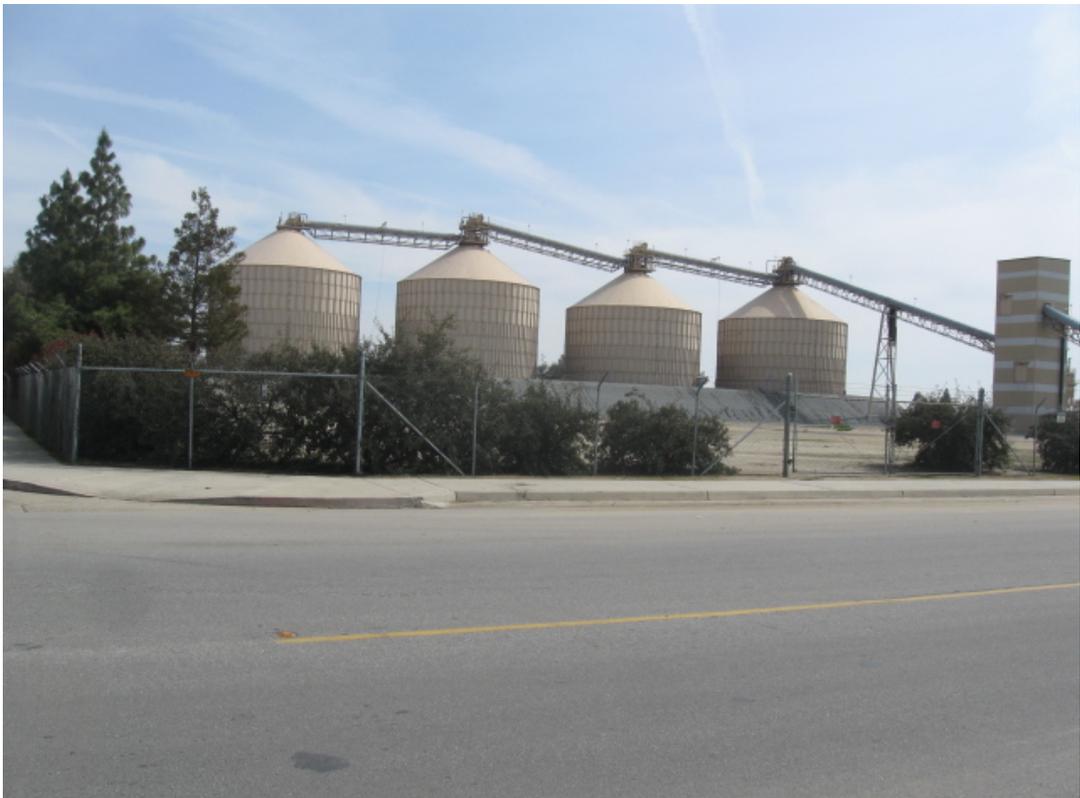
<p><b>Photo No.</b>  <b>3</b></p>

<p><b>Direction Photo Taken:</b>                   Looking east</p>	
<p><b>Description:</b>                   Coal storage silos east of H street are not on the subject property.</p>

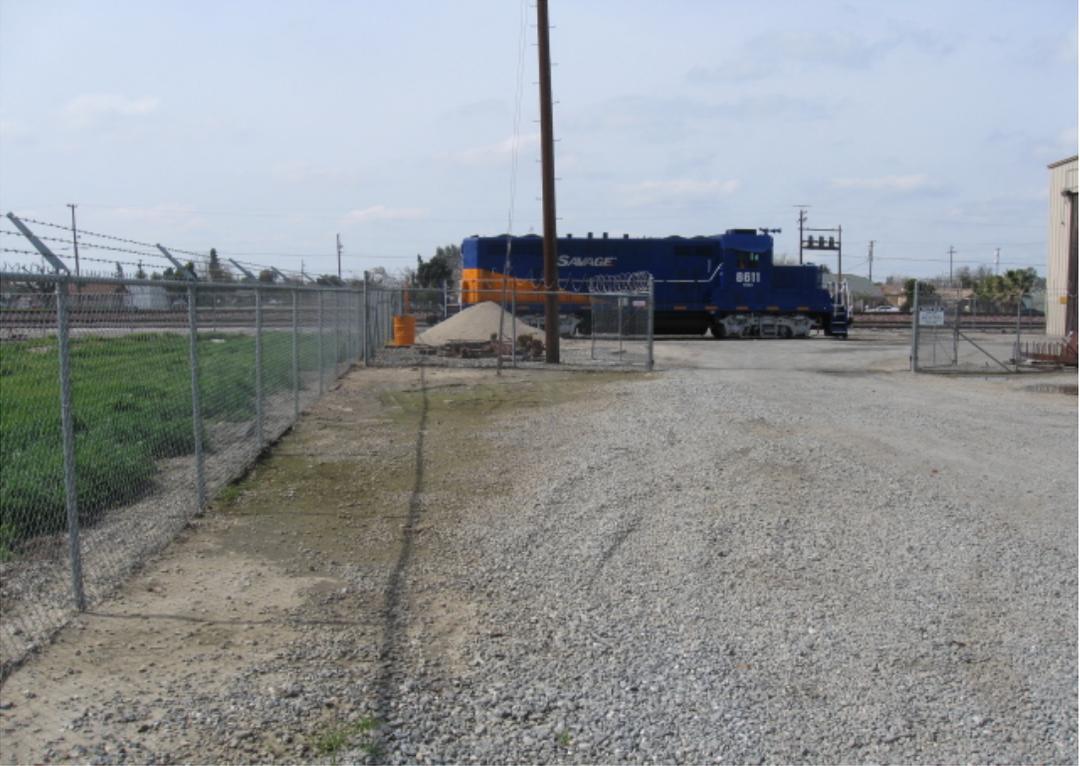
<p><b>Photo No.</b>  <b>4</b></p>

<p><b>Direction Photo Taken:</b>                   Looking west</p>	
<p><b>Description:</b>                   Locomotive used to shuttle coal-filled rail cars on the site.</p>

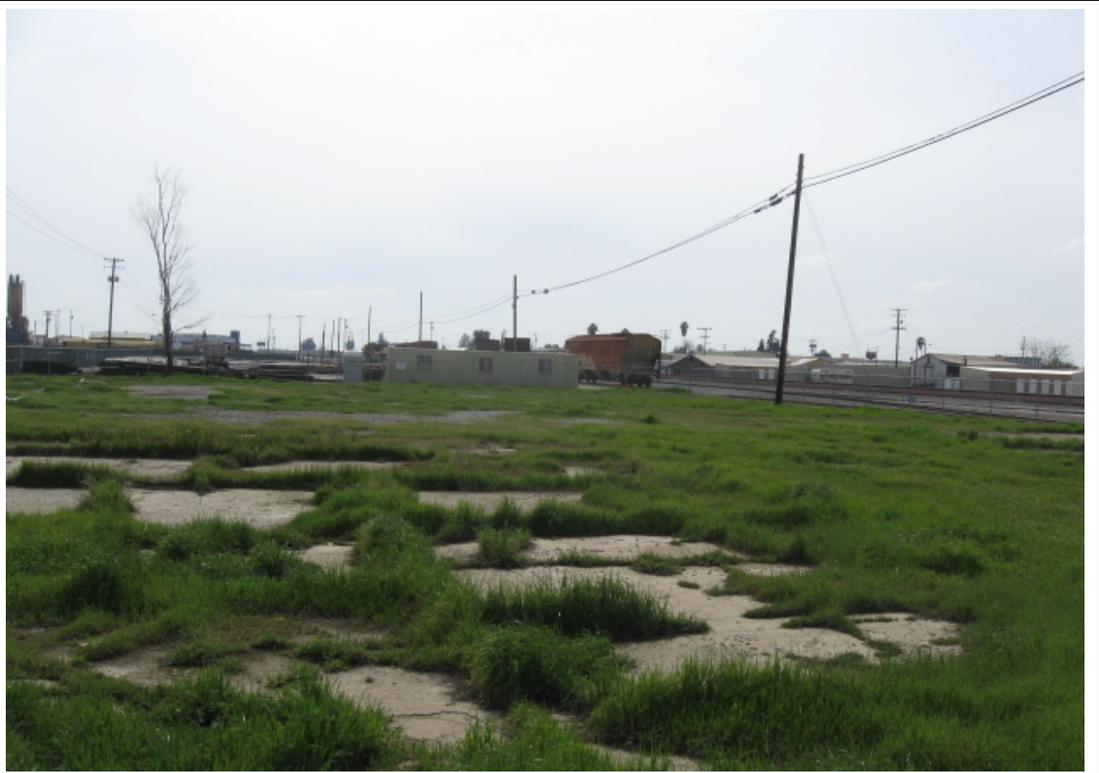
<p><b>Photo No.</b>  <b>5</b></p>	
<p><b>Direction Photo Taken:</b>                   Looking southwest</p>	
<p><b>Description:</b>                   View from the north center of the site.</p>

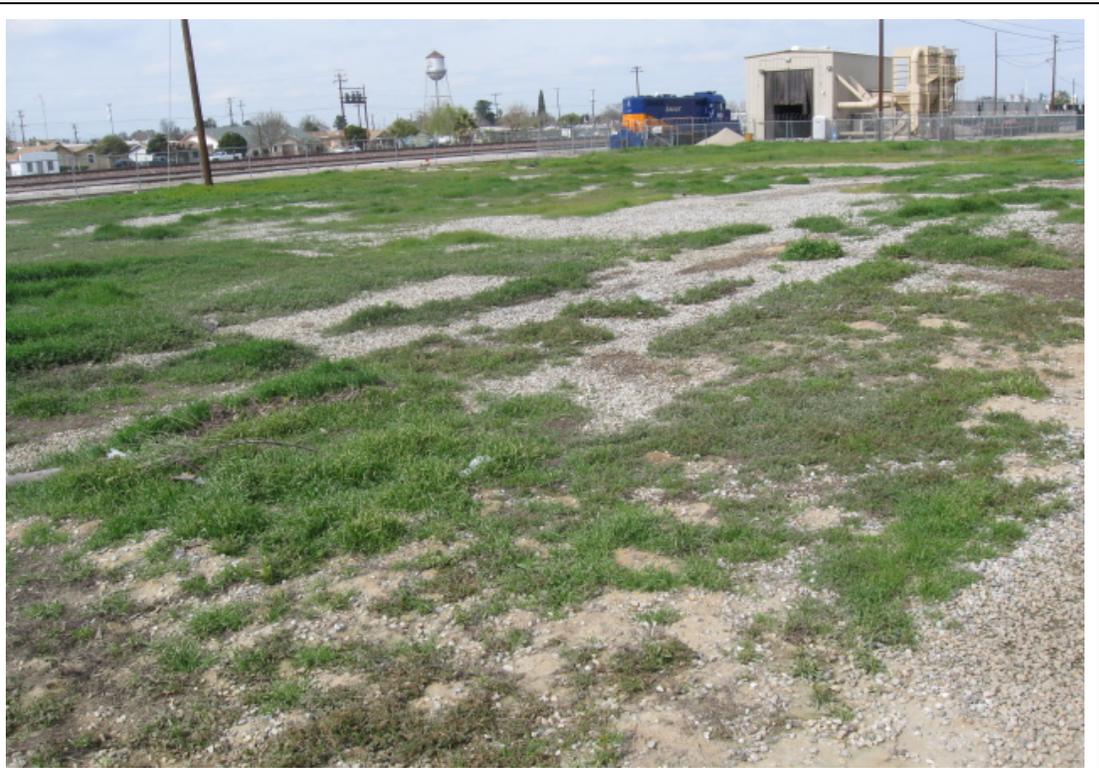
<p><b>Photo No.</b>  <b>6</b></p>	
<p><b>Direction Photo Taken:</b>                   Looking northwest</p>	
<p><b>Description:</b>                   View from the southeast corner of the site.</p>

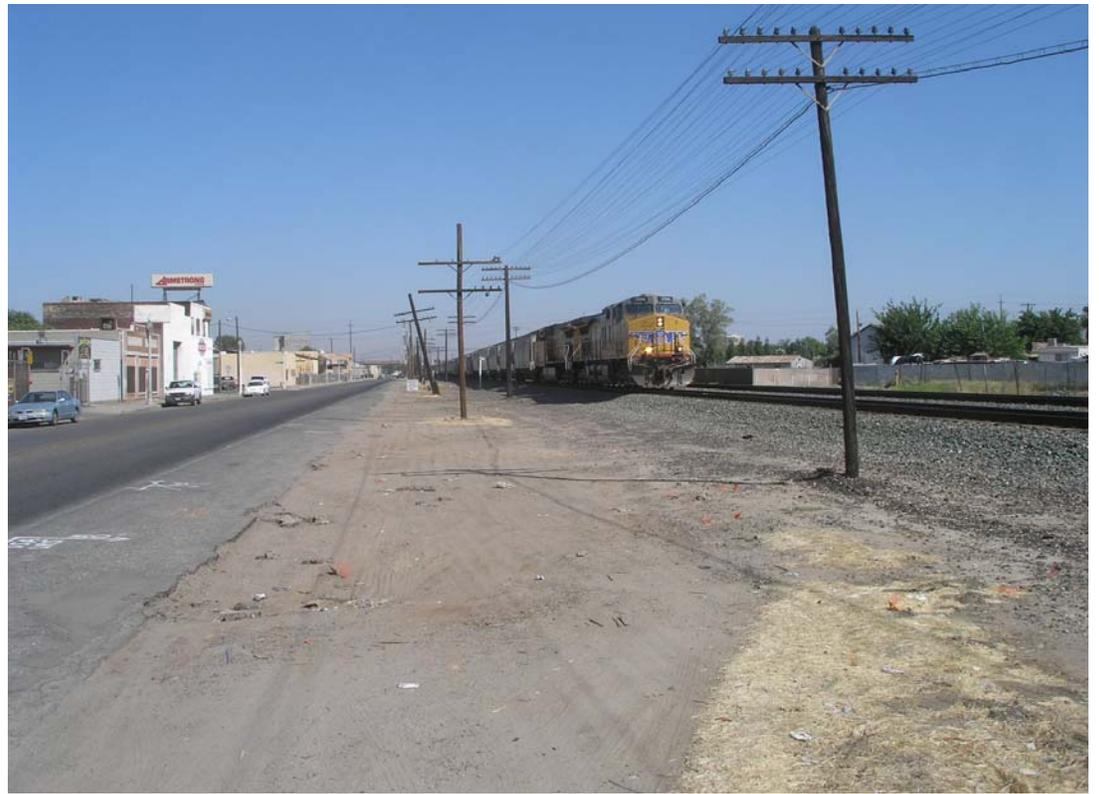
<p><b>Photo No.</b>  <b>1</b></p>	
<p><b>Direction Photo Taken:</b>                   Looking north</p>	
<p><b>Description:</b>                   View of the Union Pacific Railroad and Railroad Avenue, the dividing line between plume operational unit one (UO-1) and OU-2 north of Church Avenue.</p>

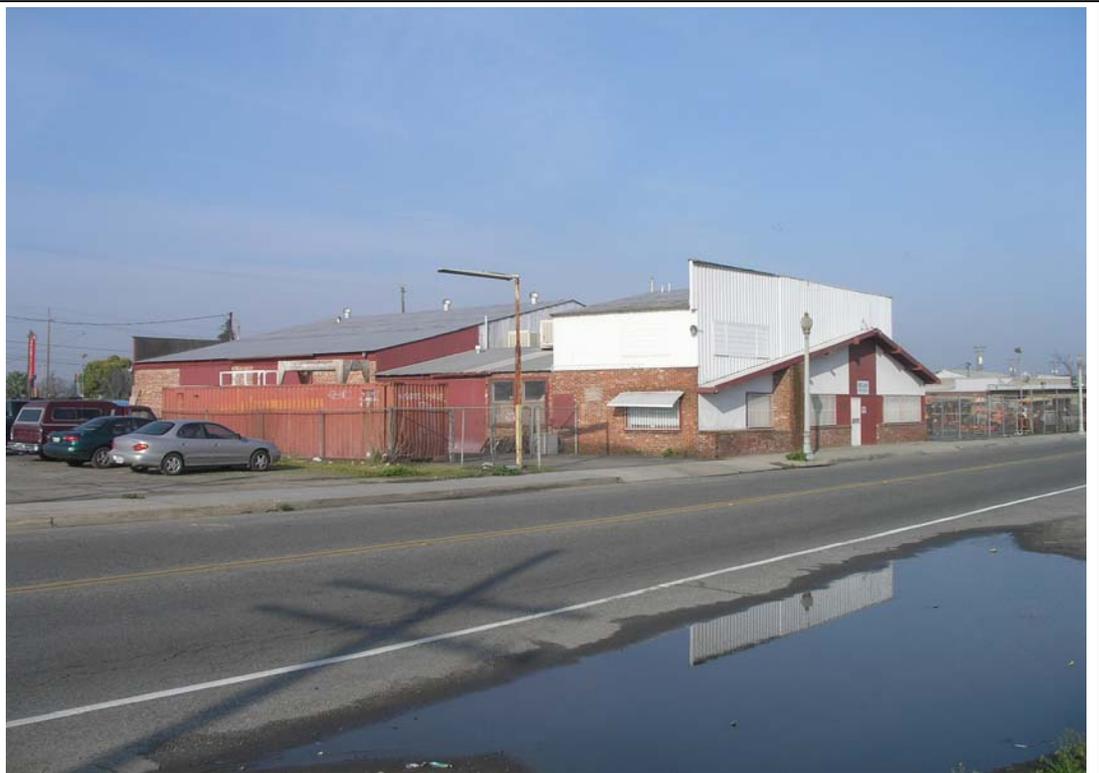
<p><b>Photo No.</b>  <b>2</b></p>	
<p><b>Direction Photo Taken:</b>                   Looking northwest</p>	
<p><b>Description:</b>                   Long-established businesses along Railroad Avenue in the commercial OU-1 area. Proposed alignments lay within the plume area.</p>
