# Appendix D

## Phase I Site Reconnaissance, Field Notes, Photographs, and Photo Logs Part 1

**HST PHASE I ENVIRONMENTAL SITE ASSESSMENT**

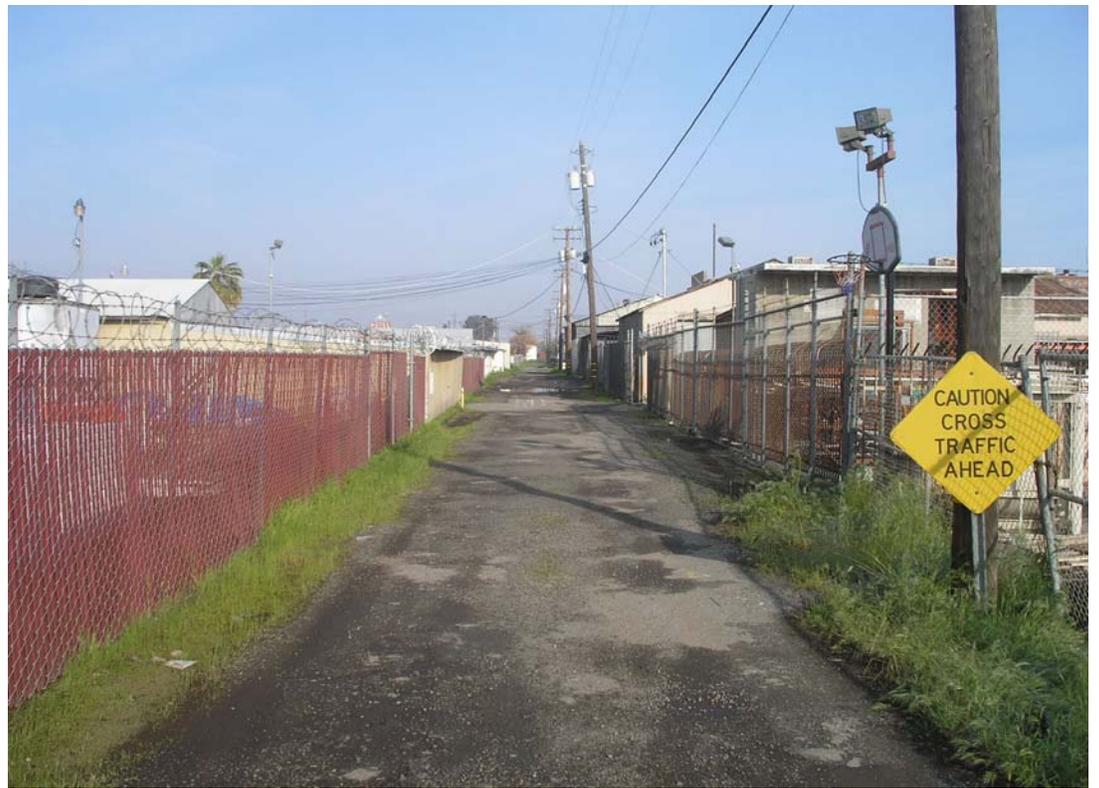
<p>Photo No.  <b>3</b></p>	
<p>Direction Photo Taken:                  Looking north</p>	
<p>Description:                  Commercial area within the plume north of Church.</p>

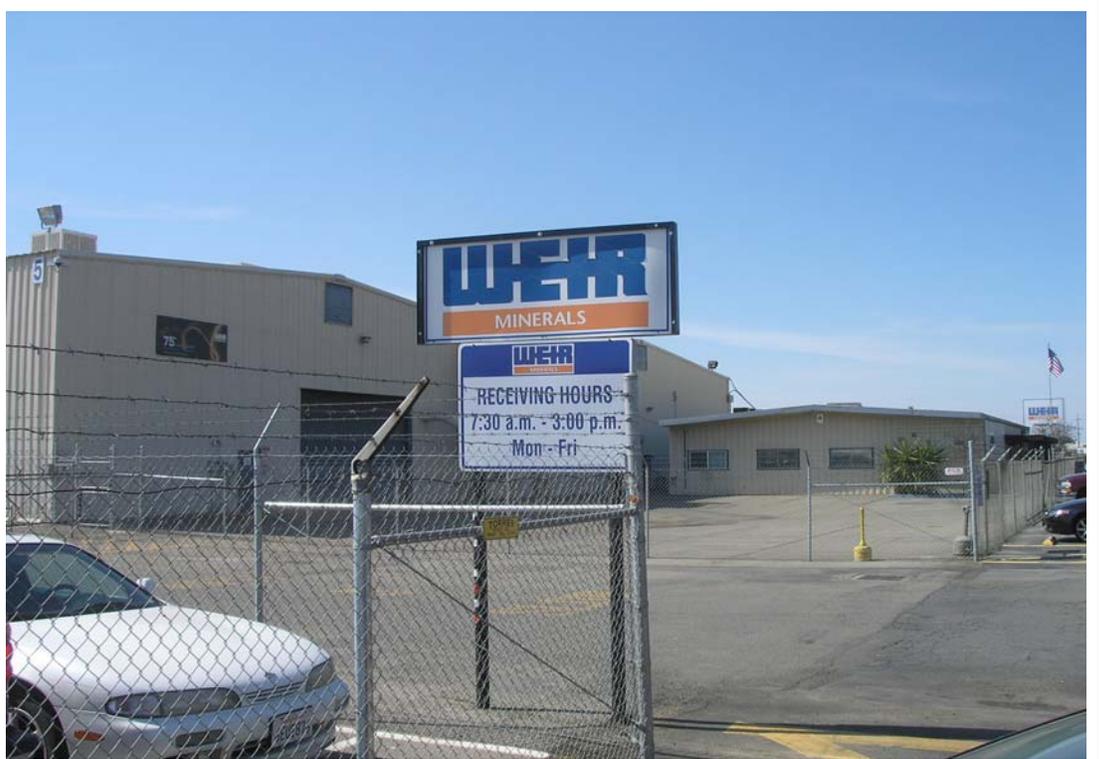
<p>Photo No.  <b>4</b></p>	
<p>Direction Photo Taken:                  Looking northwest</p>	
<p>Description:                  Weir/Floway (formerly Vendo) – source area for the OU-1 plume.</p>

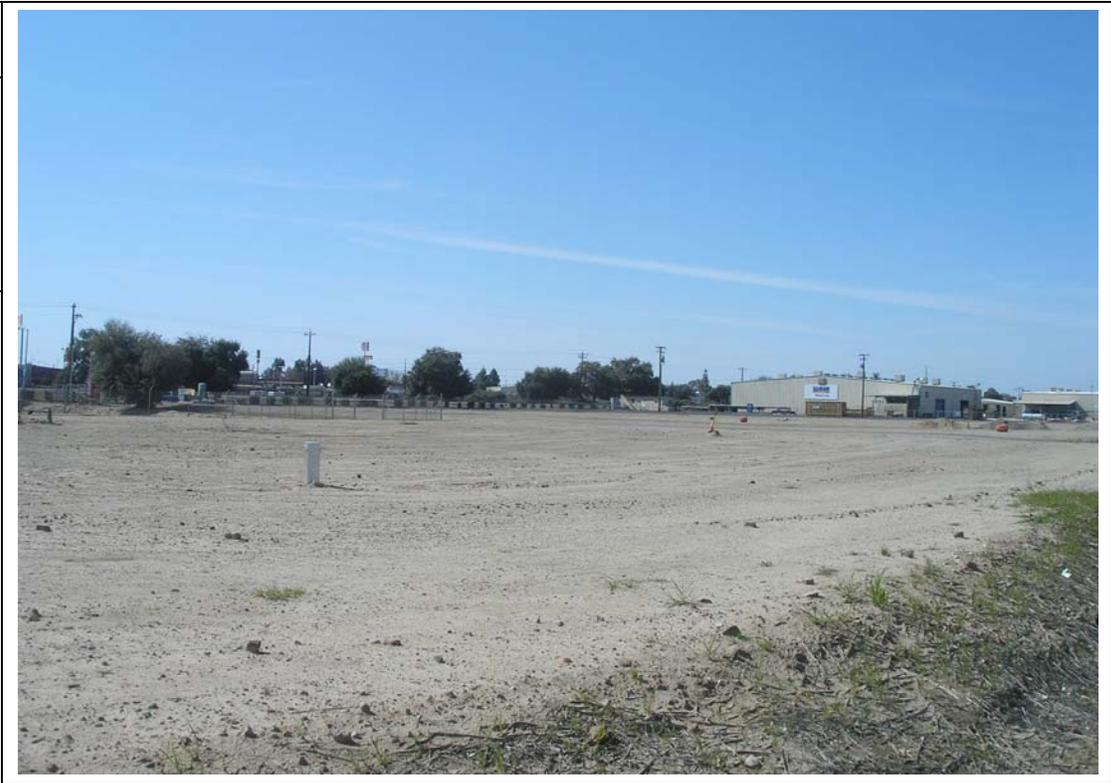
**Description:**  
Monitoring wells and remediation well field in the Weir/Floway south yard.

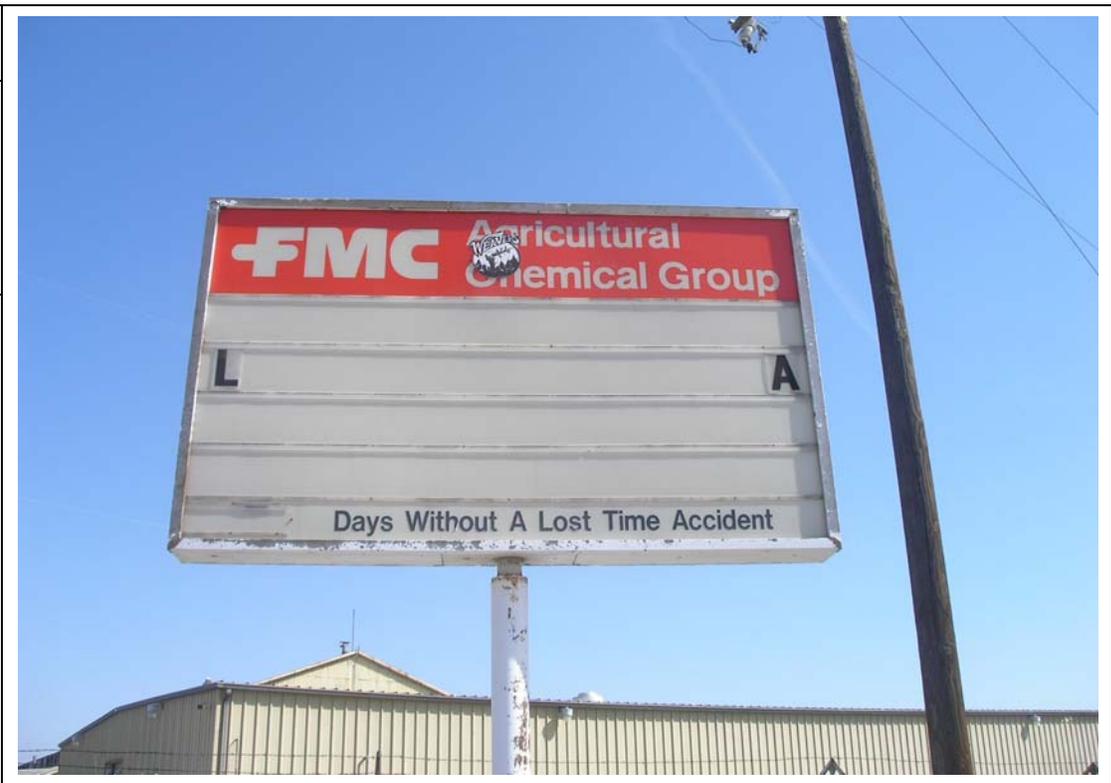
**Description:**  
FMC is the source area for the plume in OU-2.

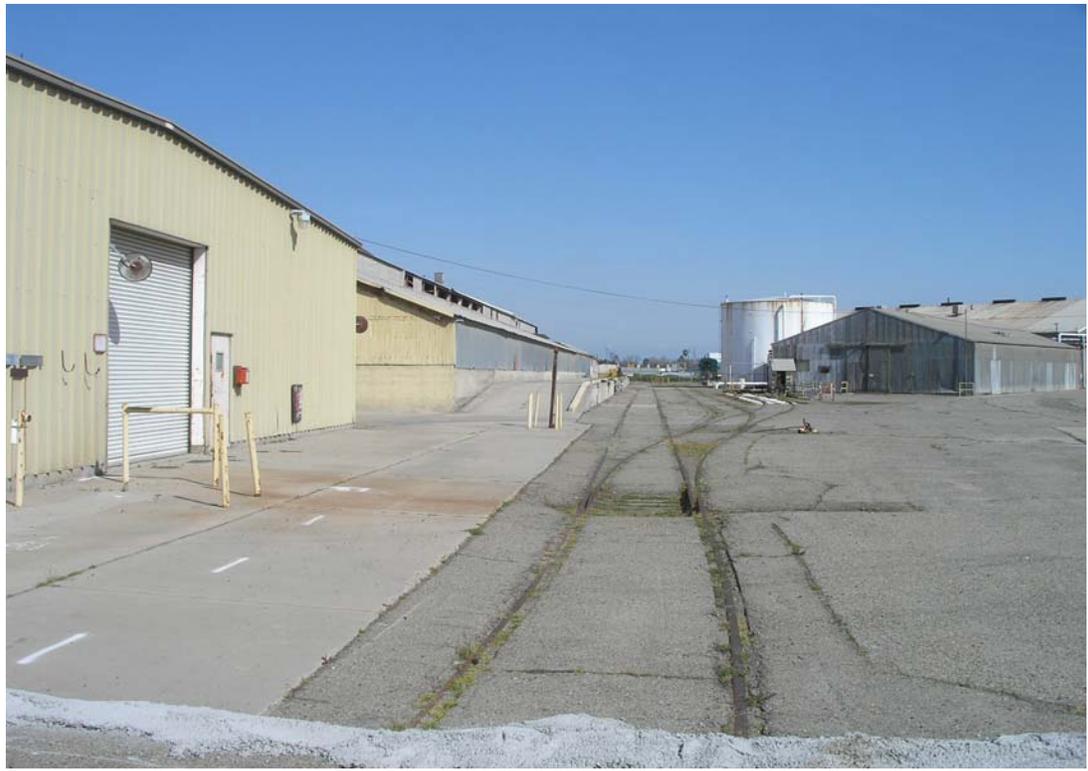
<b>Photo No.</b> <b>7</b>

<b>Direction Photo Taken:</b>  Looking east	
<b>Description:</b>  FMC warehouse and chemical formulation buildings. Note the concrete "berm" in the lower front of the frame installed to keep stormwater runoff onsite.

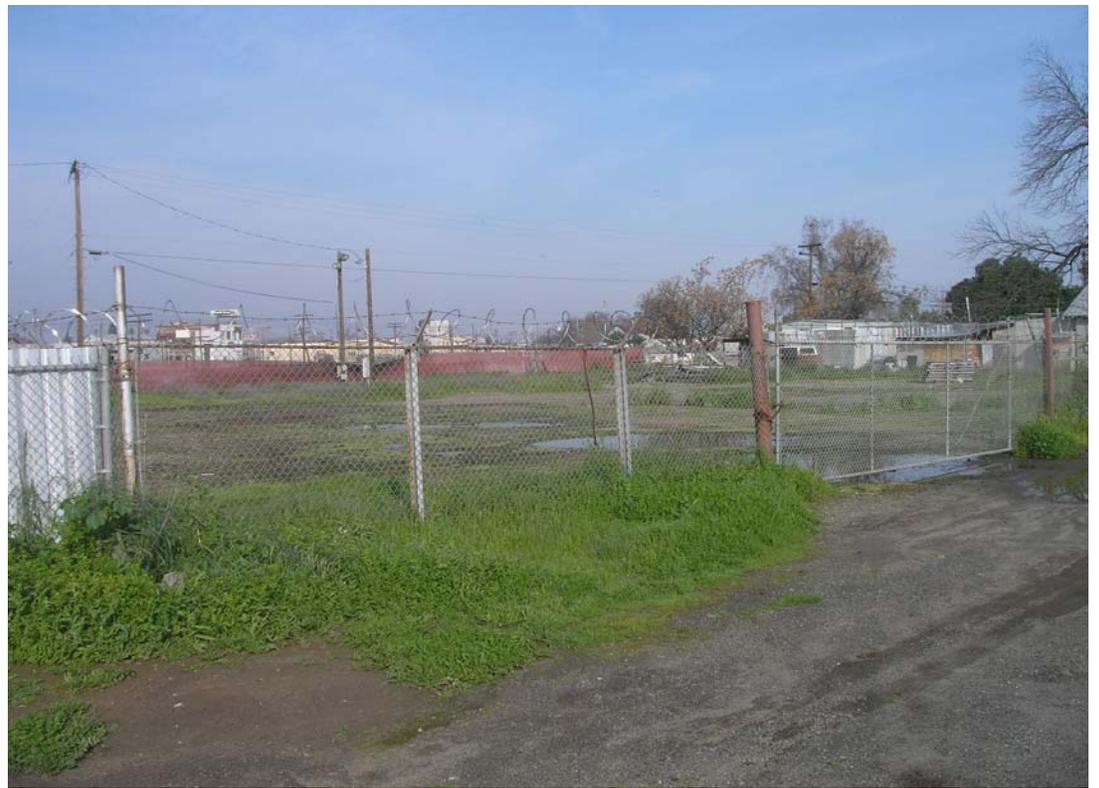
<p>Photo No.  <b>1</b></p>	
<p>Direction Photo Taken:                  Looking northwest</p>	
<p>Description:                  View of the two vacant lots from near the southeast corner.</p>

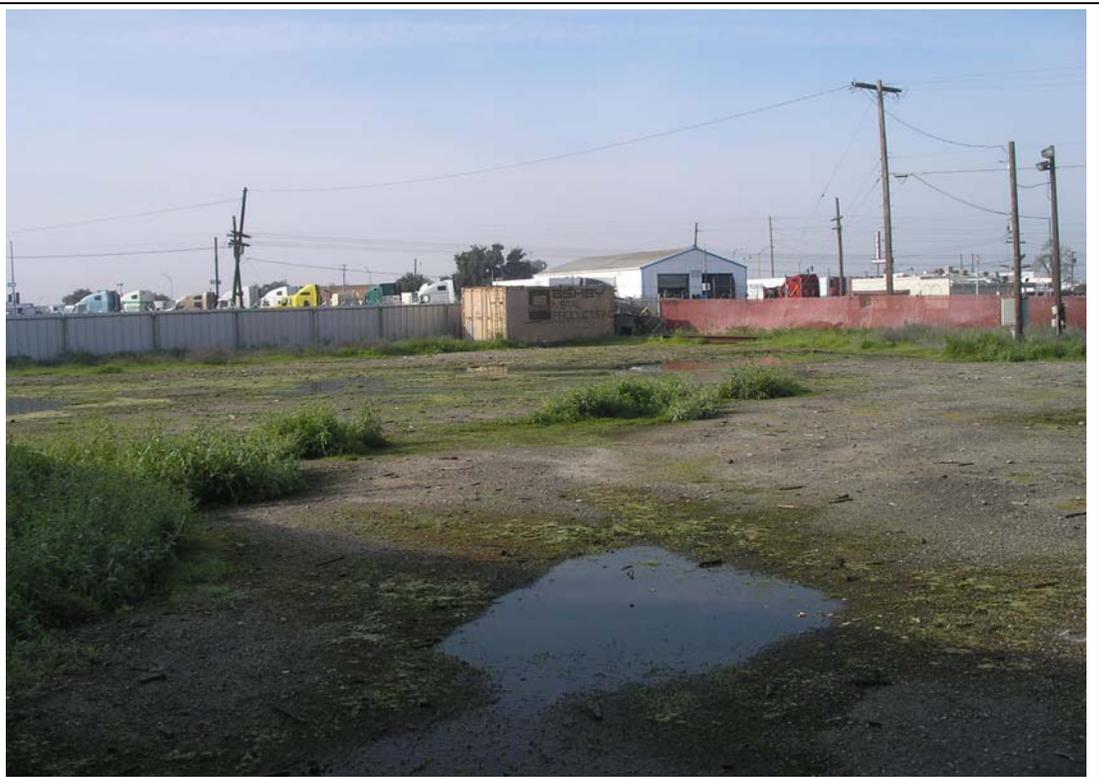
<p>Photo No.  <b>2</b></p>	
<p>Direction Photo Taken:                  Looking southwest</p>	
<p>Description:                  View across the two lots from the northeast corner. Note the locked cargo container in the southwest corner of the site.</p>

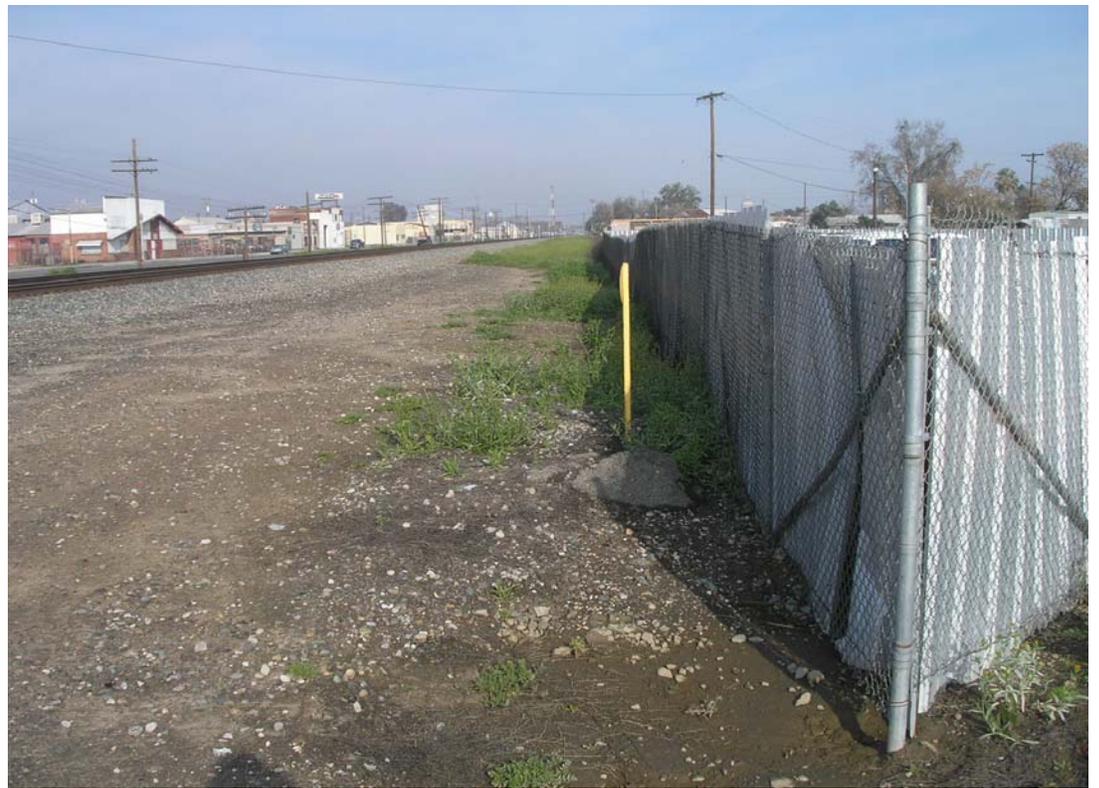
<p>Photo No.  <b>4</b></p>	
<p>Direction Photo Taken:                  Looking north</p>	
<p>Description:                  Looking across the west side of the site. Scrap metal and some concrete and wooden pallet debris are hidden by the tall grass.</p>

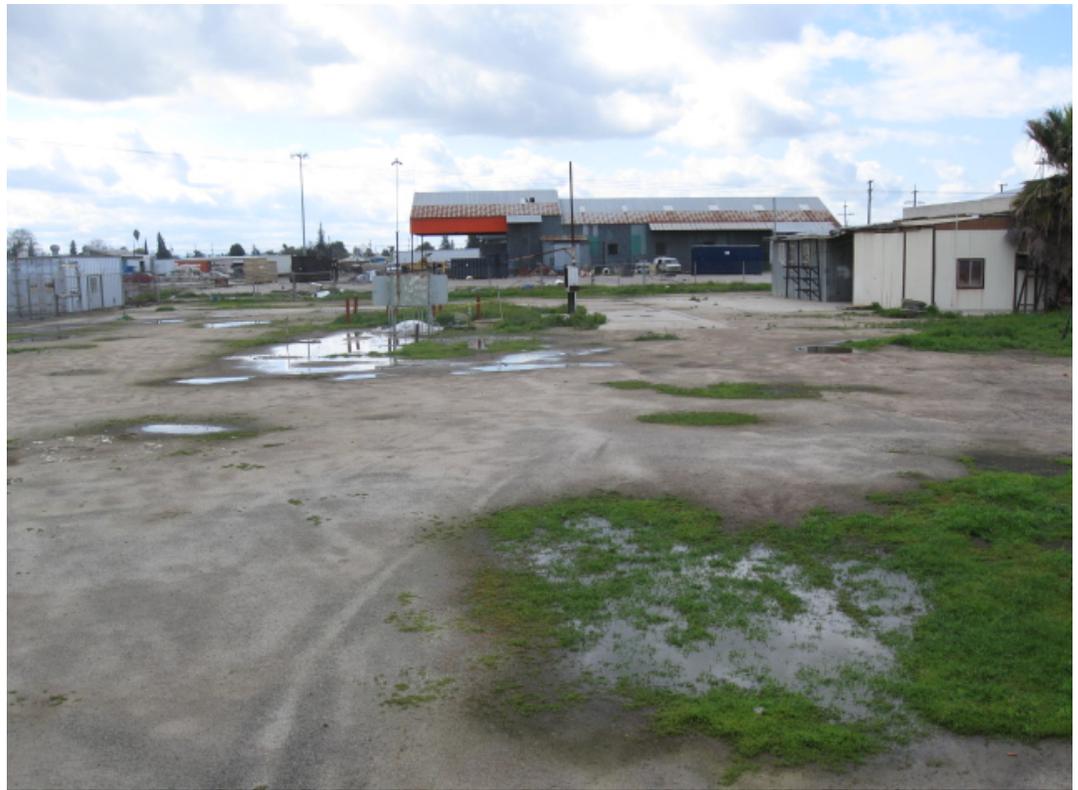
<p>Photo No.  <b>1</b></p>	
<p>Direction Photo Taken:                  Looking west</p>	
<p>Description:                  View near the southwest corner of the site. Note soil vapor extraction (SVE) system. Structures in the background are not onsite. Brick and steel-sided structure in the right of the frame is the only building on the site.</p>

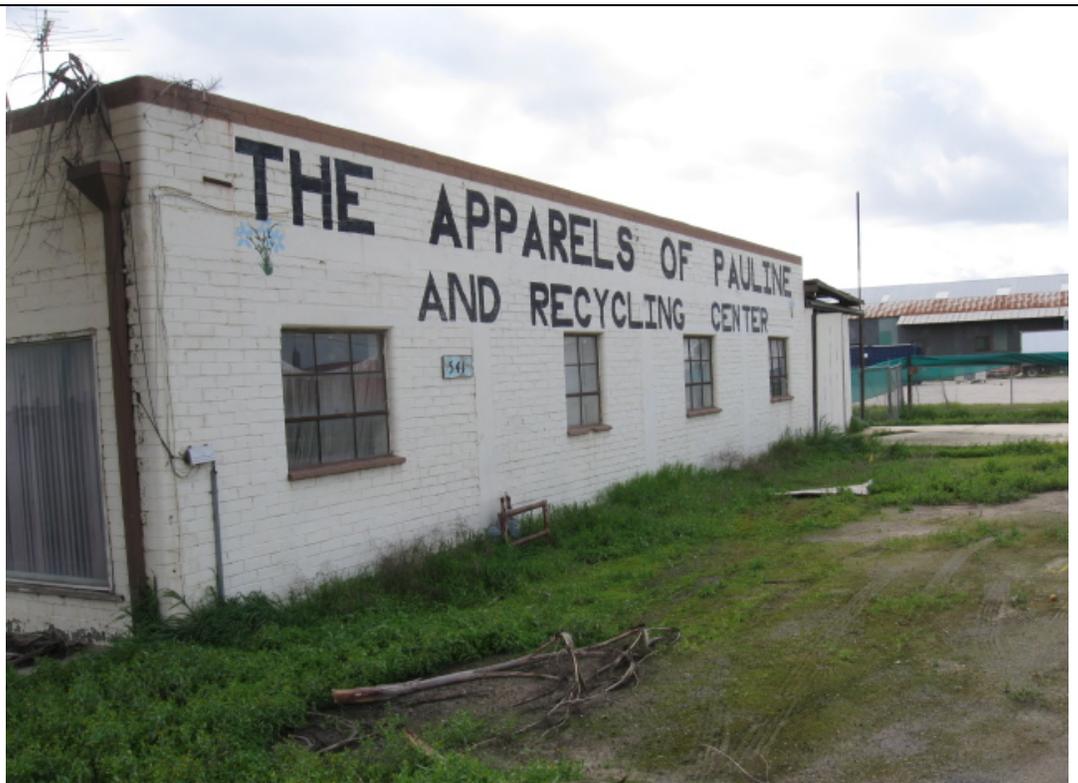
<p>Photo No.  <b>2</b></p>	
<p>Direction Photo Taken:                  Looking southwest</p>	
<p>Description:                  View of brick and steel-sided structure located near the western edge of the site.</p>

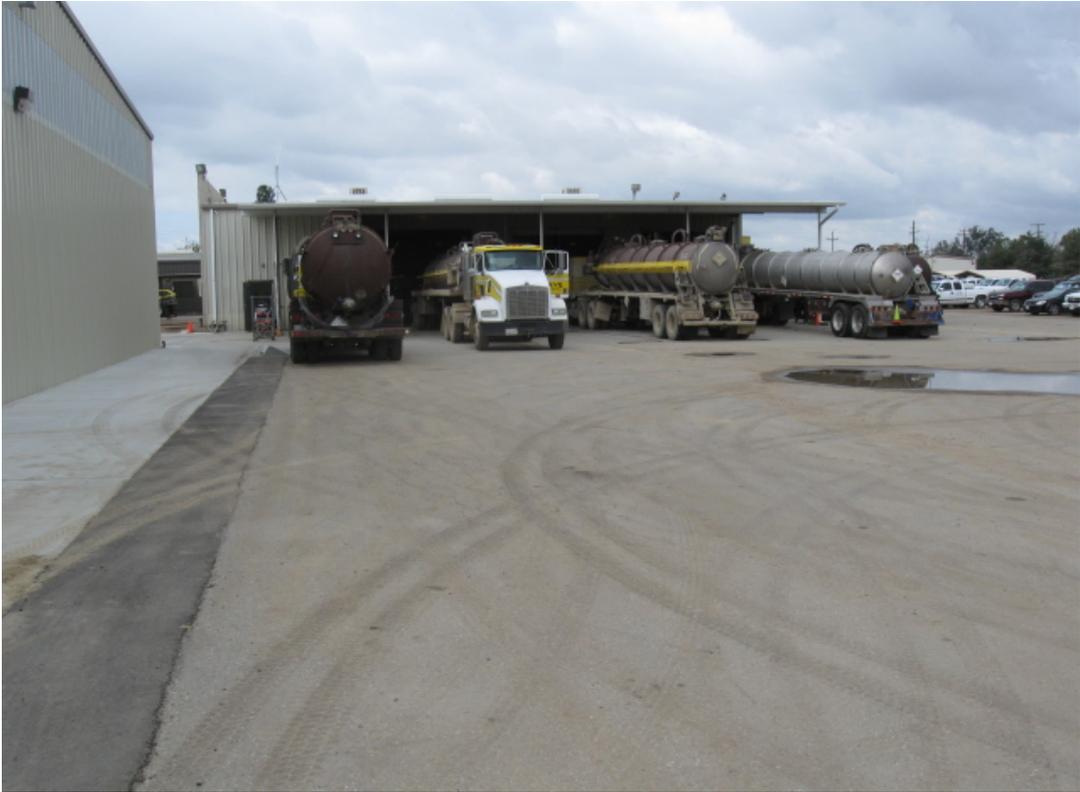
<p><b>Photo No.</b>  <b>3</b></p>

<p><b>Direction Photo Taken:</b>                   Looking west</p>	
<p><b>Description:</b>                   Another view of the truck and equipment maintenance shop.</p>

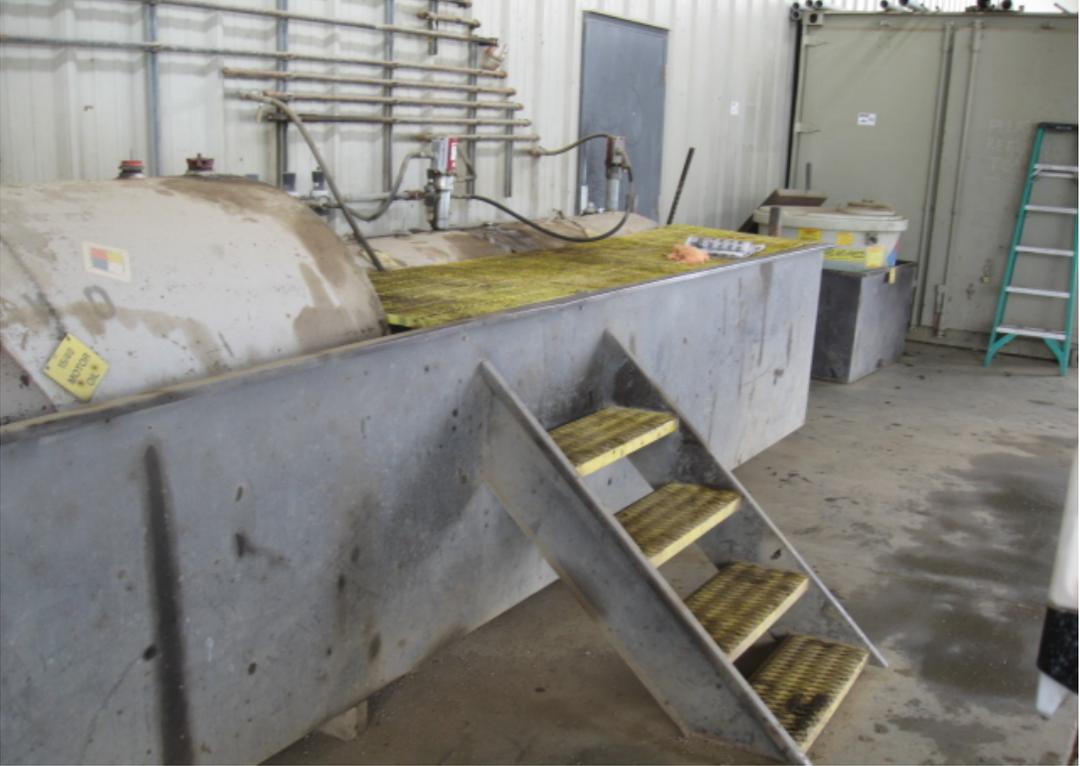
<p><b>Photo No.</b>  <b>4</b></p>

<p><b>Direction Photo Taken:</b>                   Interior view</p>	
<p><b>Description:</b>                   Used oil storage tank in secondary containment in the shop area.</p>

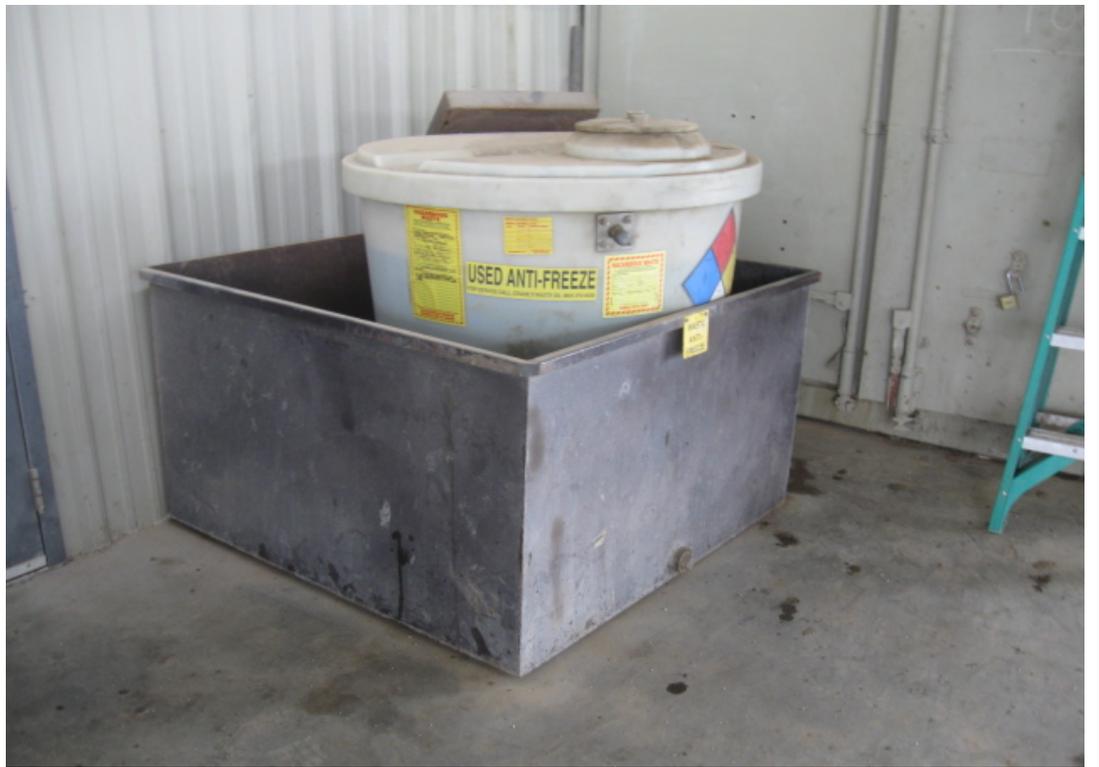
<p><b>Photo No.</b>  <b>5</b></p>	
<p><b>Direction Photo Taken:</b>                   Interior view</p>	
<p><b>Description:</b>                   Used antifreeze tank in secondary containment in the shop area.</p>

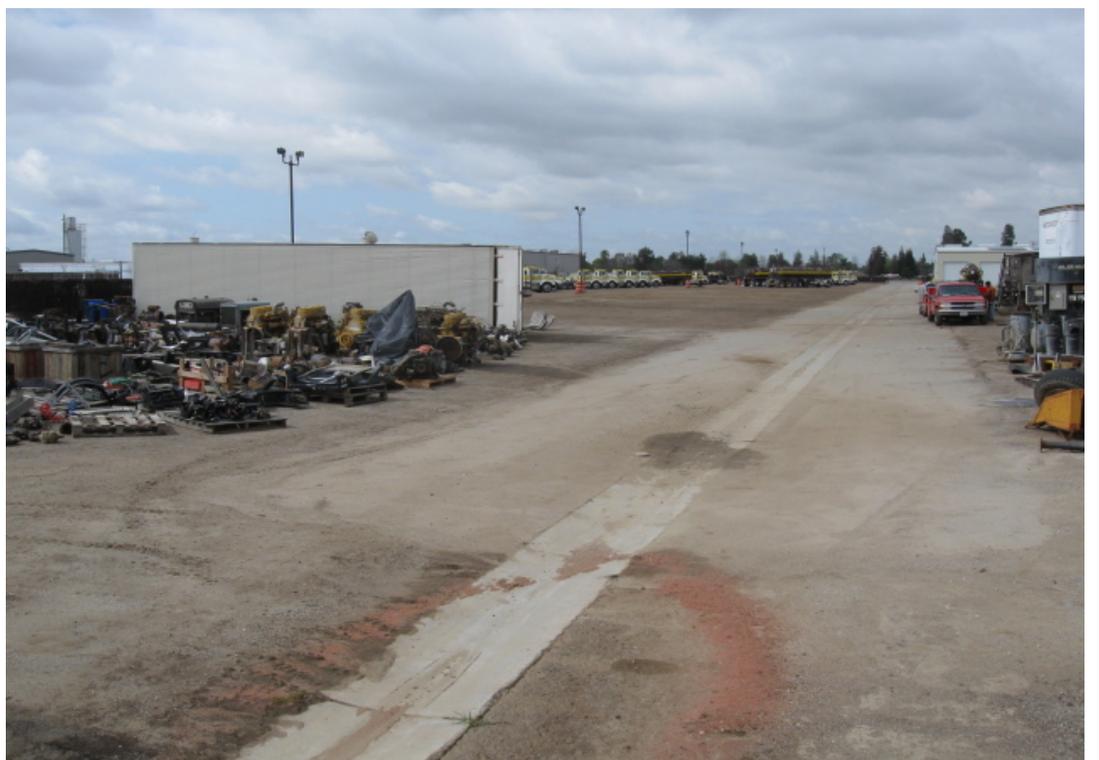
<p><b>Photo No.</b>  <b>6</b></p>	
<p><b>Direction Photo Taken:</b>                   Looking west</p>	
<p><b>Description:</b>                   View of stored parts and equipment in the KVS Transportation yard.</p>

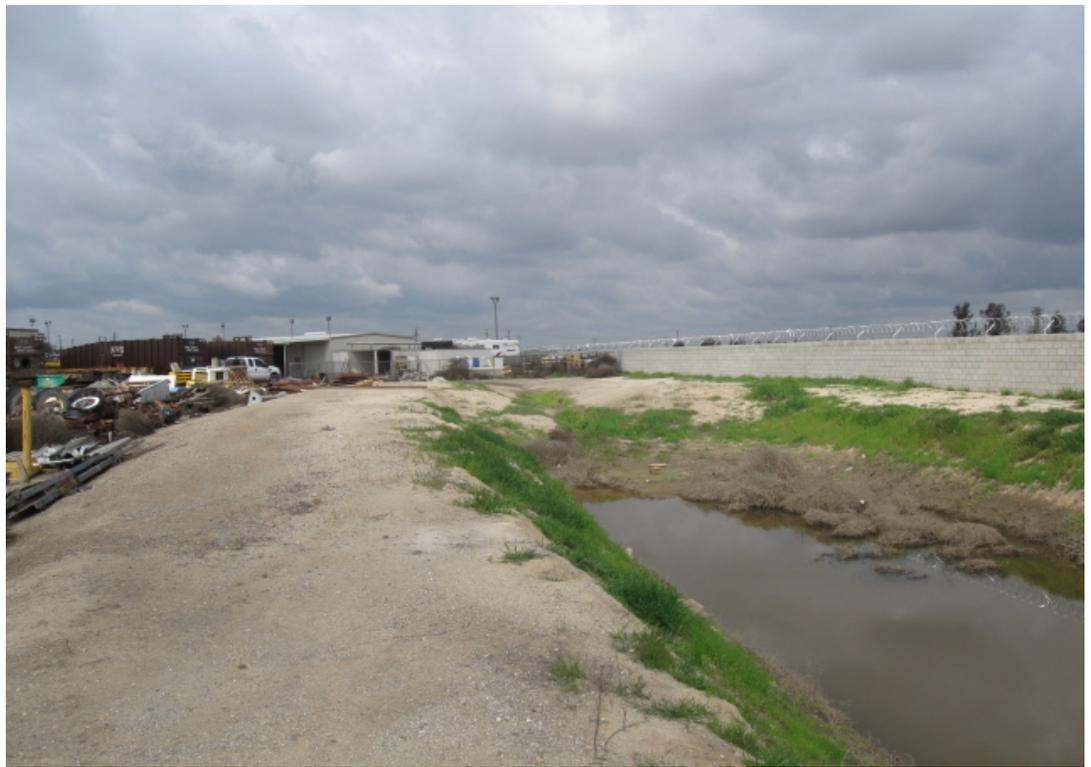
**Description:**  
 Storm water impoundment on the east end of the site, along the BNSF tracks.

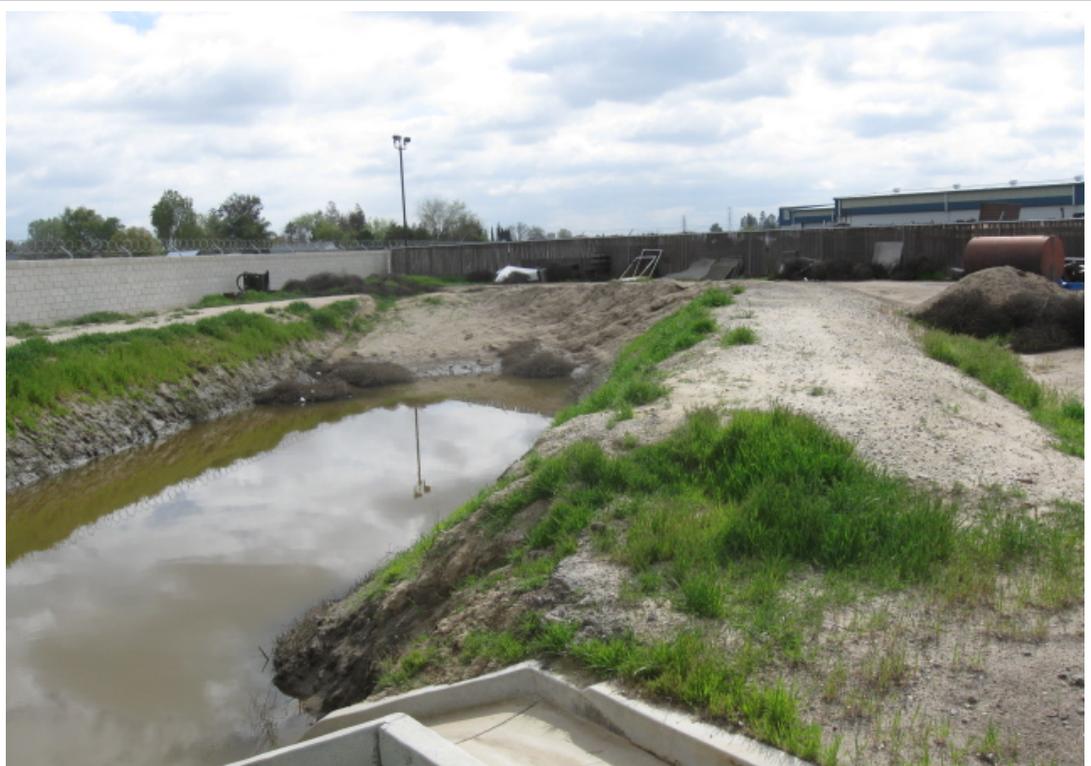
**Photo No.**  
**8**

**Description:**  
 Storm water impoundment on the east end of the site, along the BNSF tracks.

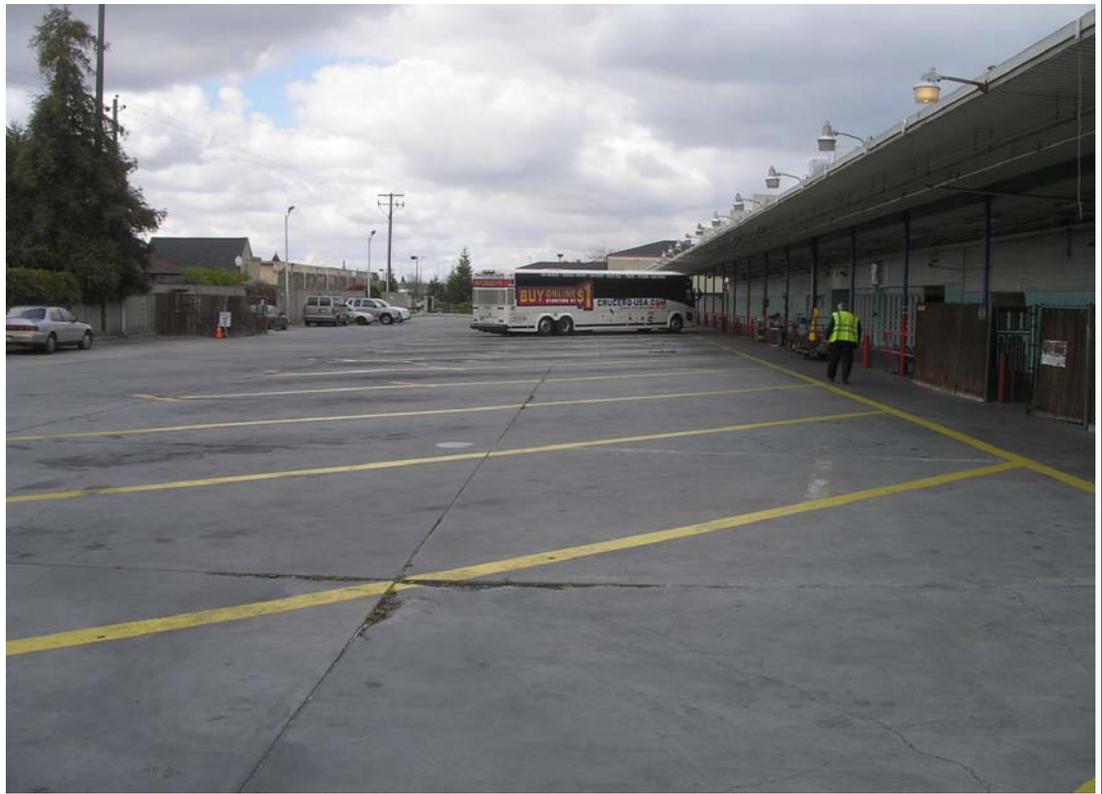
<p><b>Photo No.</b>  <b>3</b></p>	
<p><b>Direction Photo Taken:</b>                   Looking north</p>	
<p><b>Description:</b>                   View of the bus terminal driveway and loading area on the west side of the Depot.</p>

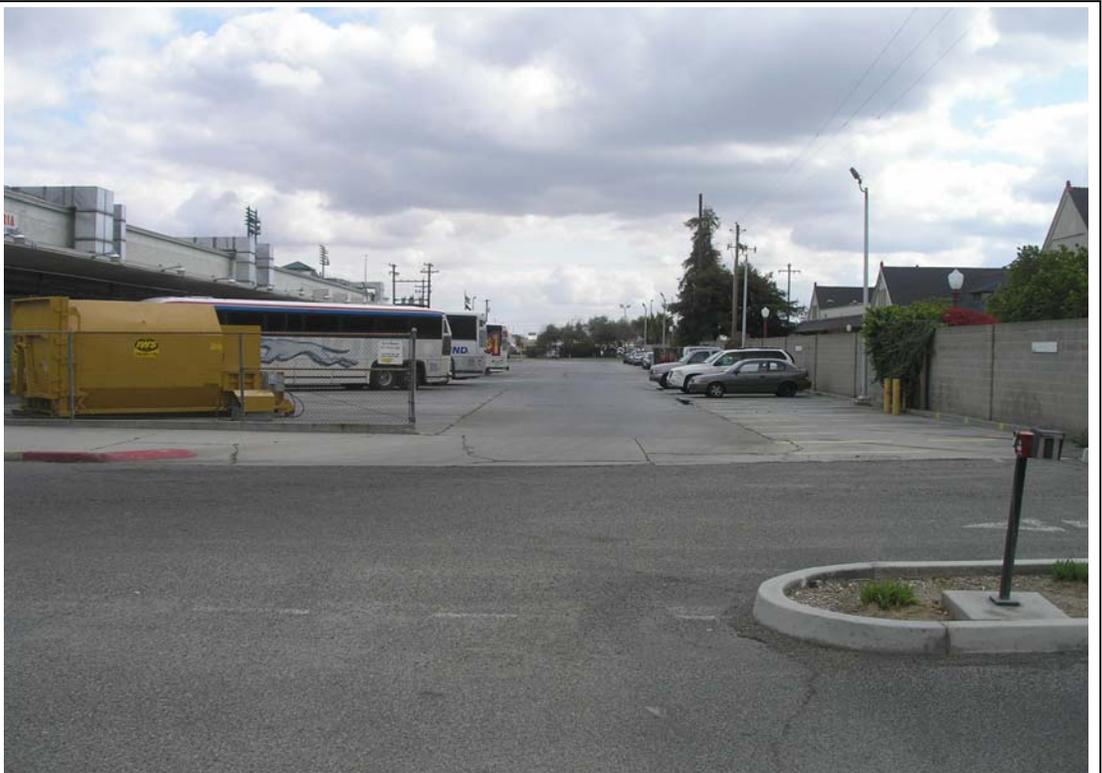
<p><b>Photo No.</b>  <b>4</b></p>	
<p><b>Direction Photo Taken:</b>                   Looking south</p>	
<p><b>Description:</b>                   View of the bus terminal driveway and loading area on the west side of the Depot. Note the historic Southern Pacific Railroad Depot beyond the block wall on the right-center of the frame.</p>

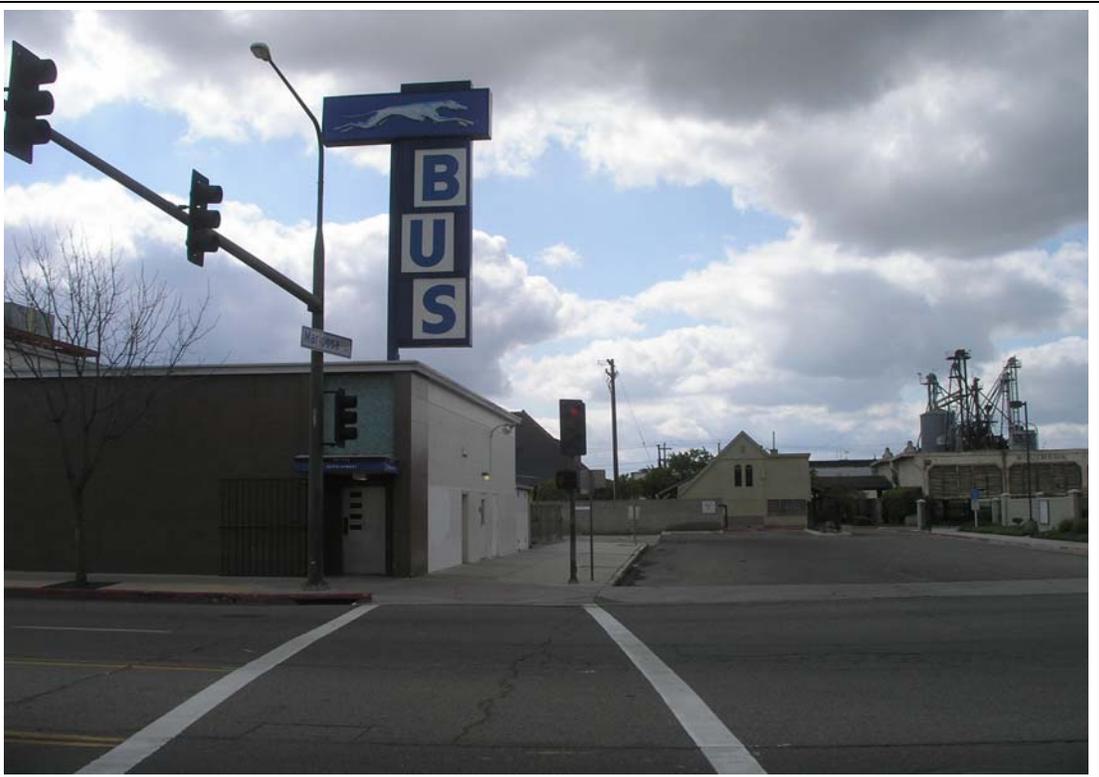
<p>Photo No.  <b>6</b></p>
<p>Direction Photo Taken:                  Looking north</p>
<p>Description:                  Former location of USTs beneath the bus loading area.</p>

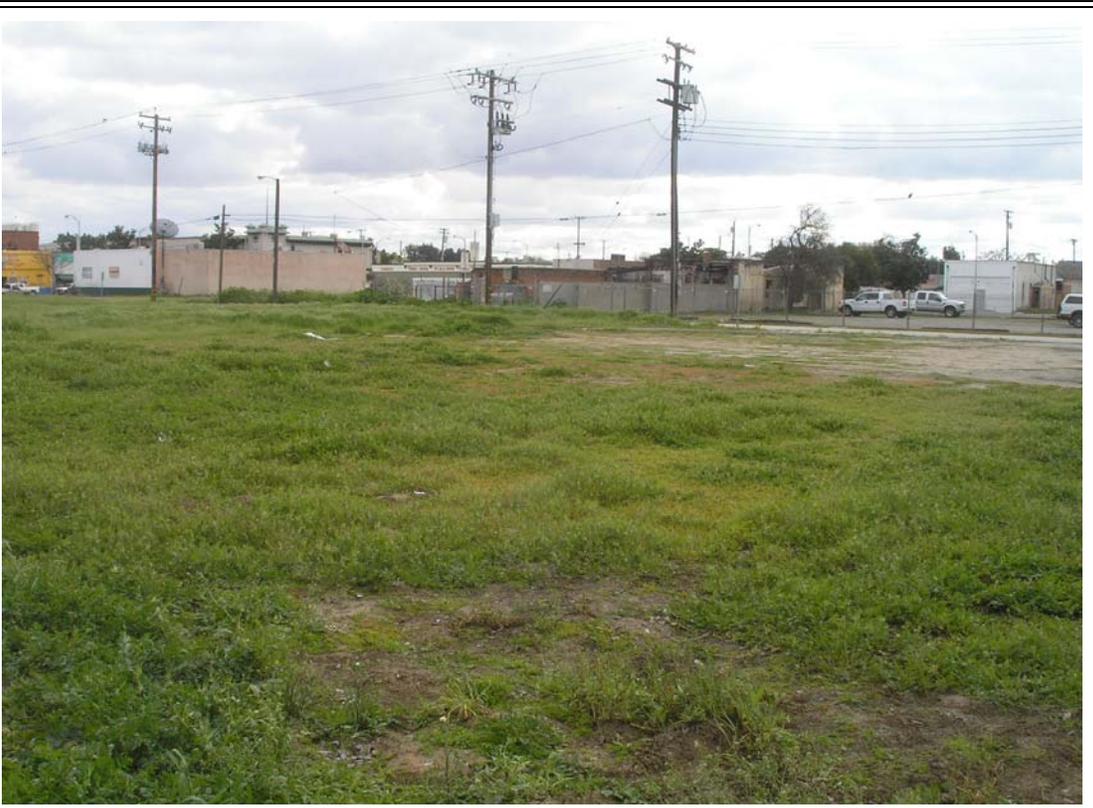
<p>Photo No.  <b>1</b></p>

<p>Direction Photo Taken:                   Looking southwest</p>	
<p>Description:                   Generally the south end of the site. The Basque Hotel parking lot, vacant structures, and vacant area east of subject property parcels APN 467-063-033 &amp; 034.</p>

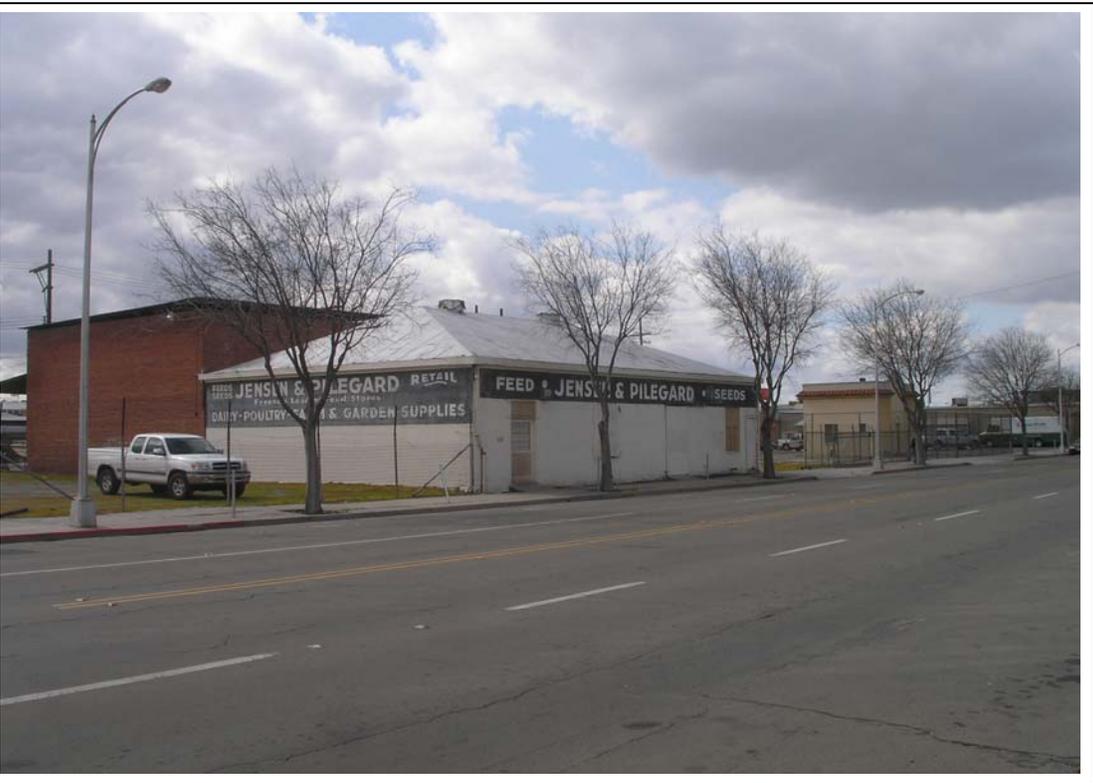
<p>Photo No.  <b>2</b></p>

<p>Direction Photo Taken:                   Looking northwest</p>	
<p>Description:                   View of the Jensen and Pilegard Feed and Seed tool storage building and shop building on subject property parcel APN 467-062-06 (across G Street west of the main feed mill and storage facility).</p>

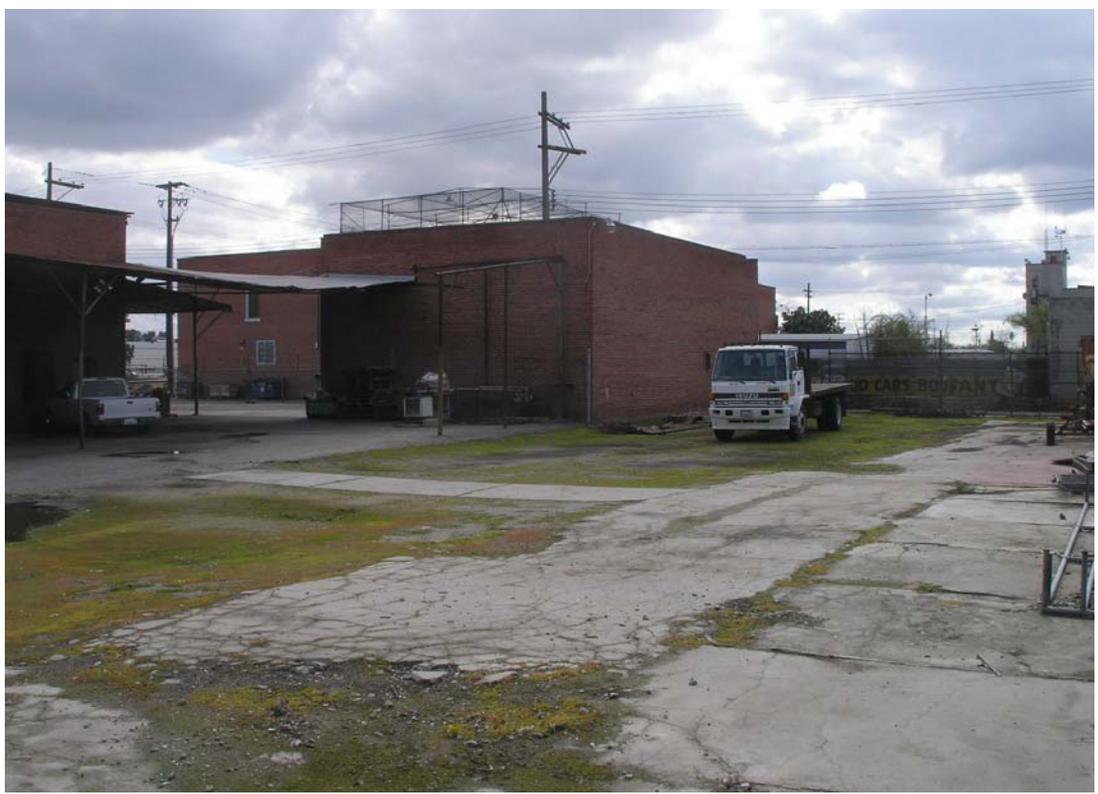
<p><b>Photo No.</b>  <b>3</b></p>

<p><b>Direction Photo Taken:</b>                   Looking west</p>	
<p><b>Description:</b>                   View of the Jensen and Pilegard shop building on subject property parcel APN 467-062-06.</p>

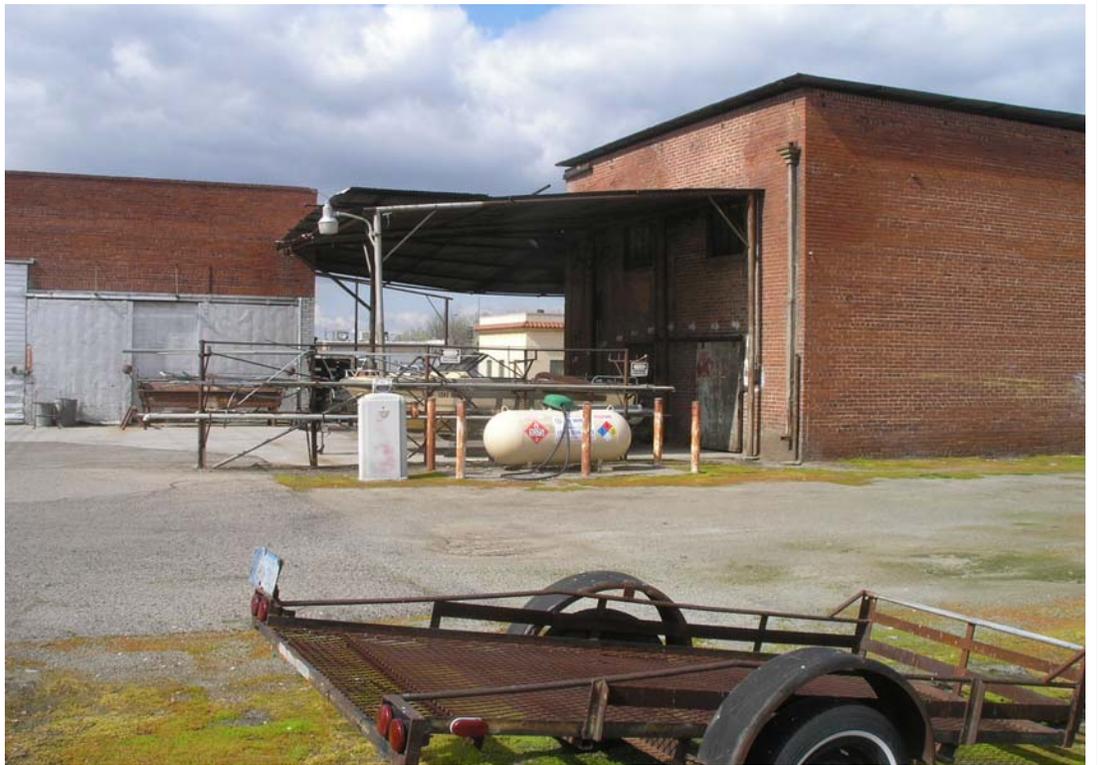
<p><b>Photo No.</b>  <b>4</b></p>

<p><b>Direction Photo Taken:</b>                   Looking north</p>	
<p><b>Description:</b>                   View of the Jensen and Pilegard tool storage building (right) and shop building (left) on subject property parcel APN 467-062-06.</p>

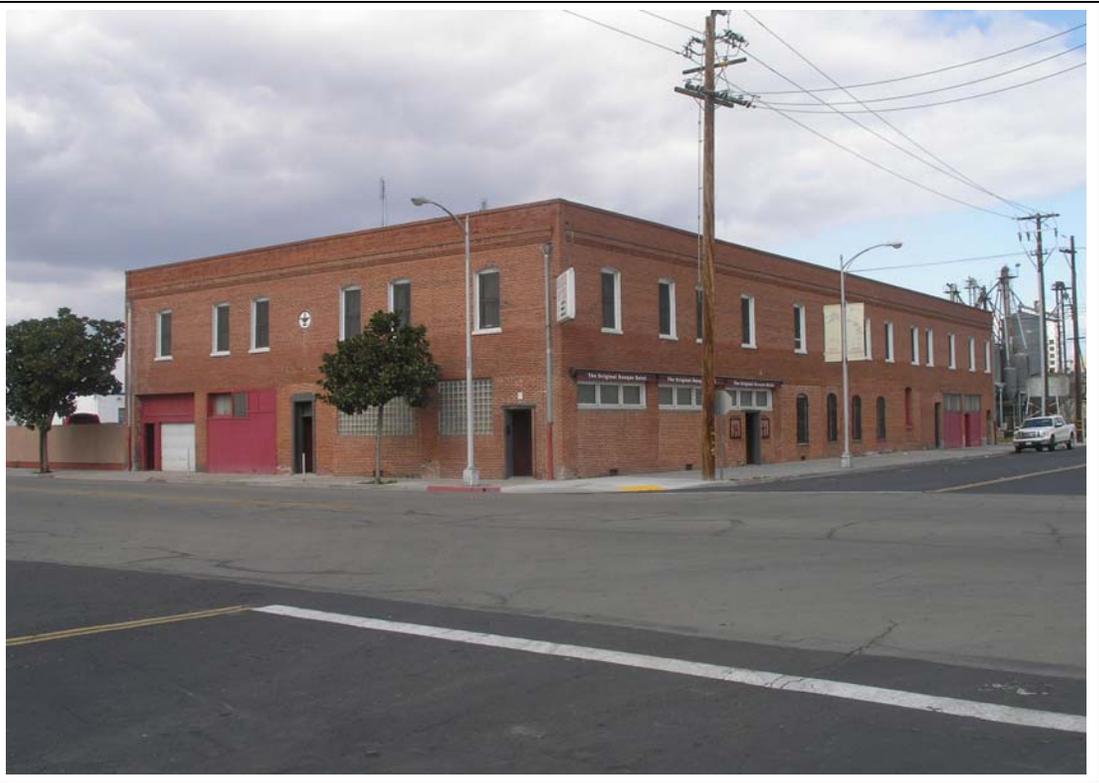
<p><b>Photo No.</b>                  7</p>
<p><b>Direction Photo Taken:</b>                   Looking northeast</p>
<p><b>Description:</b>                   The Basque Hotel on the northeast corner of F and Mariposa Streets, subject property parcel APN 467-062-08.</p>

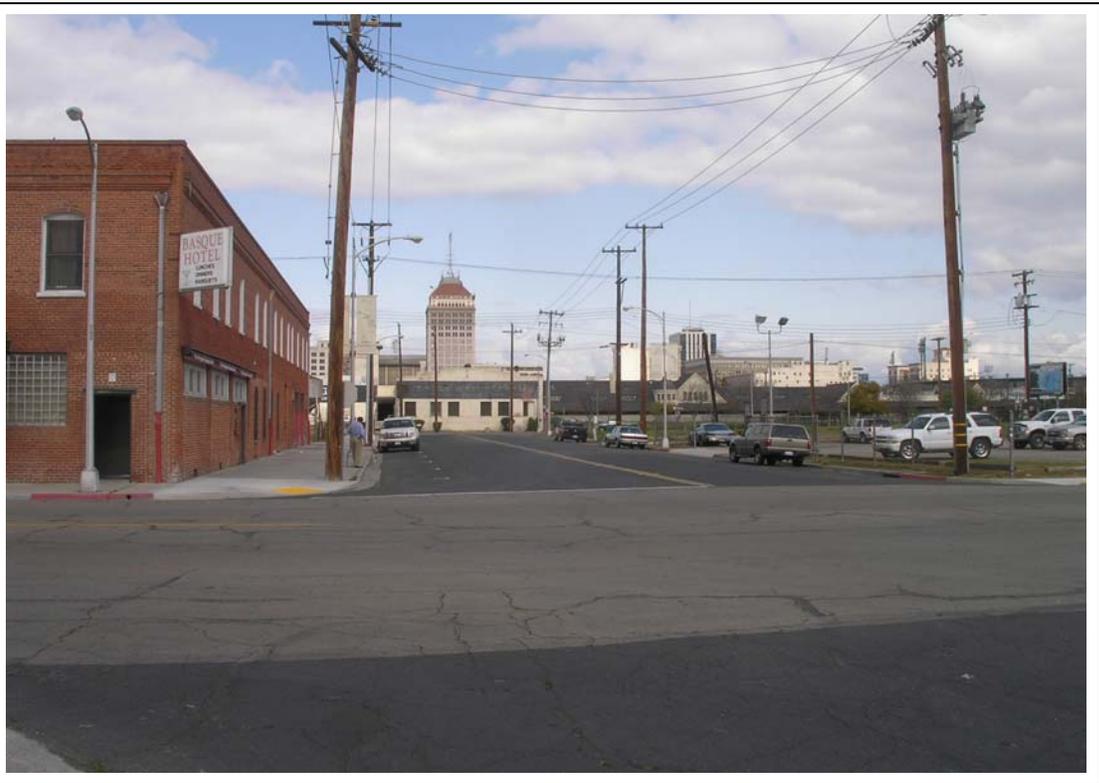
<p><b>Photo No.</b>                  8</p>
<p><b>Direction Photo Taken:</b>                   Looking east</p>
<p><b>Description:</b>                   View across F Street at Mariposa Street, which bisects the subject property. The Hotel is on the left and the parking area is on the right.</p>
