# Appendix D

## Phase I Site Reconnaissance, Field Notes, Photographs, and Photo Logs Part 1

**HST PHASE I ENVIRONMENTAL SITE ASSESSMENT**

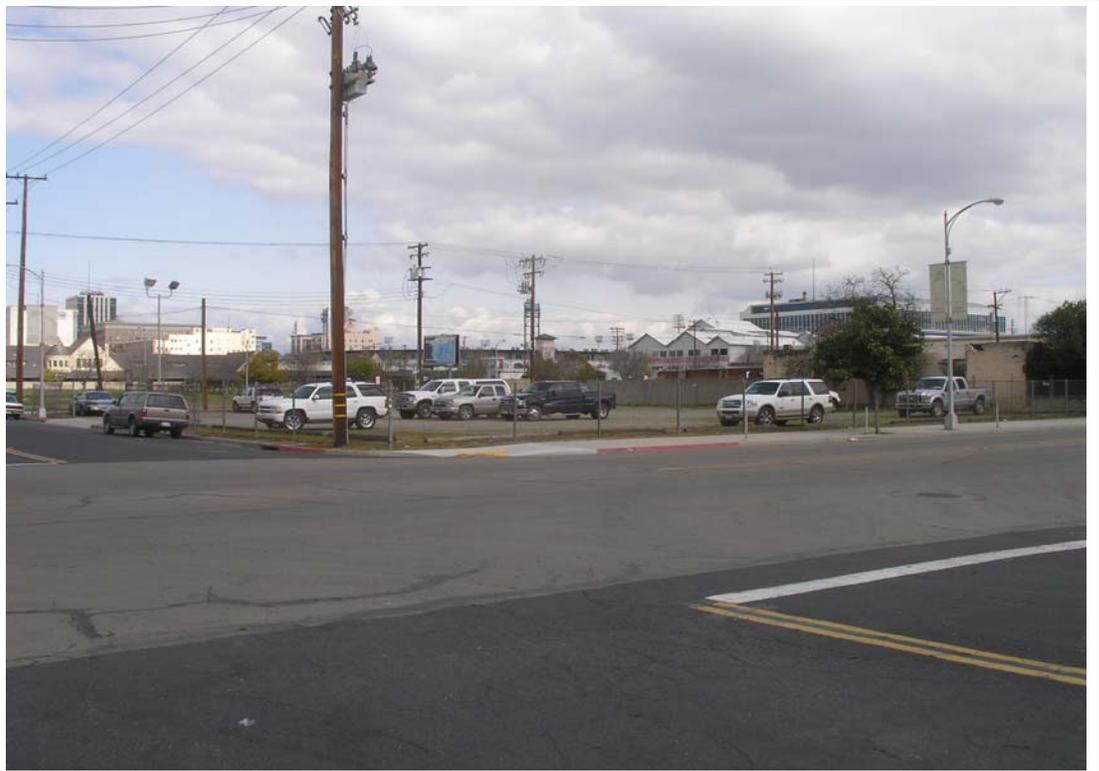
<p>Photo No.  <b>9</b></p>
<p>Direction Photo Taken:                   Looking southeast</p>
<p>Description:                   View across F Street (and Mariposa Street) at the Basque Hotel parking area on subject property parcels APN 467-063-033 &amp; 034.</p>

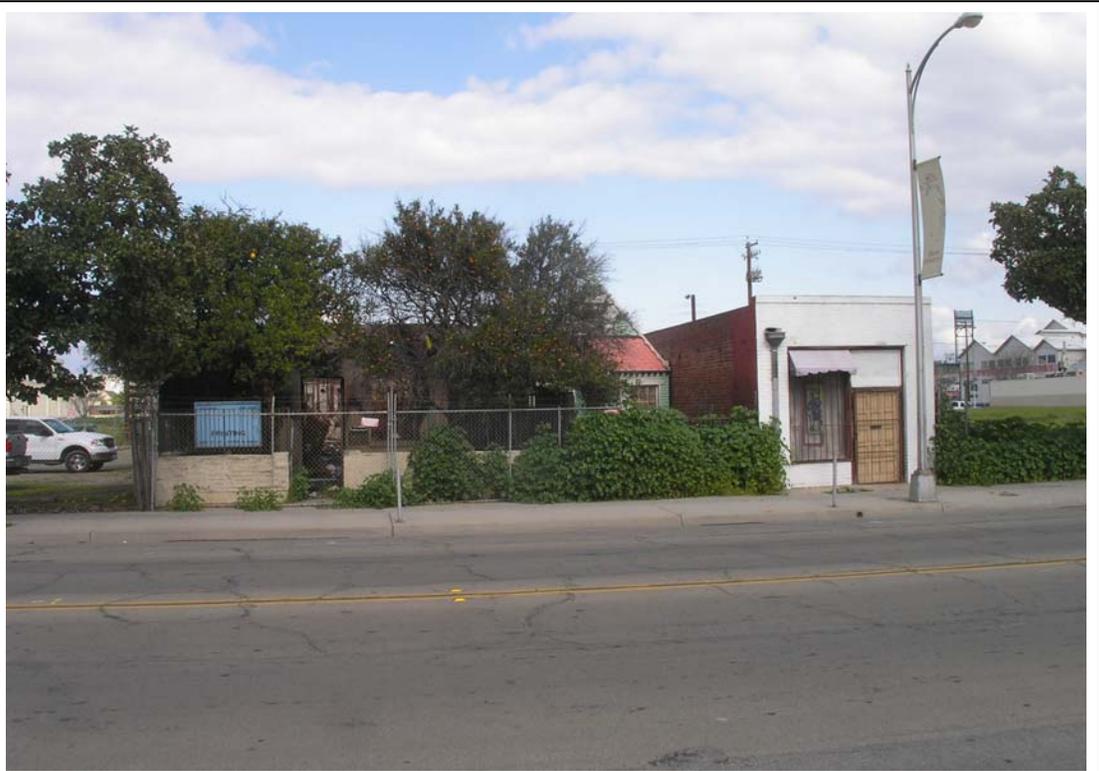
<p>Photo No.  <b>10</b></p>
<p>Direction Photo Taken:                   Looking east</p>
<p>Description:                   View of the vacant and gutted structures at the south end of the site along F Street on subject property parcels APN 467-063-033 &amp; 034.</p>

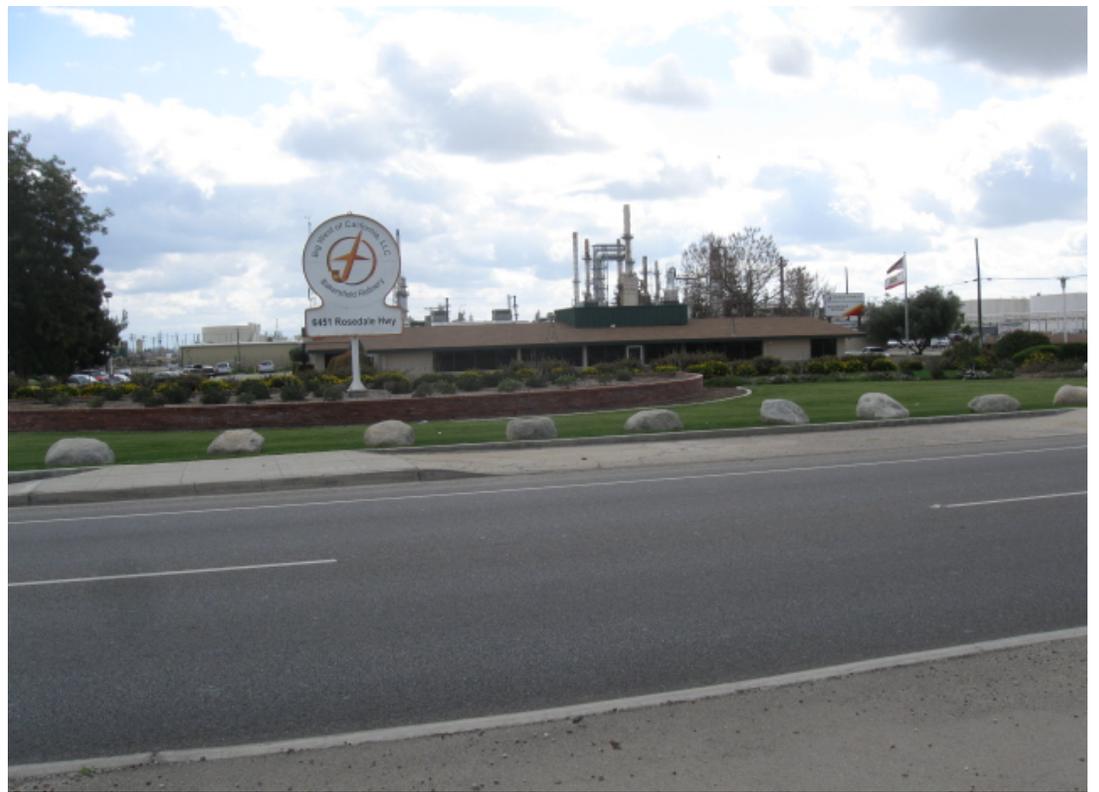
<p><b>Photo No.</b>  <b>1</b></p>	
<p><b>Direction Photo Taken:</b>                   Looking south</p>	
<p><b>Description:</b>                   View of the former Texaco refinery entrance from across Rosedale Highway on the north. The site is currently operated by Big West of California – Flying J.</p>

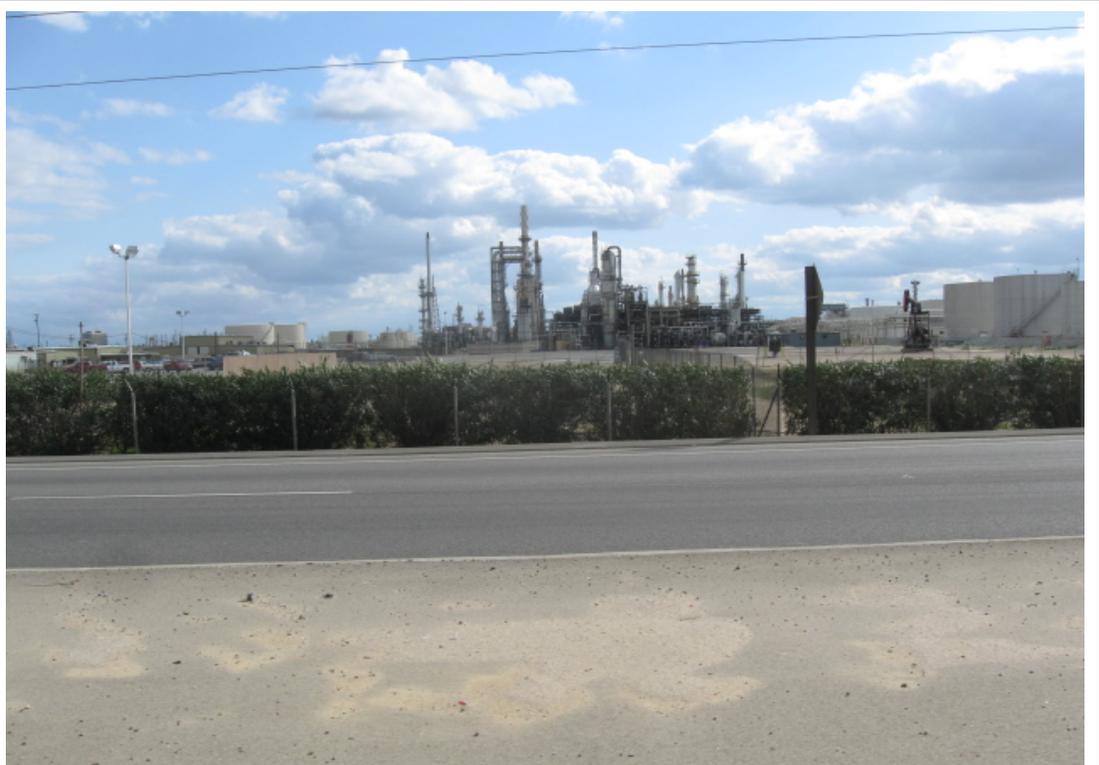
<p><b>Photo No.</b>  <b>2</b></p>	
<p><b>Direction Photo Taken:</b>                   Looking south</p>	
<p><b>Description:</b>                   View of the former Texaco refinery from across Rosedale Highway on the north.</p>

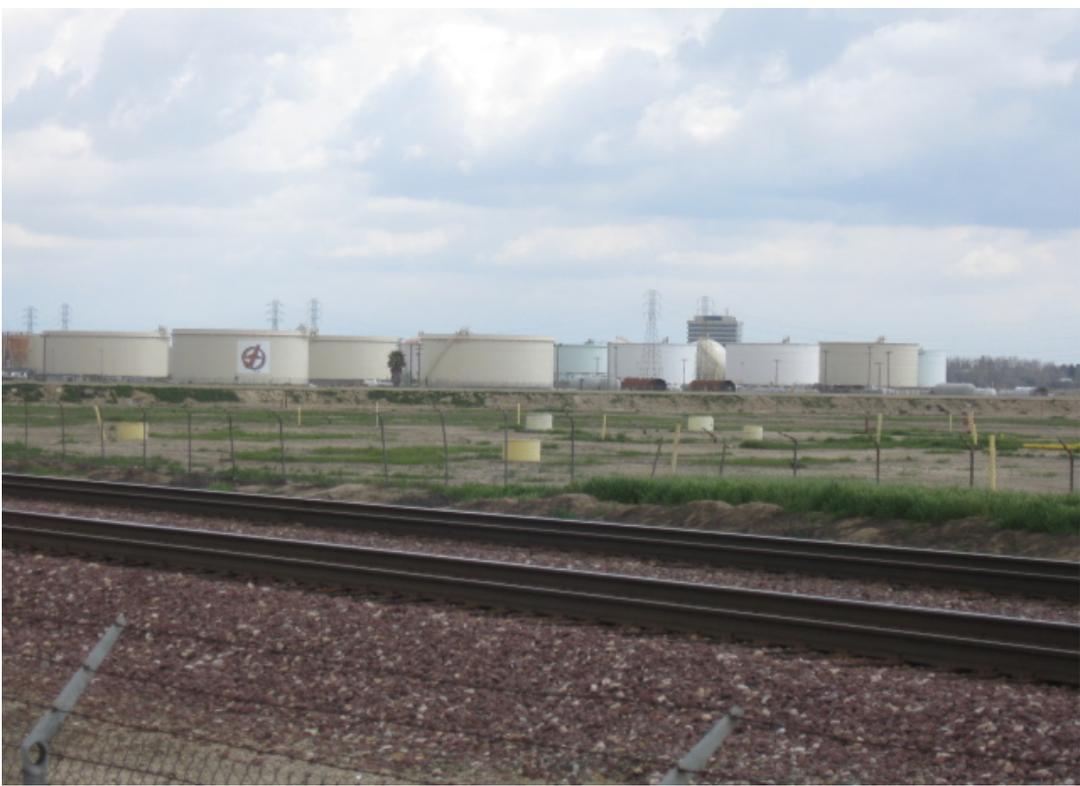
<p><b>Photo No.</b>  <b>3</b></p>

<p><b>Direction Photo Taken:</b>                   Looking southeast</p>	
<p><b>Description:</b>                   View of the tank farm from the BNSF tracks that bisect the site from east to west.</p>

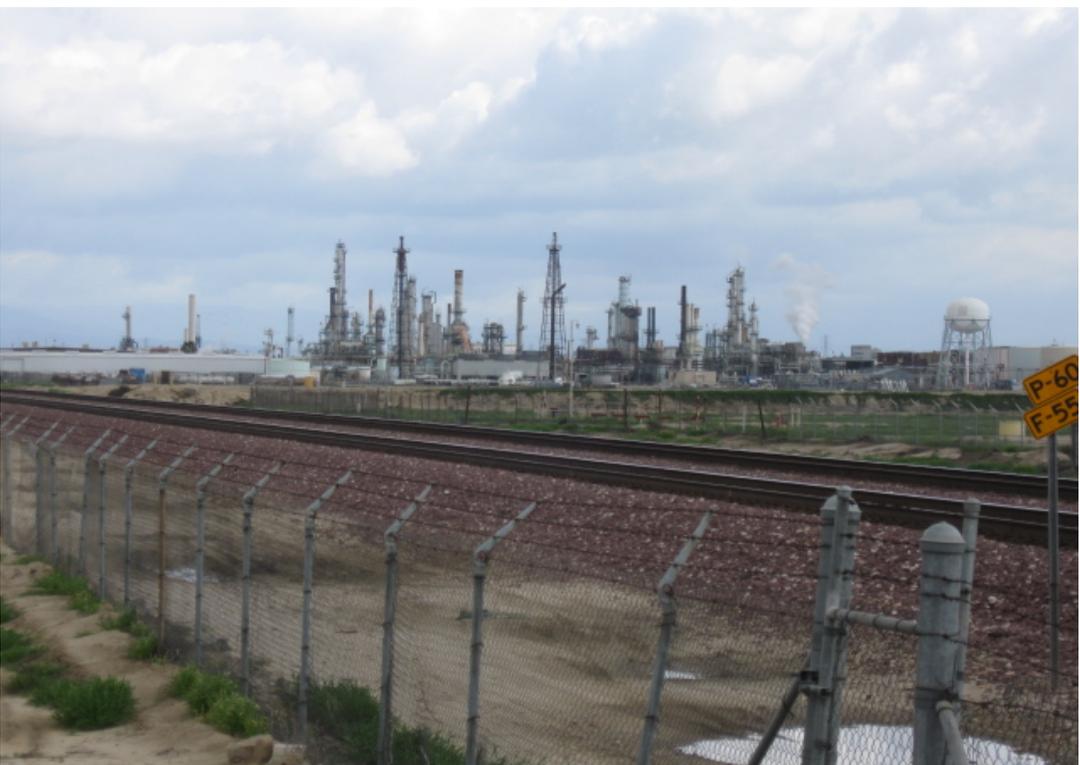
<p><b>Photo No.</b>  <b>4</b></p>

<p><b>Direction Photo Taken:</b>                   Looking southeast</p>	
<p><b>Description:</b>                   View of the former Tosco refinery from the BNSF tracks that bisect the site from east to west.</p>

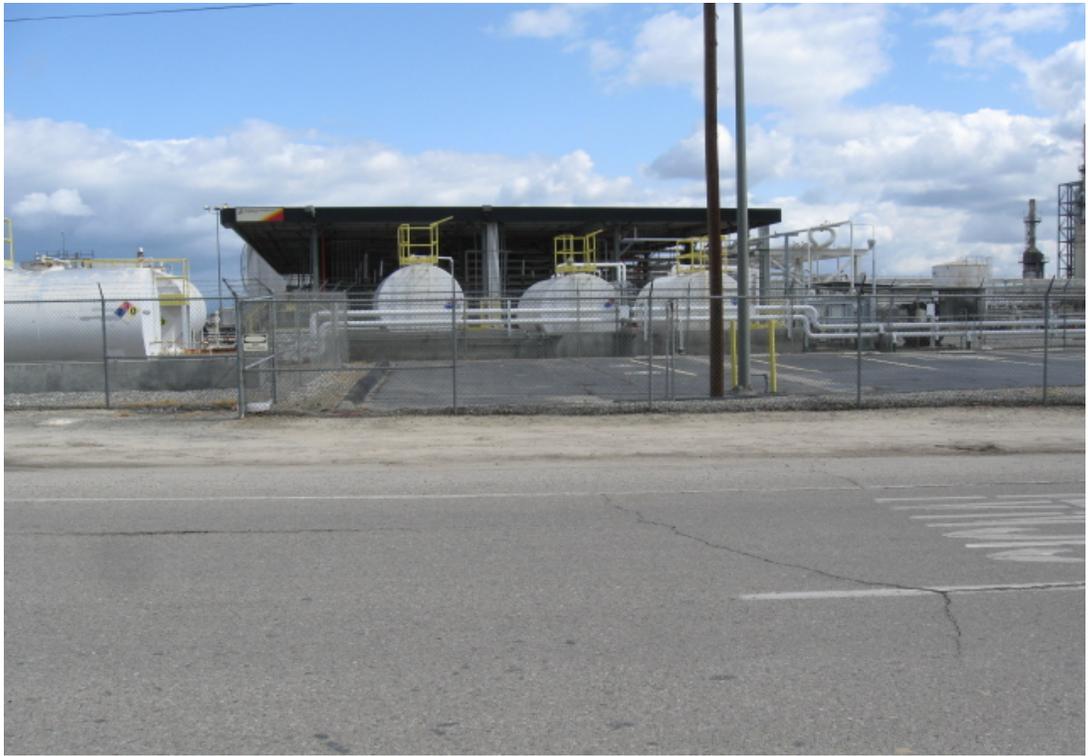
<p><b>Photo No.</b>  <b>5</b></p>

<p><b>Direction Photo Taken:</b>                   Looking east</p>	
<p><b>Description:</b>                   Typical view of storage tanks along Fruitvale Avenue that bisects the site from north to south.</p>

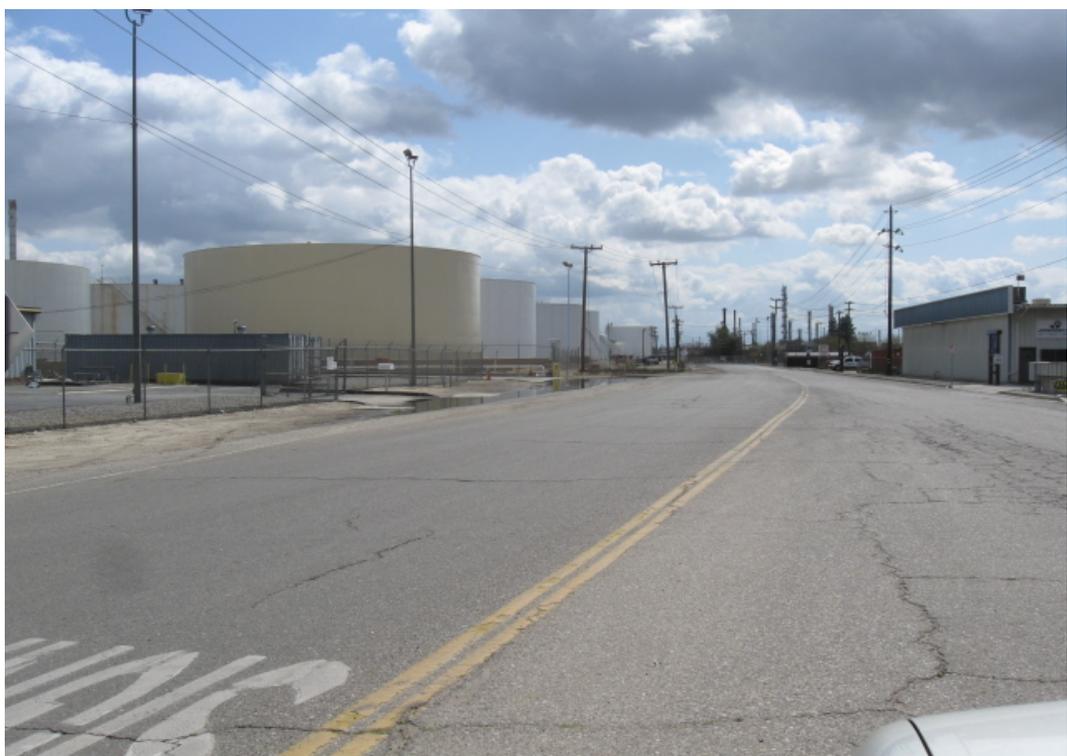
<p><b>Photo No.</b>  <b>6</b></p>

<p><b>Direction Photo Taken:</b>                   Looking south</p>	
<p><b>Description:</b>                   View along Fruitvale Avenue near the center of the former Texaco site.</p>

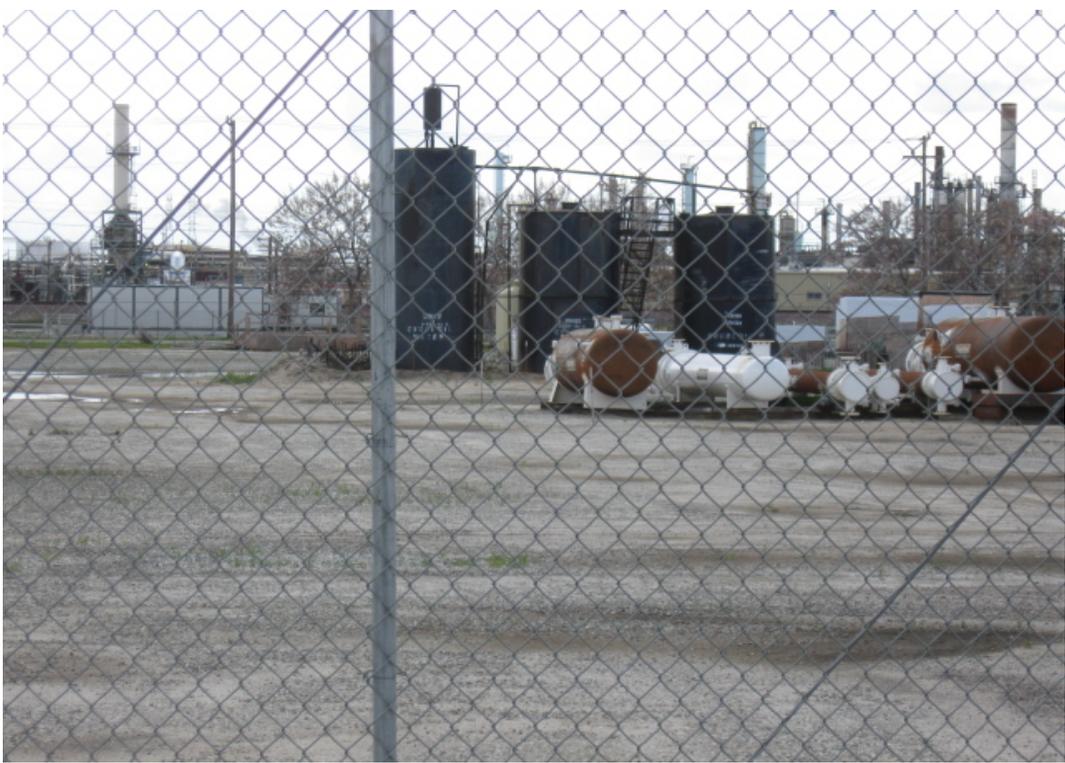
<p><b>Photo No.</b>  <b>7</b></p>

<p><b>Direction Photo Taken:</b>                   Looking west</p>	
<p><b>Description:</b>                   View of crude oil storage tanks at a (former?) oil well location near the center of the site. The location is in a storage yard south of Charity Avenue.</p>

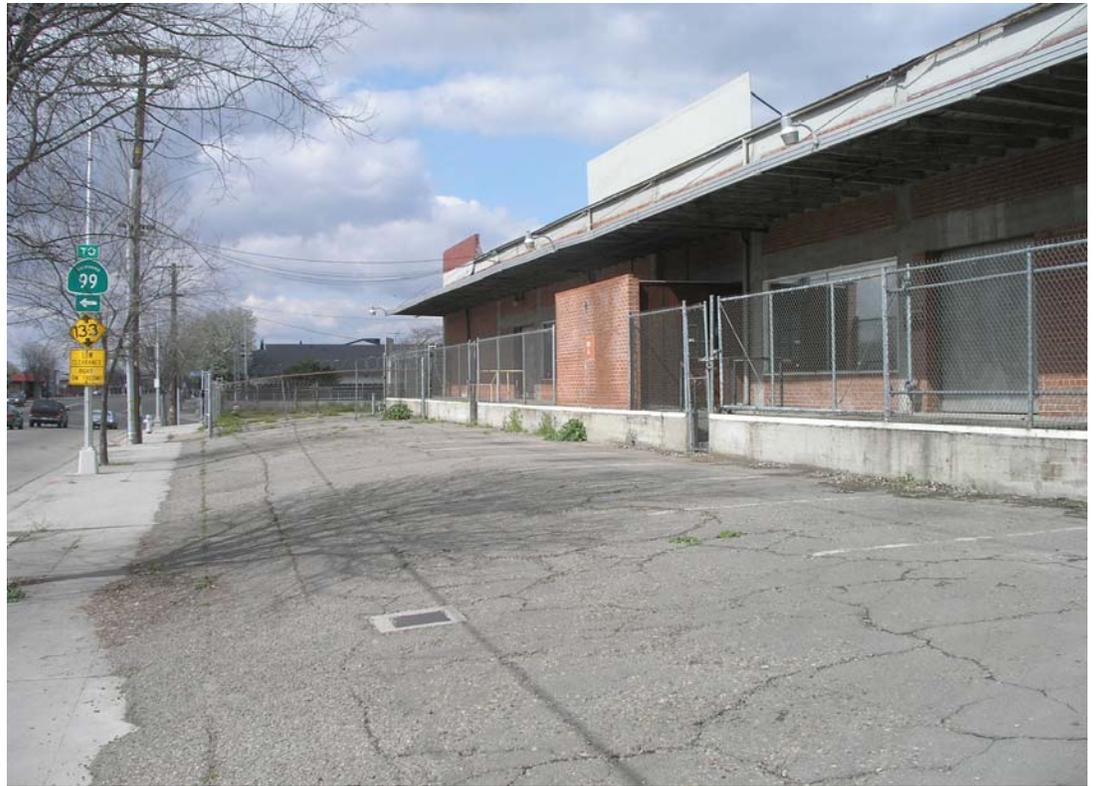
<p><b>Photo No.</b>  <b>1</b></p>	
<p><b>Direction Photo Taken:</b>                   Looking north</p>	
<p><b>Description:</b>                   View of the F Street entrance to the abandoned site.</p>

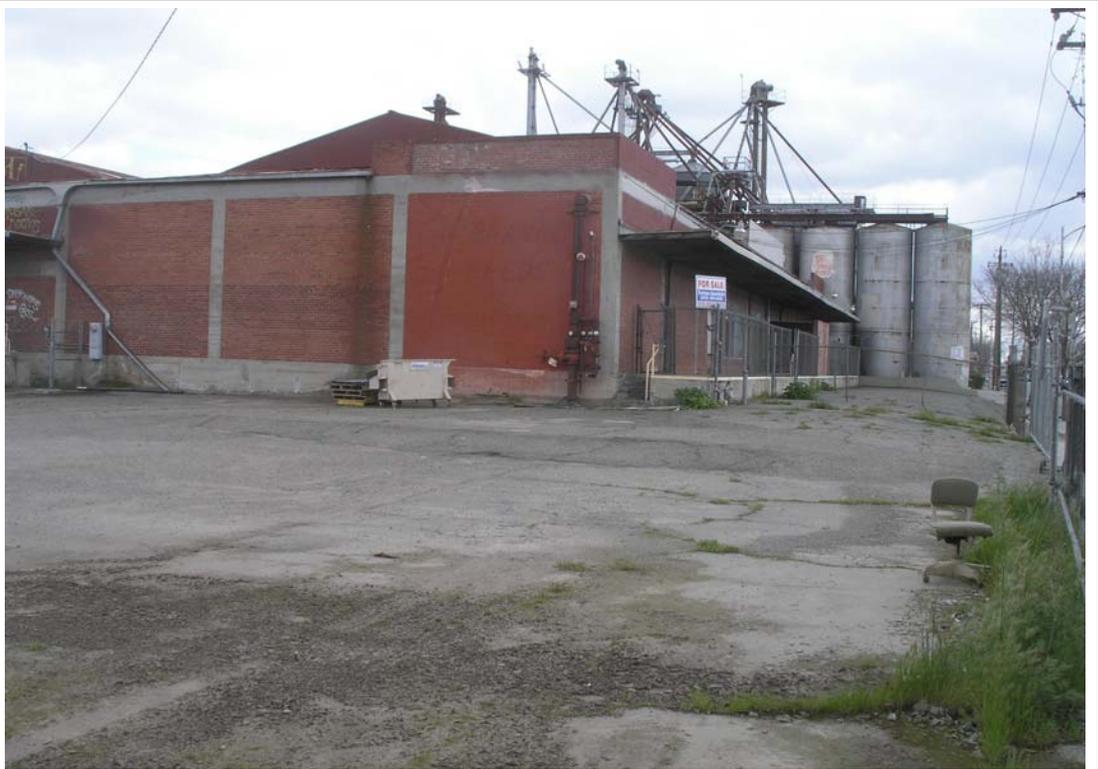
<p><b>Photo No.</b>  <b>2</b></p>	
<p><b>Direction Photo Taken:</b>                   Looking south</p>	
<p><b>Description:</b>                   View from the northwest corner of the site. The gray tanks and works in the background are the Jensen and Pilegard Feed Mill.</p>

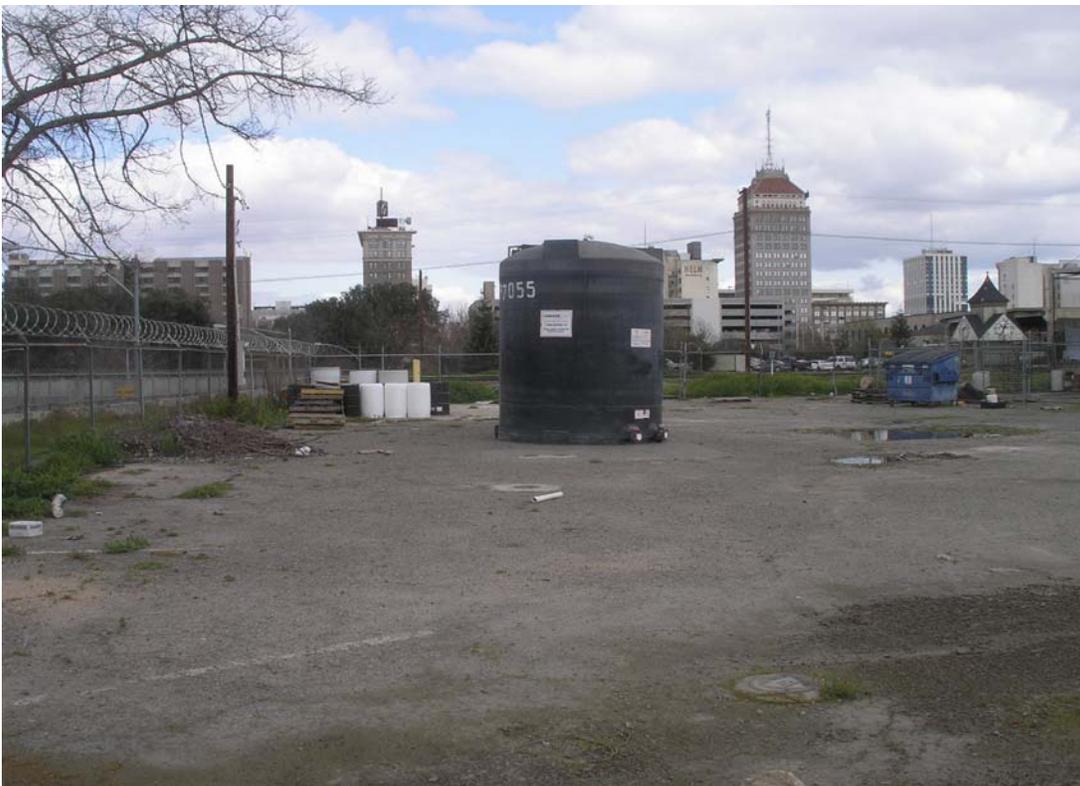
<p><b>Photo No.</b>  <b>3</b></p>

<p><b>Direction Photo Taken:</b>                   Looking east</p>	
<p><b>Description:</b>                   View of the north end of the site and the former treatment system. Note the groundwater monitoring wells.</p>

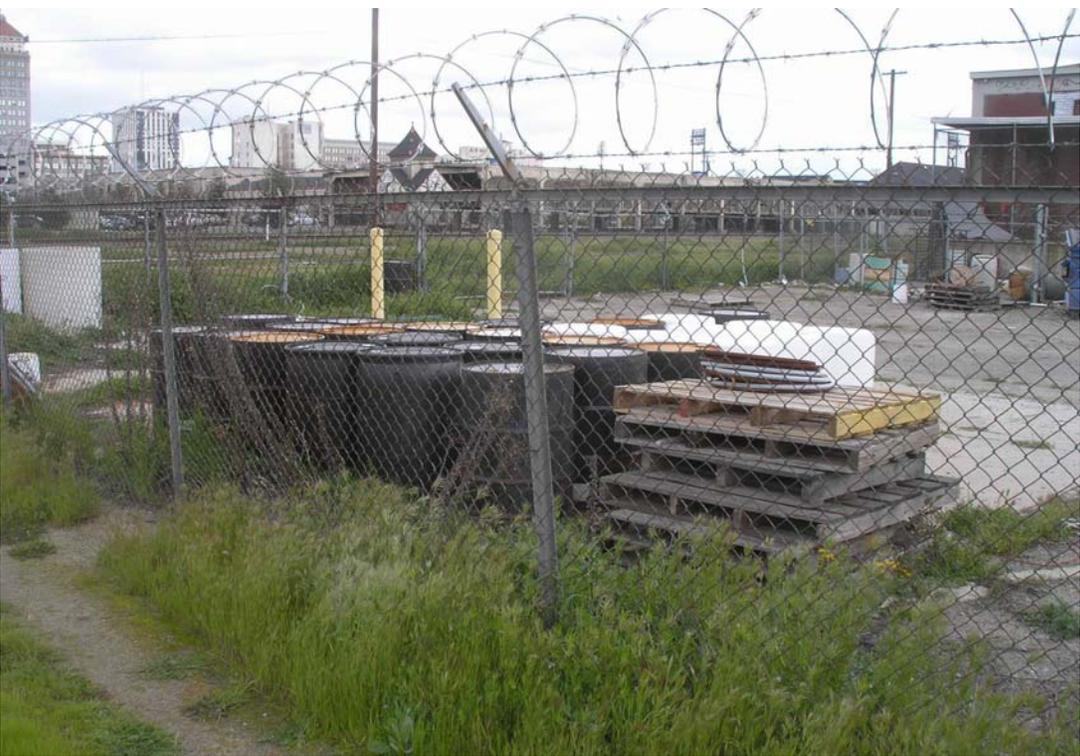
<p><b>Photo No.</b>  <b>4</b></p>

<p><b>Direction Photo Taken:</b>                   Looking southeast</p>	
<p><b>Description:</b>                   Drums used for the former treatment system located at the north end of the site.</p>

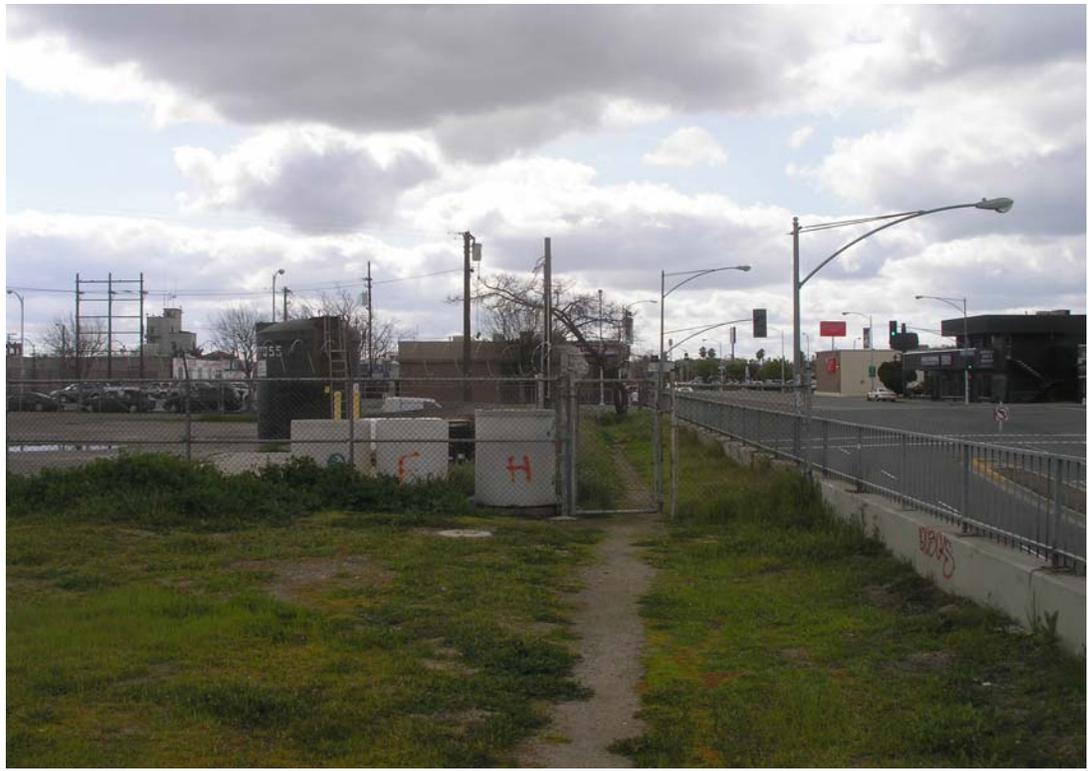
<p><b>Photo No.</b>  <b>5</b></p>

<p><b>Direction Photo Taken:</b>                  Looking west</p>	
<p><b>Description:</b>                  View of the north end of the site along Fresno Street.</p>

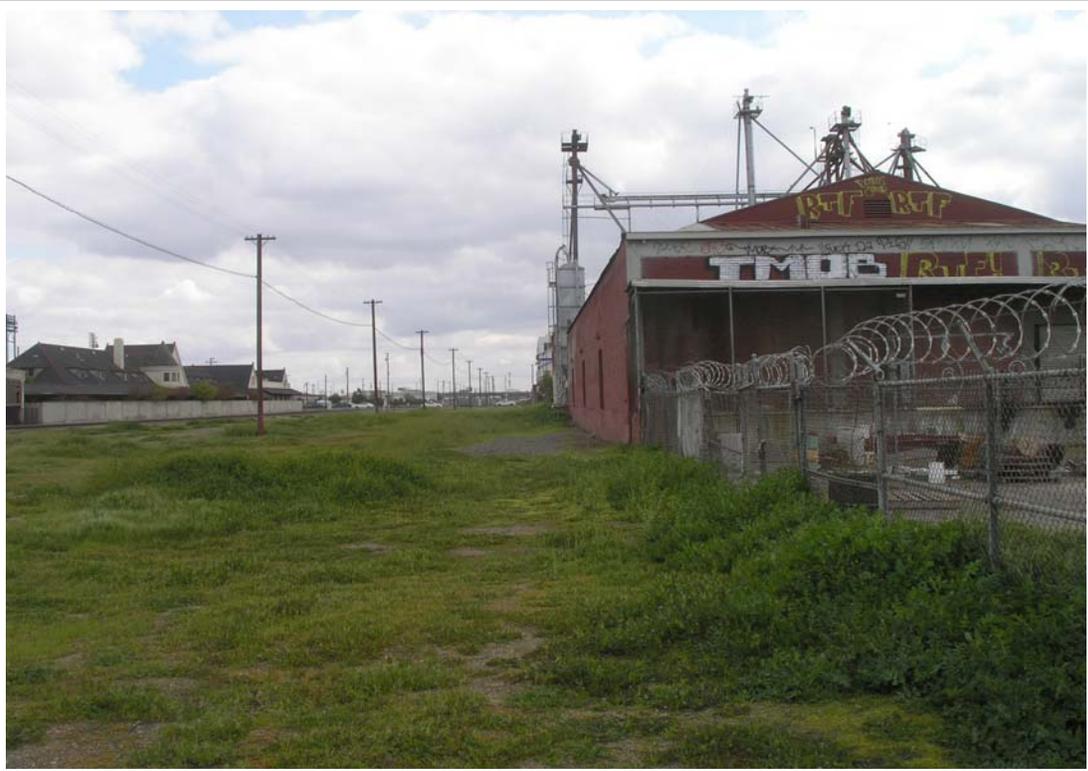
<p><b>Photo No.</b>  <b>6</b></p>

<p><b>Direction Photo Taken:</b>                  Looking south</p>	
<p><b>Description:</b>                  View from the northeast corner of the site. The gray tanks and works in the background are the Jensen and Pilegard Feed Mill. Note the Union Pacific tracks on the left and the historic Southern Pacific Railroad Depot beyond.</p>

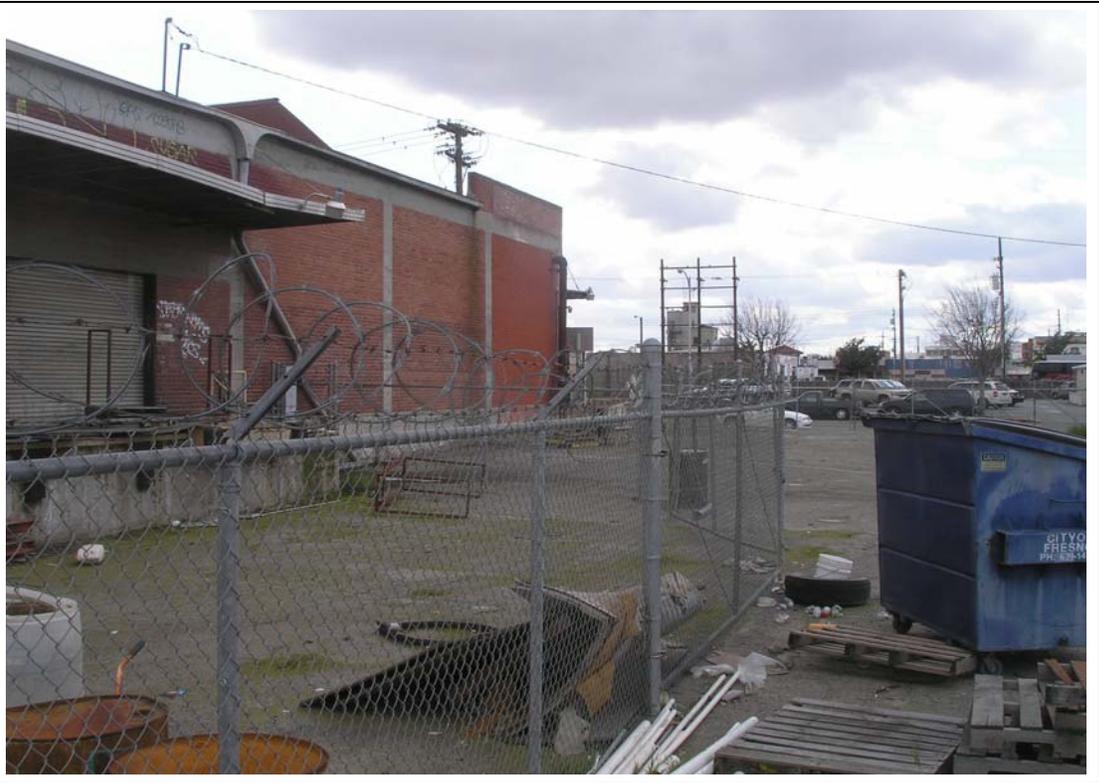
<p>Photo No.  <b>7</b></p>	
<p>Direction Photo Taken:                  Looking west</p>	
<p>Description:                  Pallets, drums and other debris; remnants of the former treatment system on the north side of the site.</p>

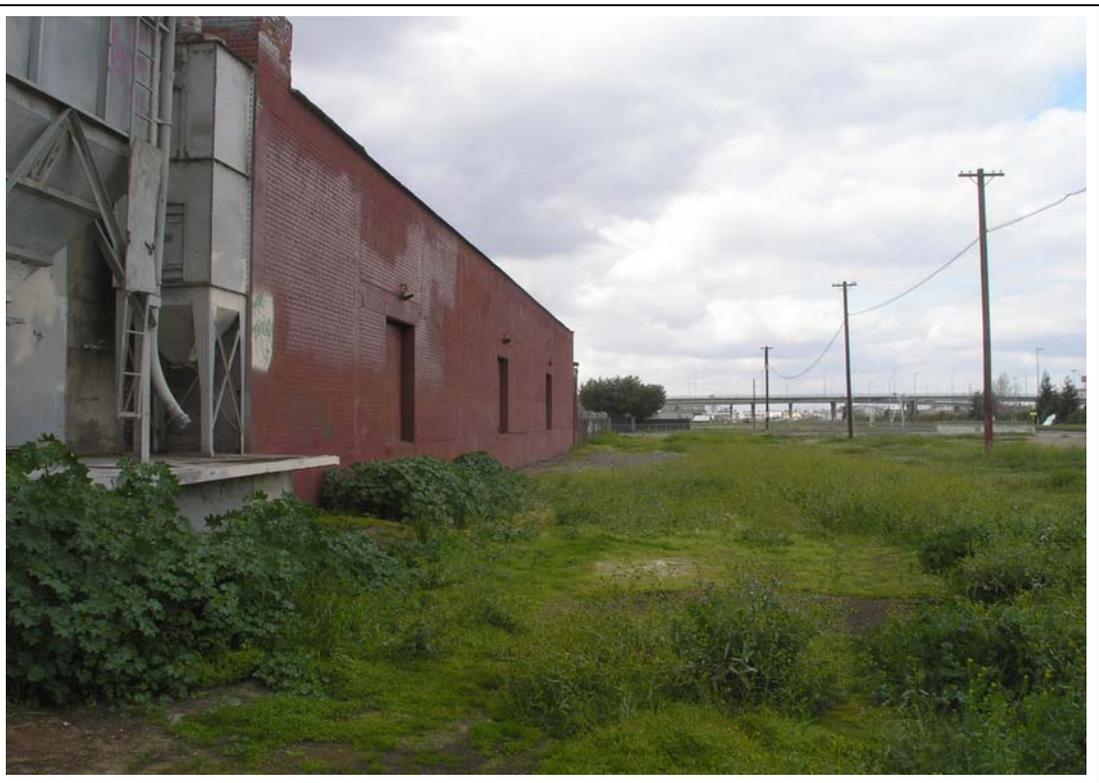
<p>Photo No.  <b>8</b></p>	
<p>Direction Photo Taken:                  Looking north</p>	
<p>Description:                  View of the east side of the site structure.</p>

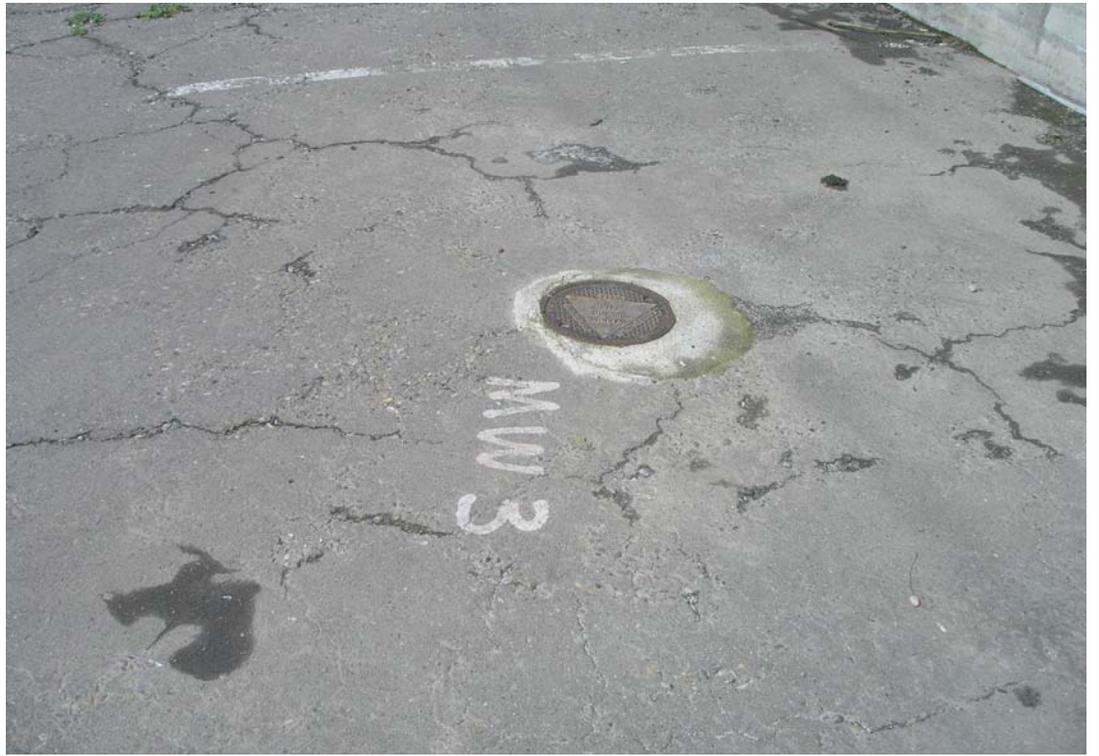
<p><b>Photo No.</b>  <b>9</b></p>
<p><b>Direction Photo Taken:</b>                   Looking north</p>
<p><b>Description:</b>                   One of several groundwater monitoring wells located on site.</p>

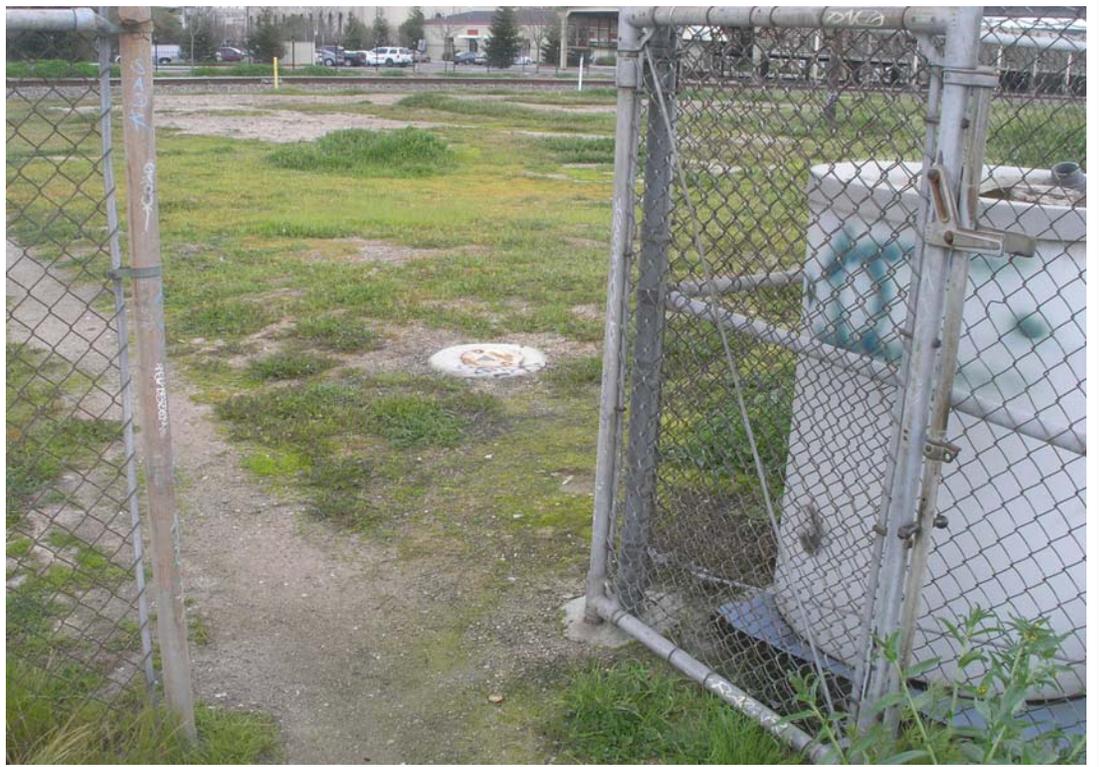
<p><b>Photo No.</b>  <b>10</b></p>
<p><b>Direction Photo Taken:</b>                   Looking east</p>
<p><b>Description:</b>                   Groundwater monitoring well located at the northeast corner of the site. Note the Union Pacific tracks in the background.</p>

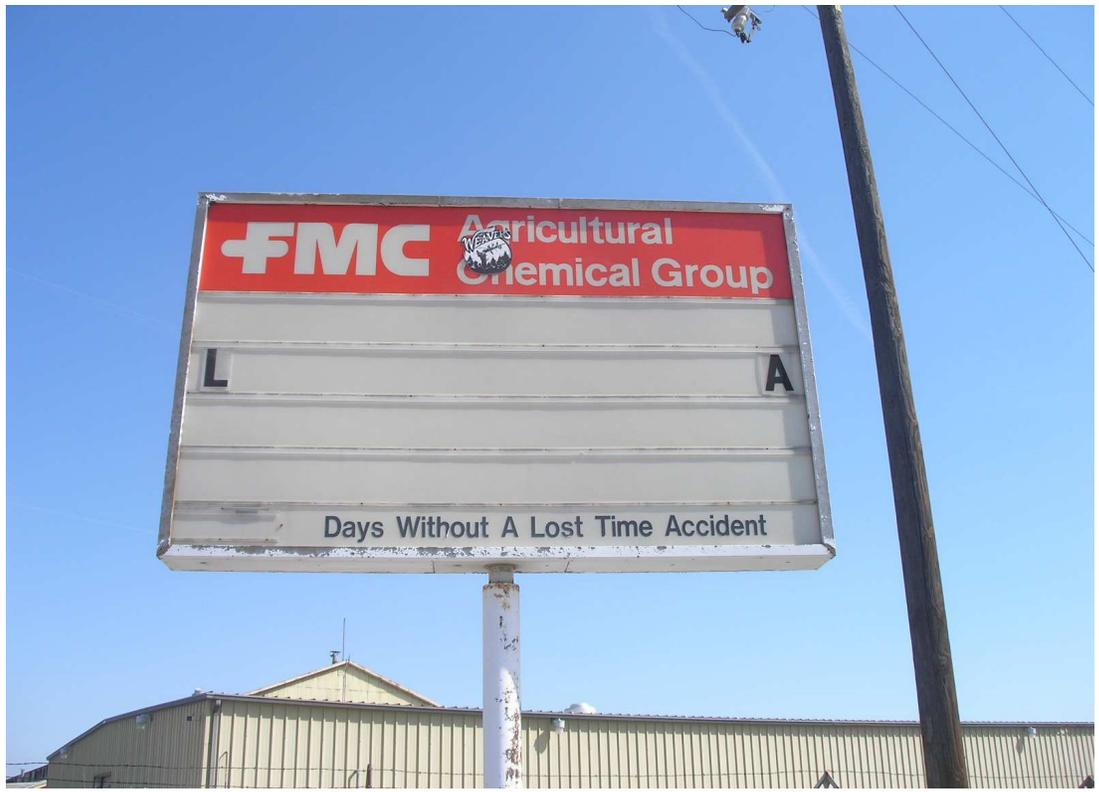
<p><b>Photo No.</b>                  1</p>	
<p><b>Direction Photo Taken:</b>                   Looking east</p>	
<p><b>Description:</b>                   FMC is the reported source for extensive groundwater contamination. The site has been identified as the source area for the South Fresno Regional Groundwater Plume operational unit #2 (OU-2).</p>

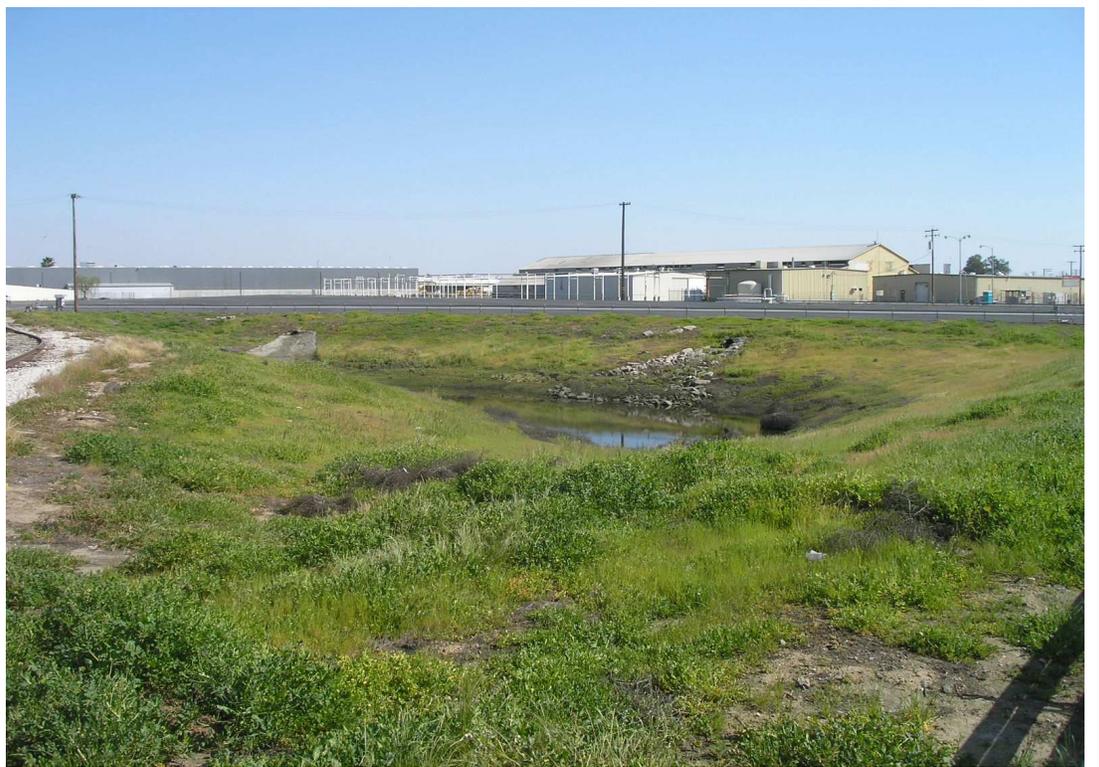
<p><b>Photo No.</b>                  2</p>	
<p><b>Direction Photo Taken:</b>                   Looking southeast</p>	
<p><b>Description:</b>                   Stormwater retention basin located near the northwest corner of the site. Berms have been installed so that no runoff leaves the site. Stormwater is piped to the retention basin via a series of pumps and pipelines.</p>

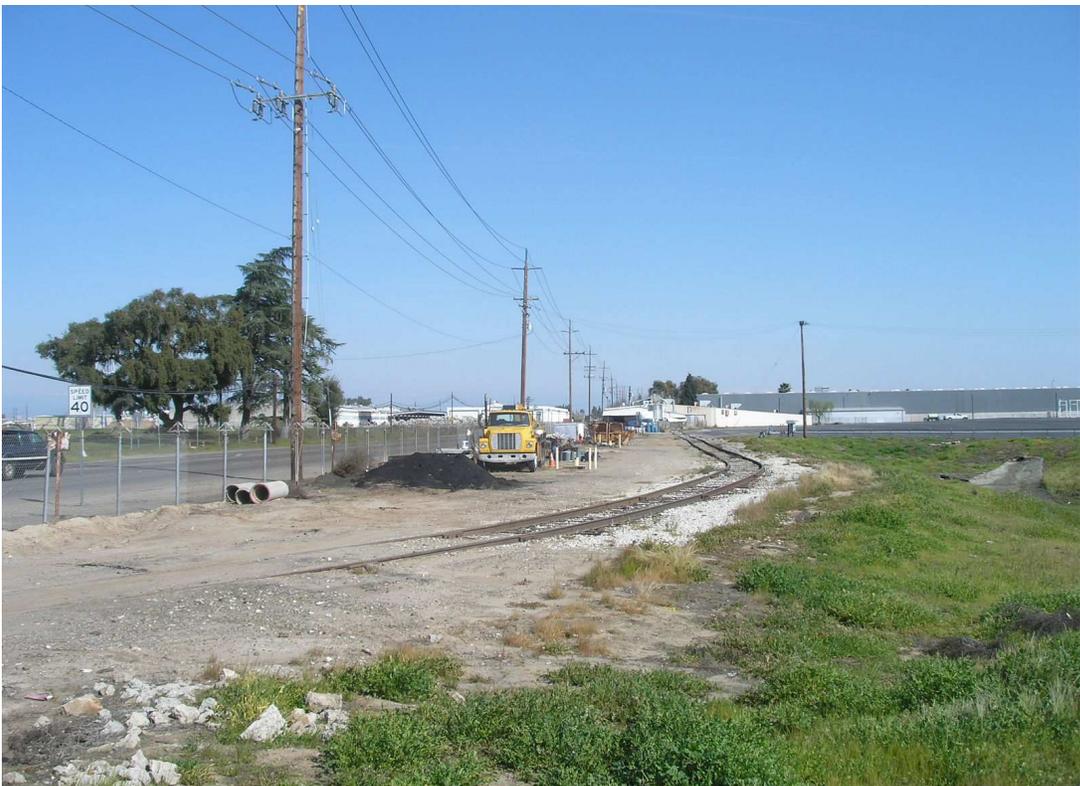
<p><b>Photo No.</b>  <b>3</b></p>

<p><b>Direction Photo Taken:</b>                   Looking east</p>	
<p><b>Description:</b>                   Railroad spur on the north end of the site.</p>

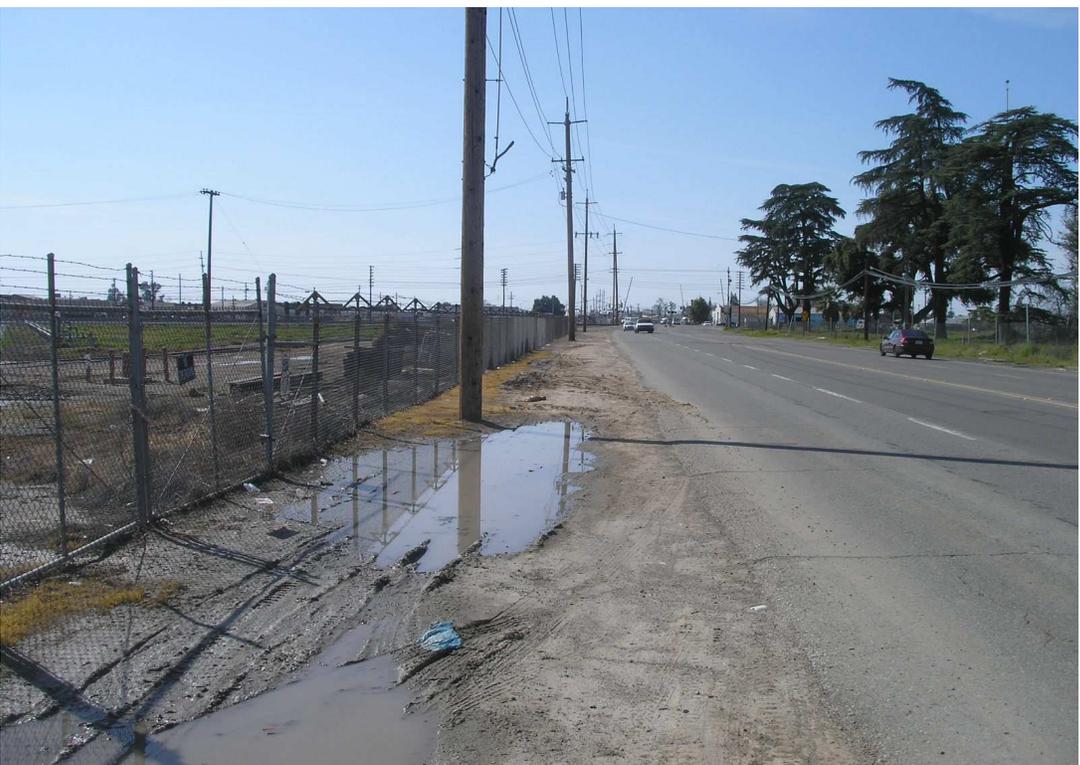
<p><b>Photo No.</b>  <b>4</b></p>

<p><b>Direction Photo Taken:</b>                   Looking west</p>	
<p><b>Description:</b>                   North end of the site along Church Avenue.</p>

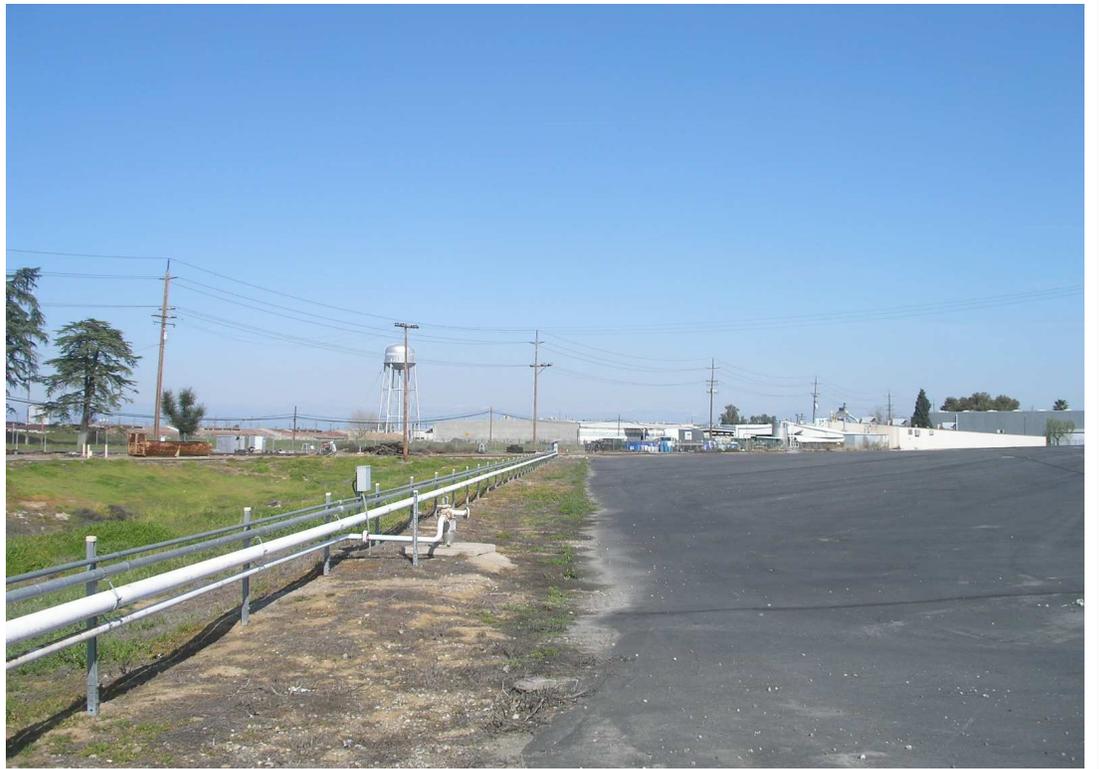
<p><b>Photo No.</b>  <b>5</b></p>
<p><b>Direction Photo Taken:</b>                   Looking northeast</p>
<p><b>Description:</b>                   View across the north lot. Pipeline is used to transport stormwater from various locations to the retention basin.</p>

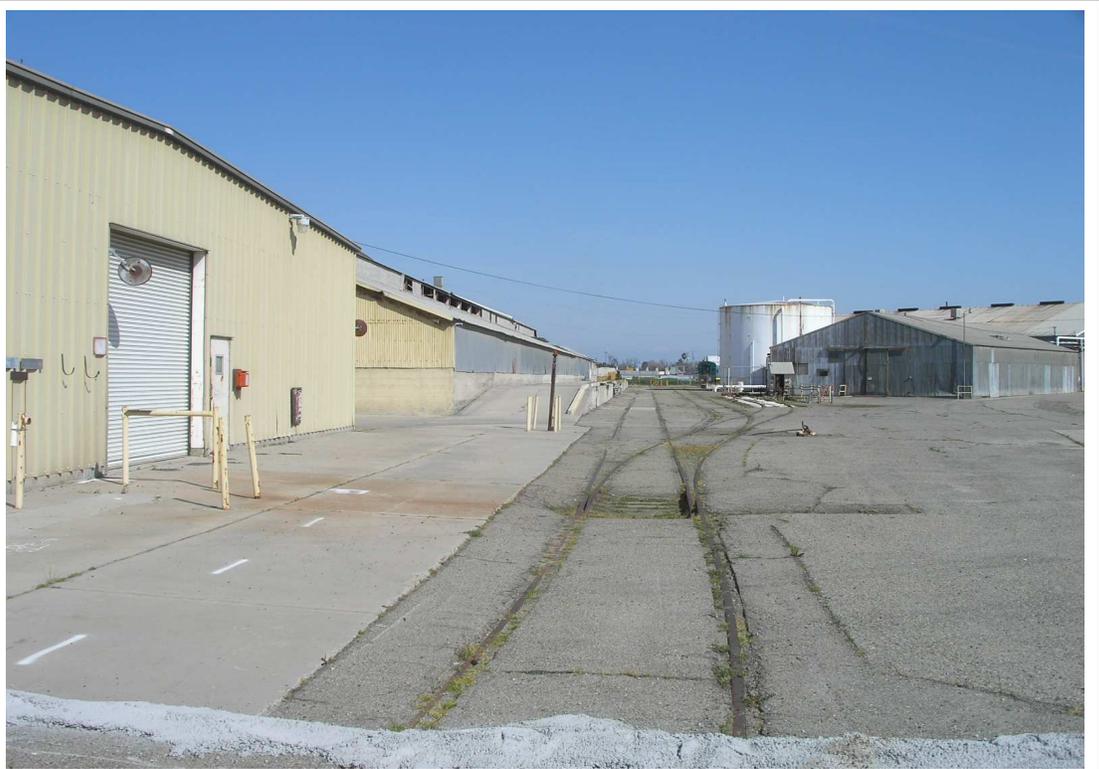
<p><b>Photo No.</b>  <b>6</b></p>
<p><b>Direction Photo Taken:</b>                   Looking east</p>
<p><b>Description:</b>                   Railroad spur into the main facility; a former agricultural chemical manufacturing and storage plant.</p>
