# Appendix D

## Phase I Site Reconnaissance, Field Notes, Photographs, and Photo Logs Part 1

**HST PHASE I ENVIRONMENTAL SITE ASSESSMENT**

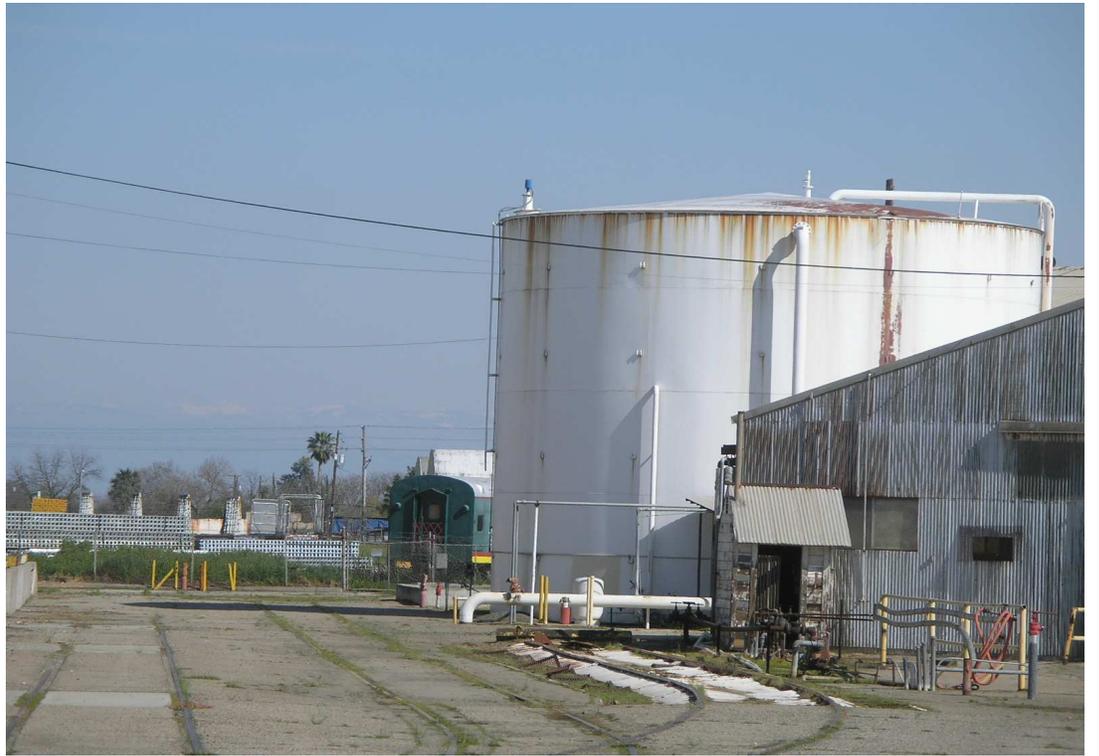
<p><b>Photo No.</b>  <b>7</b></p>	
<p><b>Direction Photo Taken:</b>                   Looking east</p>	
<p><b>Description:</b>                   Chemical storage and transport.</p>

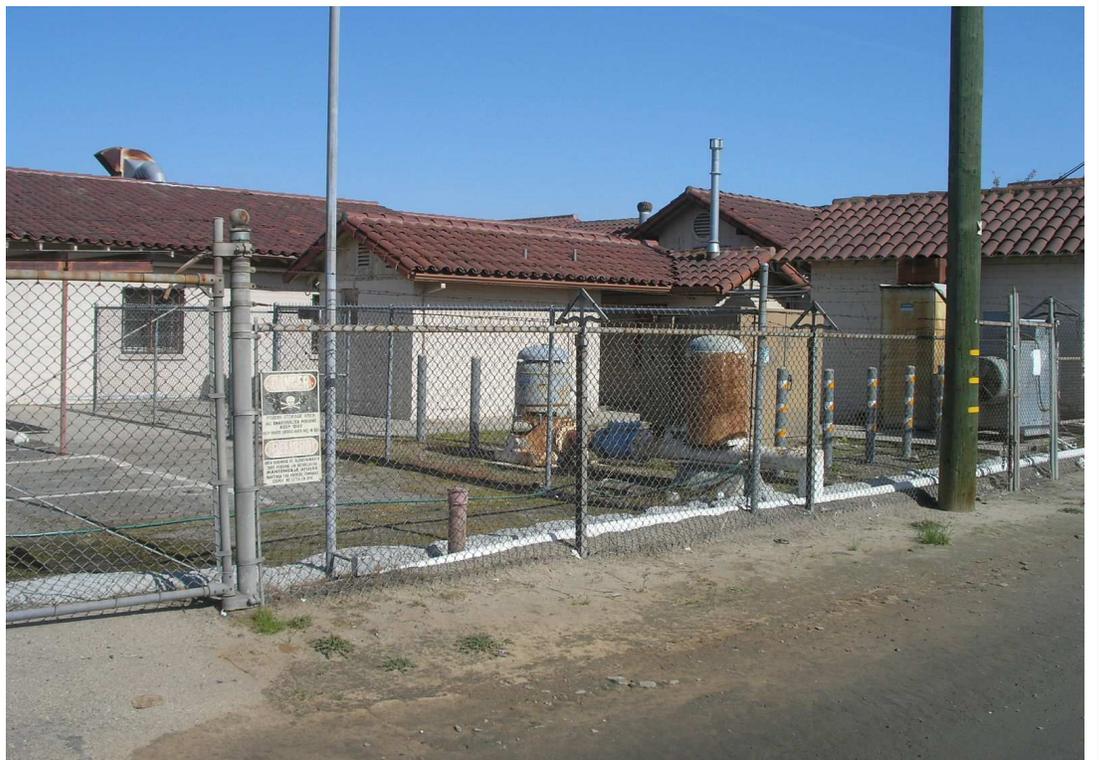
<p><b>Photo No.</b>  <b>8</b></p>	
<p><b>Direction Photo Taken:</b>                   Looking southeast</p>	
<p><b>Description:</b>                   Onsite water supply well near Sunland Avenue. Note the hazardous materials warning sign and pad-mounted transformer.</p>

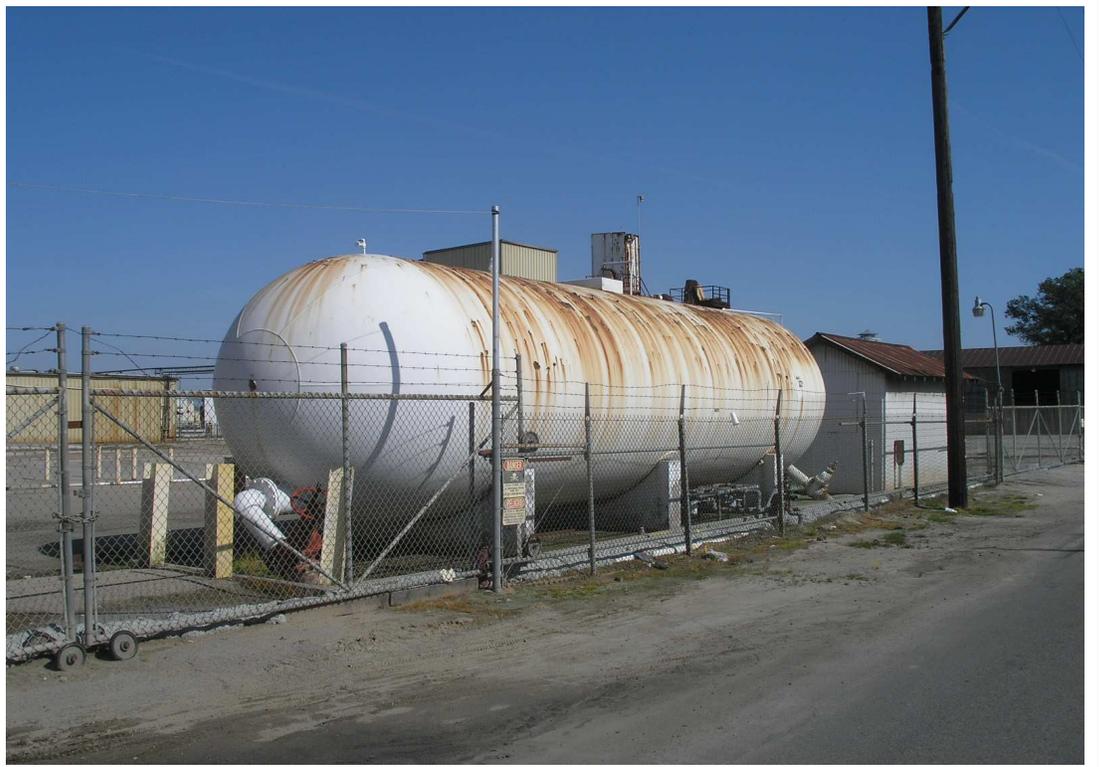
<p><b>Photo No.</b>  <b>10</b></p>
<p><b>Direction Photo Taken:</b>                   Looking southeast</p>
<p><b>Description:</b>                   Water (chemical?) storage tank near Sunland Avenue. Note the hazardous materials warning sign.</p>

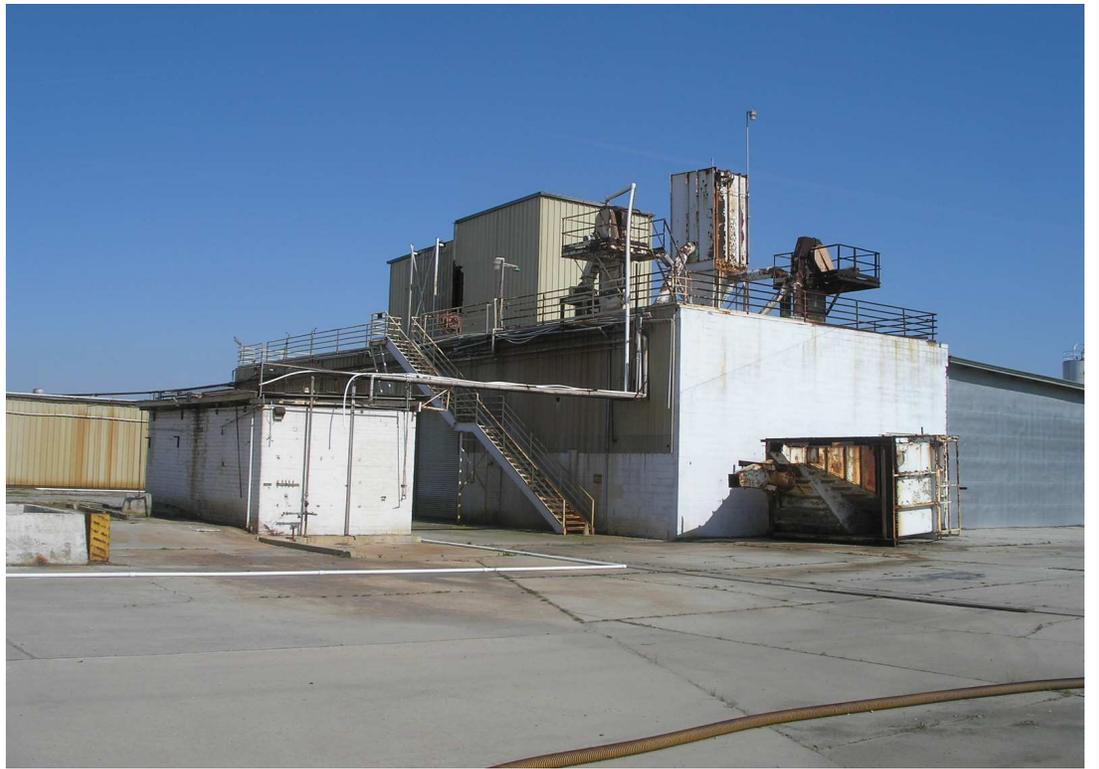
<p><b>Photo No.</b>  <b>11</b></p>	
<p><b>Direction Photo Taken:</b>                   Looking east</p>	
<p><b>Description:</b>                   Chemical formulation and storage.</p>

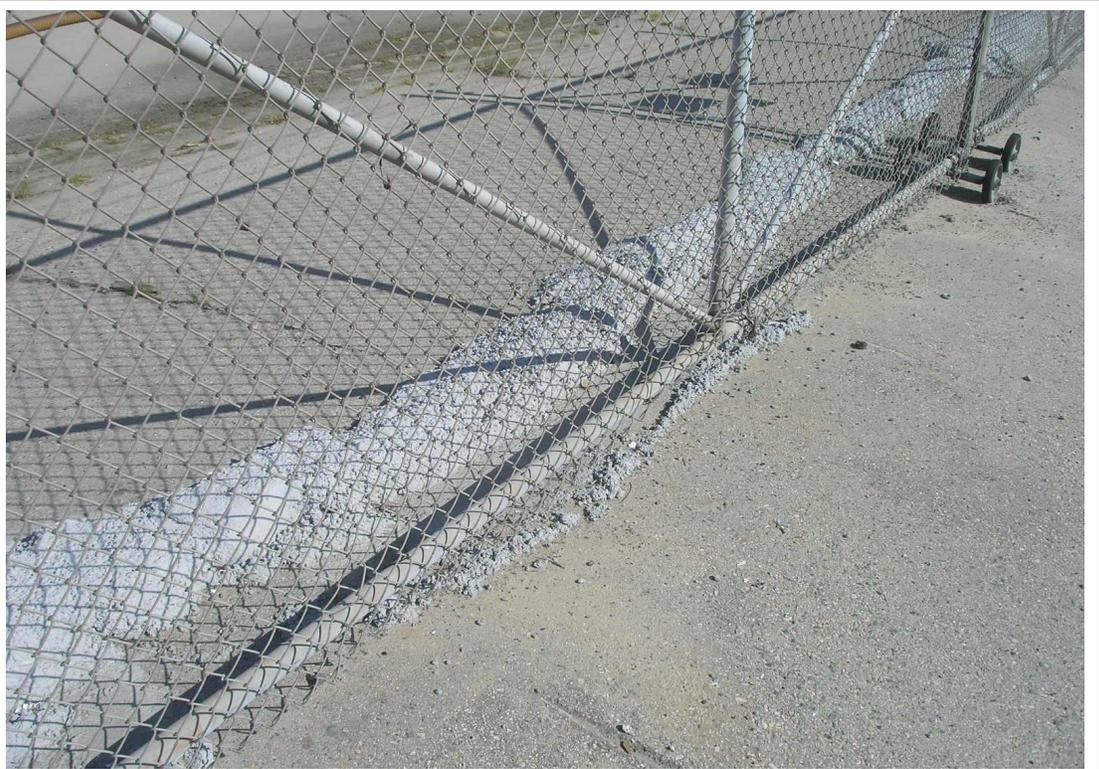
<p><b>Photo No.</b>  <b>12</b></p>	
<p><b>Direction Photo Taken:</b>                   Looking southeast</p>	
<p><b>Description:</b>                   A temporary, makeshift berm has been installed around most of the facility to keep stormwater runoff onsite.</p>

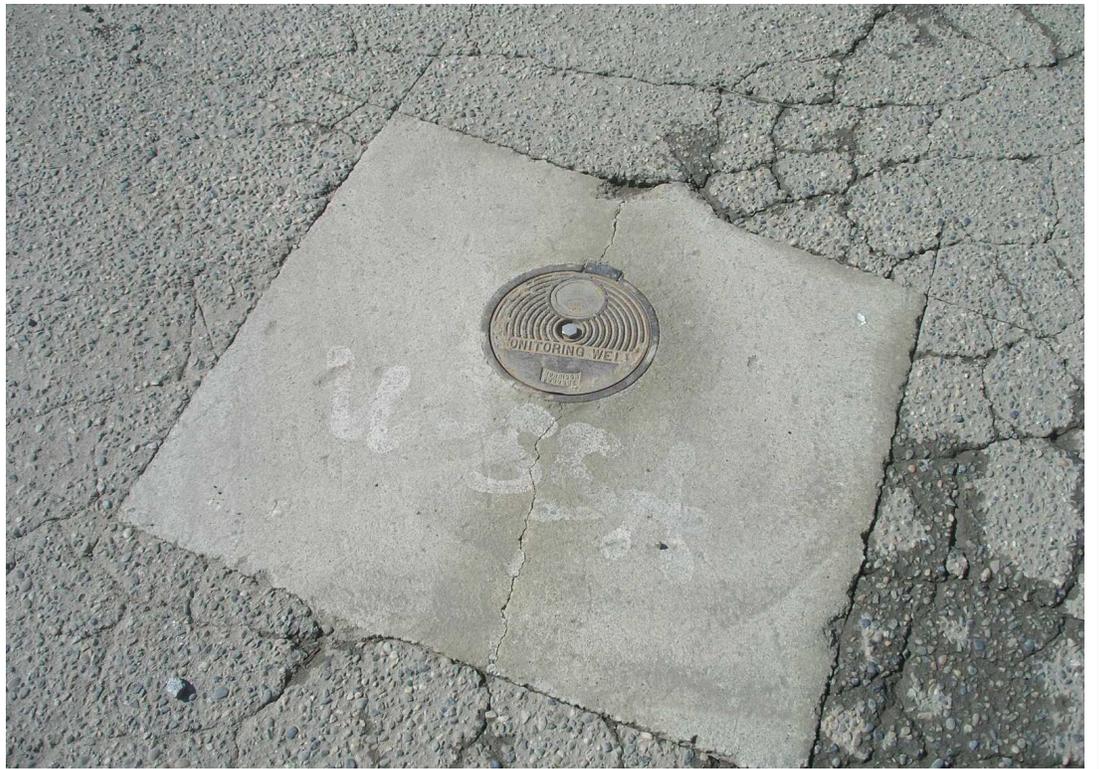
<p><b>Photo No.</b>  <b>13</b></p>	
<p><b>Direction Photo Taken:</b>                   Looking north</p>	
<p><b>Description:</b>                   Multiple groundwater monitoring wells were observed onsite.</p>

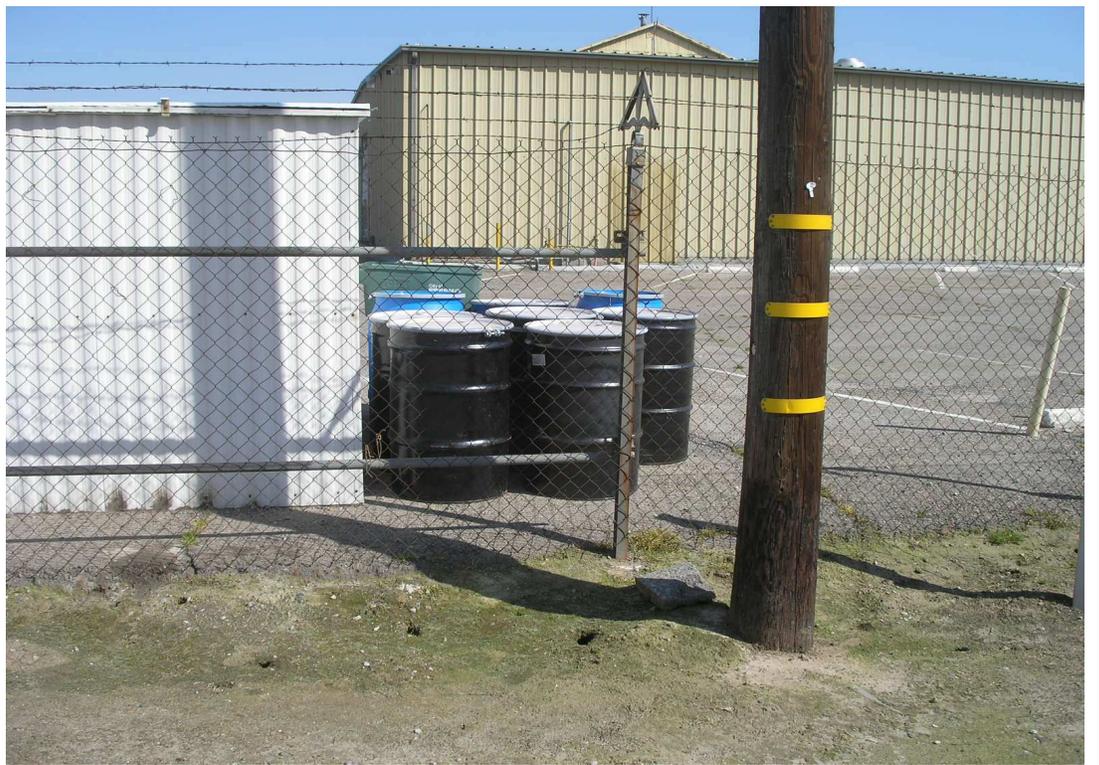
<p><b>Photo No.</b>  <b>14</b></p>	
<p><b>Direction Photo Taken:</b>                   Looking east</p>	
<p><b>Description:</b>                   Purgewater storage drums used by technicians performing groundwater monitoring onsite.</p>

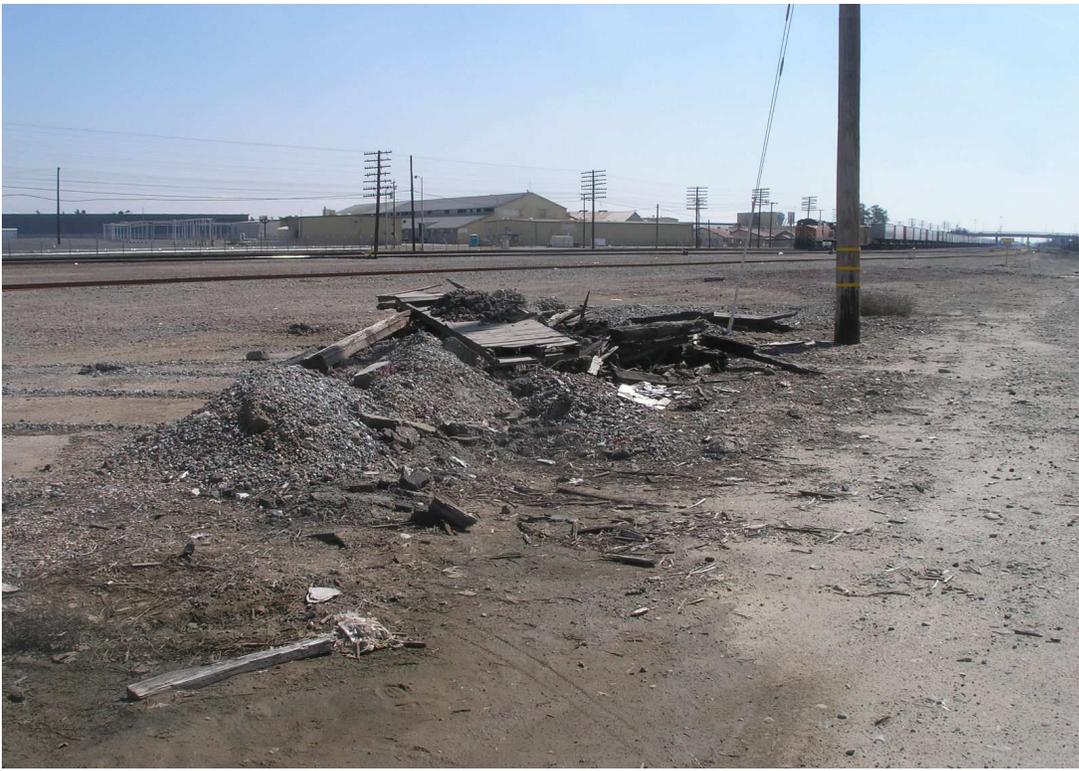
<p><b>Photo No.</b>  <b>5</b></p>

<p><b>Direction Photo Taken:</b>                   Looking southeast</p>	
<p><b>Description:</b>                   Debris near the middle of the site.</p>

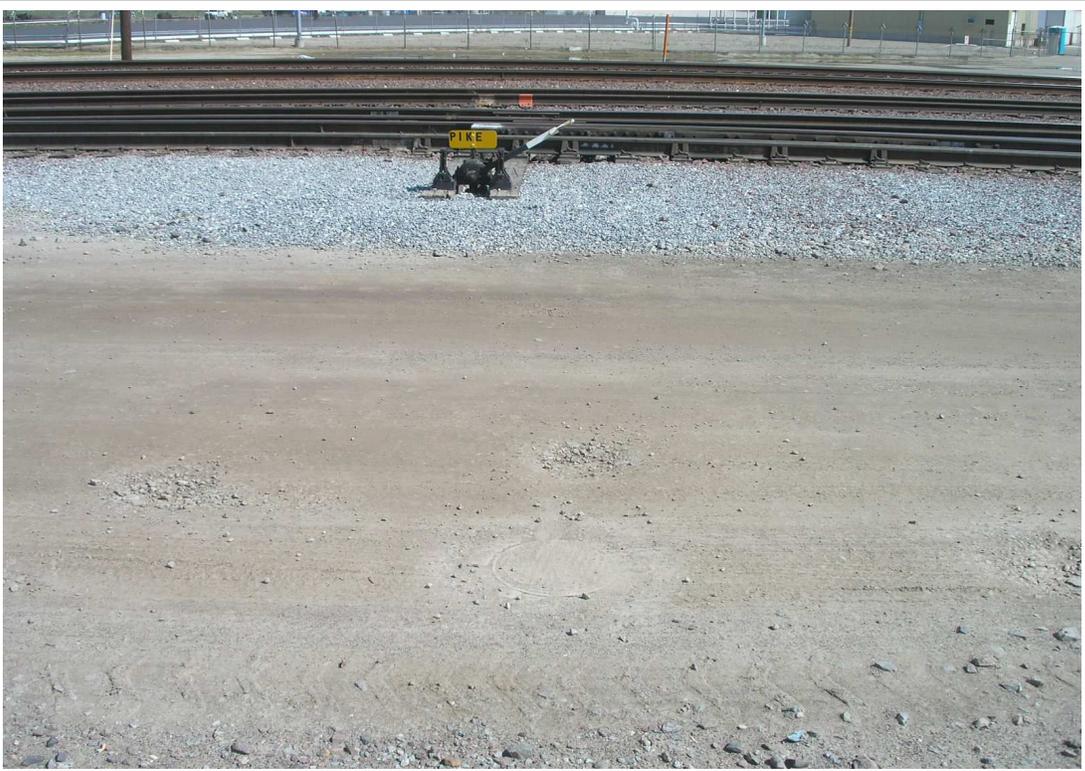
<p><b>Photo No.</b>  <b>8</b></p>

<p><b>Direction Photo Taken:</b>                   Looking east</p>	
<p><b>Description:</b>                   One of two groundwater monitoring wells located on the site (middle foreground of the frame). BNSF tracks are in the background.</p>

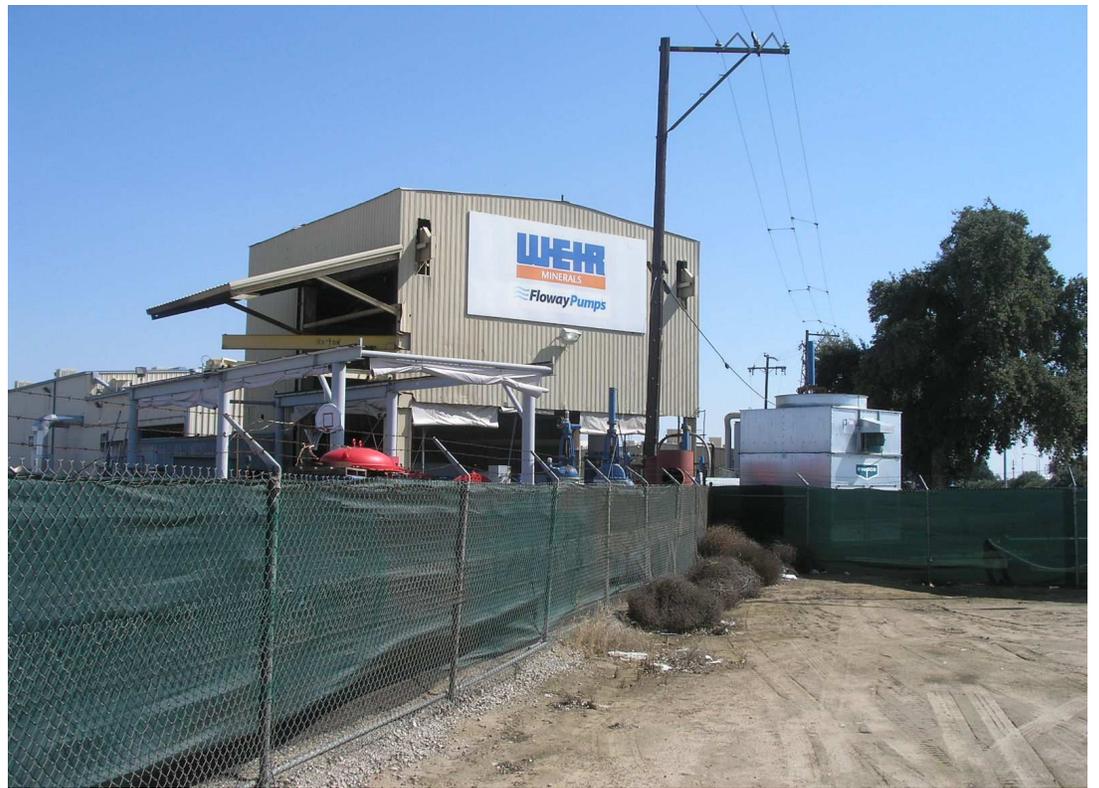
<p><b>Photo No.</b>  <b>1</b></p>	
<p><b>Direction Photo Taken:</b>                   Looking south</p>	
<p><b>Description:</b>                   Weir Floway is the reported source for extensive groundwater contamination. The site has been identified as the source area for the South Fresno Regional Groundwater Plume operational unit #1 (OU-1). The site is between Golden State Boulevard and Railroad Avenue.</p>

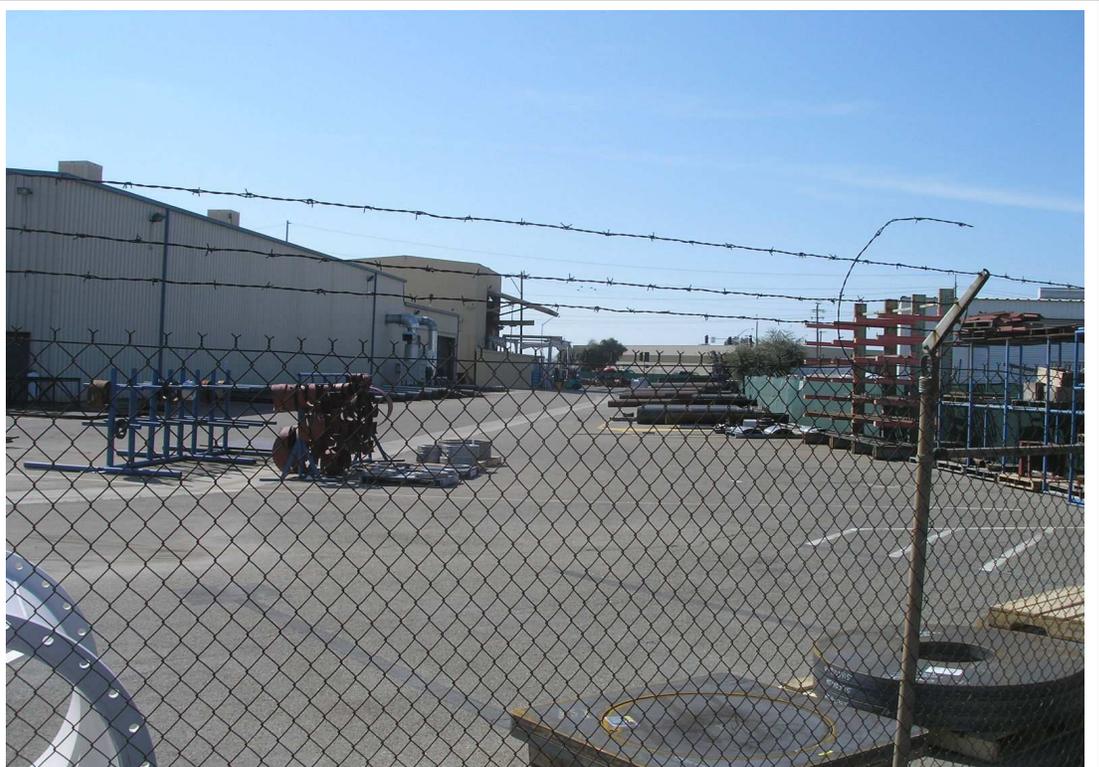
<p><b>Photo No.</b>  <b>2</b></p>	
<p><b>Direction Photo Taken:</b>                   Looking west</p>	
<p><b>Description:</b>                   Storage yard for Floway pumps manufacturing, sales and service at the north end of the site.</p>

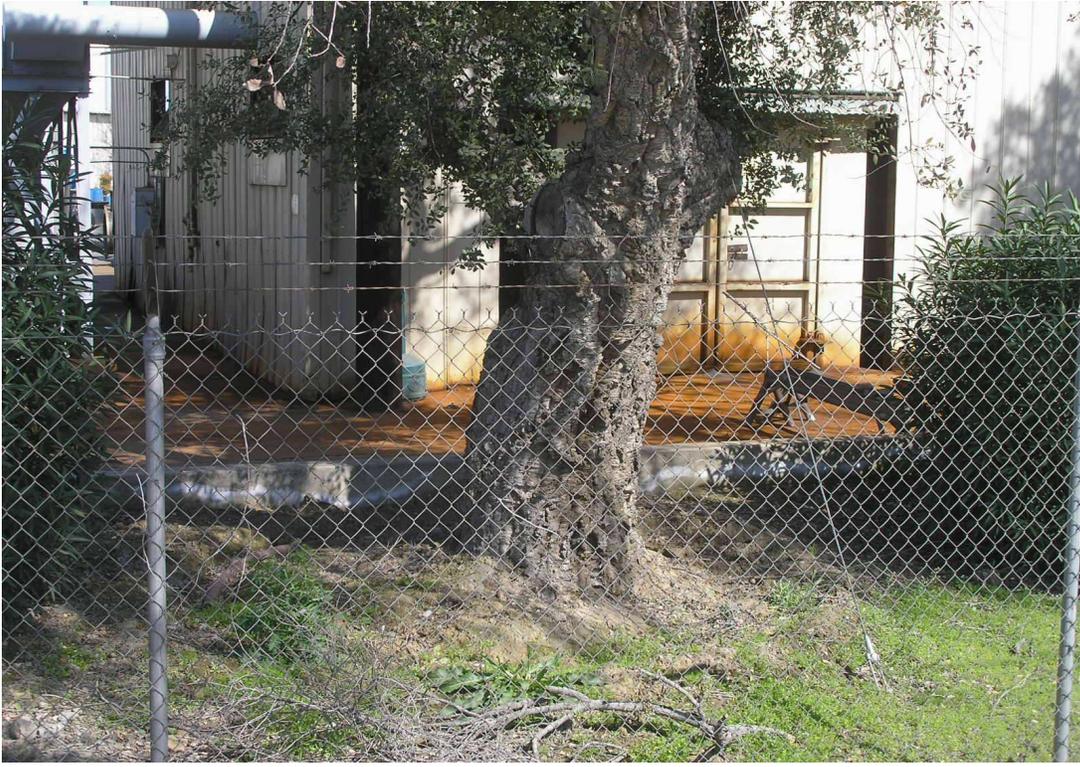
<p><b>Photo No.</b>  <b>3</b></p>

<p><b>Direction Photo Taken:</b>                   Looking east</p>	
<p><b>Description:</b>                   Chemical and mineral staining in the Floway pumps shop area on the west side of the site.</p>

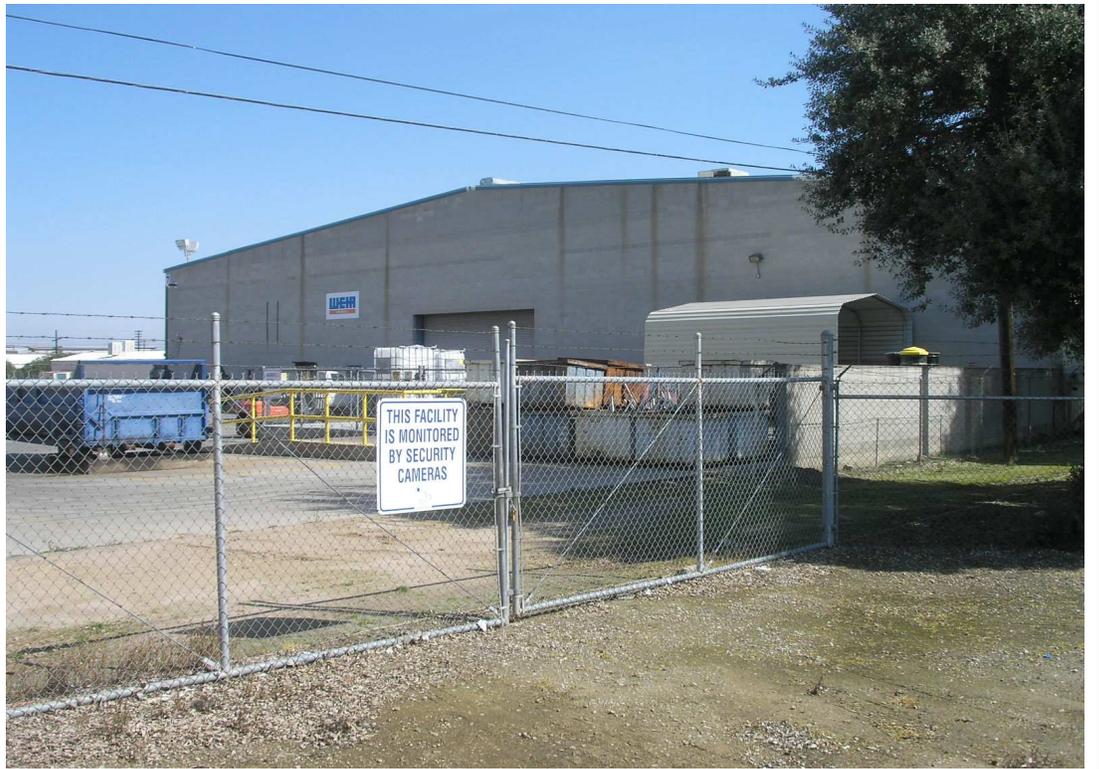
<p><b>Photo No.</b>  <b>5</b></p>
<p><b>Direction Photo Taken:</b>                   Looking southeast</p>
<p><b>Description:</b>                   Chemical totes and mineral bins located near the middle of the site along Golden State Boulevard.</p>

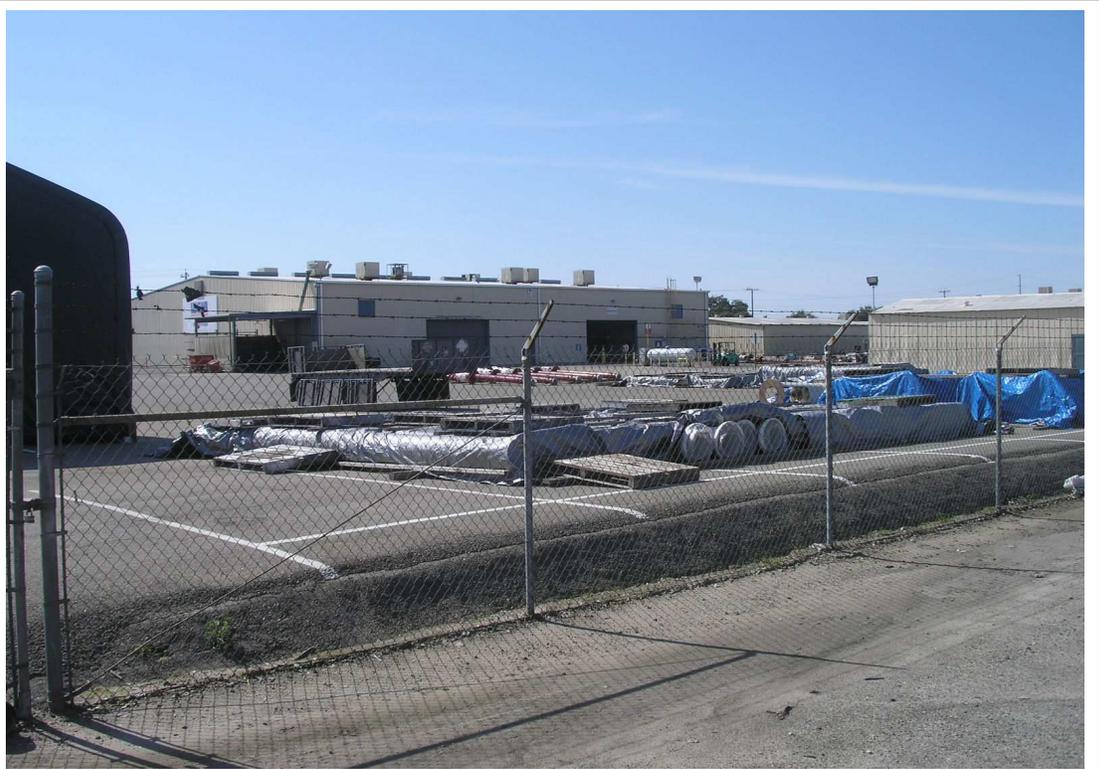
<p><b>Photo No.</b>  <b>6</b></p>
<p><b>Direction Photo Taken:</b>                   Looking northwest</p>
<p><b>Description:</b>                   Pumps and materials storage in the middle of the site along Railroad Avenue.</p>

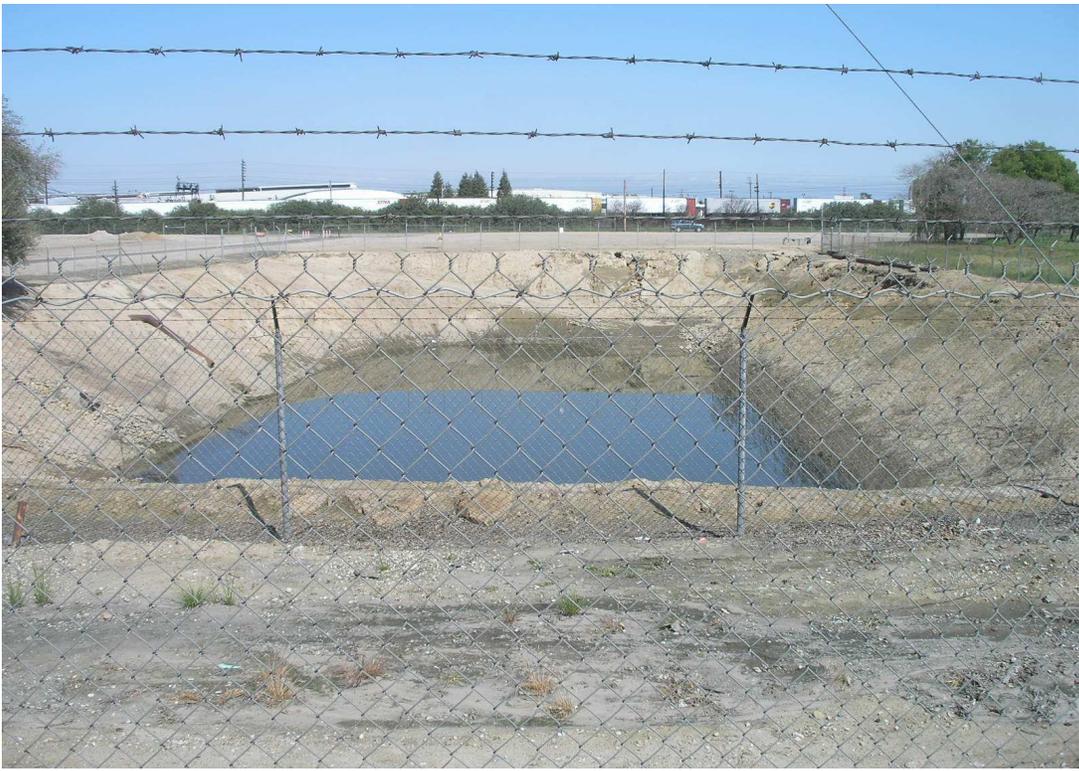
<p><b>Photo No.</b>  <b>7</b></p>

<p><b>Direction Photo Taken:</b>                  Looking east</p>	
<p><b>Description:</b>                  Stormwater retention basin located in the southwest corner of the site.</p>

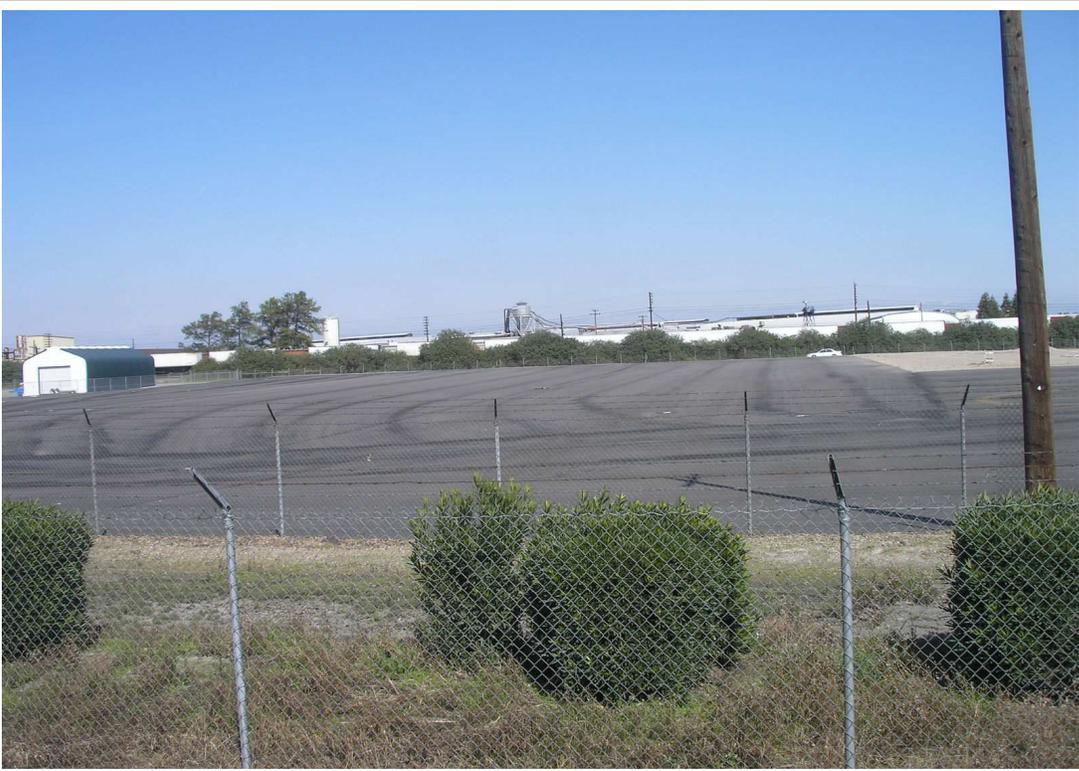
<p><b>Photo No.</b>  <b>8</b></p>

<p><b>Direction Photo Taken:</b>                  Looking east</p>	
<p><b>Description:</b>                  View of the remediation site: groundwater extraction and monitoring well field located at the south end of the site. The location is covered with asphalt to inhibit stormwater infiltration. View is from Golden State Boulevard.</p>

SOUTHERN ~ 1/4 OF THE SITE HAS AN IMPERVIOUS CAP AND IS GRADED TO CAPTURE RUNOFF TO THE ONSITE RETENTION BASIN; NUMEROUS MONITORING WELLS OBSERVED ONSITE

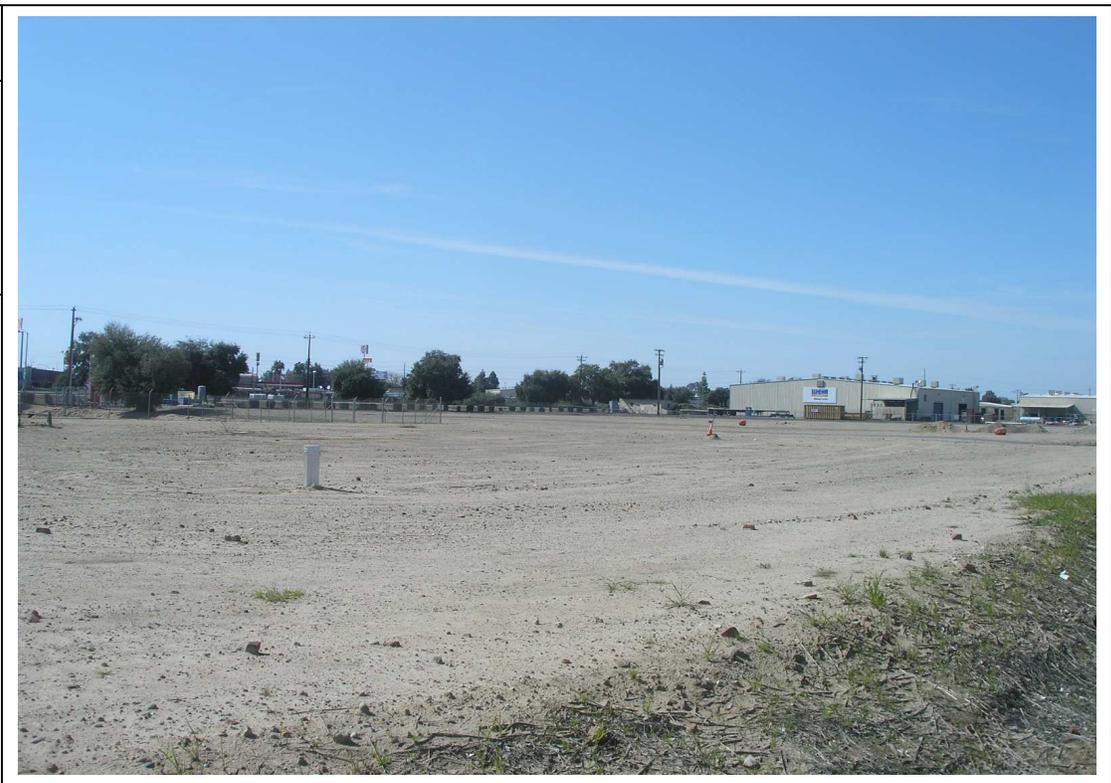
<p><b>Photo No.</b>  <b>10</b></p>
<p><b>Direction Photo Taken:</b>                   Looking northwest</p>
<p><b>Description:</b>                   View from the southeast corner of the site along Railroad Avenue. Uncovered area of the site with multiple groundwater monitoring wells.</p>
